ARLINGTON RANCH
ARLINGTON RANCH
Preliminary Defect List &
Repair Recommendations
January 7, 2008
16.0 WINDOWS

FOR MEDIATION PURPOSES ONLY.
FOR MEDIATION PURPOSES ONLY.
N.R.S. 48.109 and N.R.S.40.680

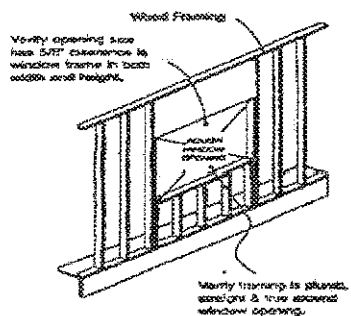
Figure 1

R.H. Adcock found 12 of 25 windows tested to have shear panel surrounding windows. For proper installation of the window flashing system the shear panel edges must continue to window frame opening so as not to create a crease in the window flashing.

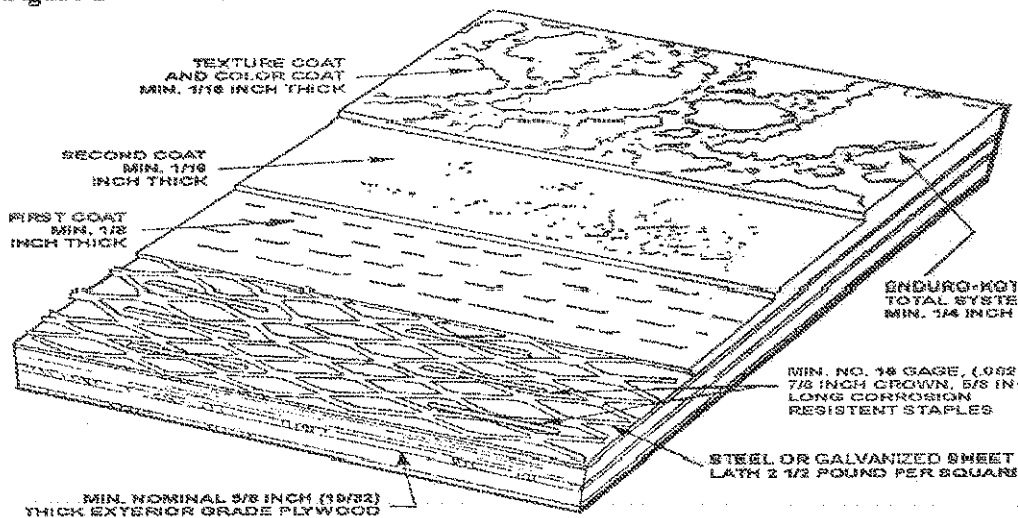
R.H. Adcock will use Enduro-Kote as a representative example as to the conditions of the balcony at High Noon. Figure 1 below shows the type of waterproof system installed at the balconies.
