ARLINGTON RANCH
Preliminary Defect List &
Repair Recommendations
January 7, 2008
16.0 WINDOWS

STRUCTURAL DEFECTS REPORT

ARLINGTON RANCH STRUCTURAL DEFECTS MATRIX

ARLINGTON RANCH STRUCTURAL REPAIR RECOMMENDATIONS

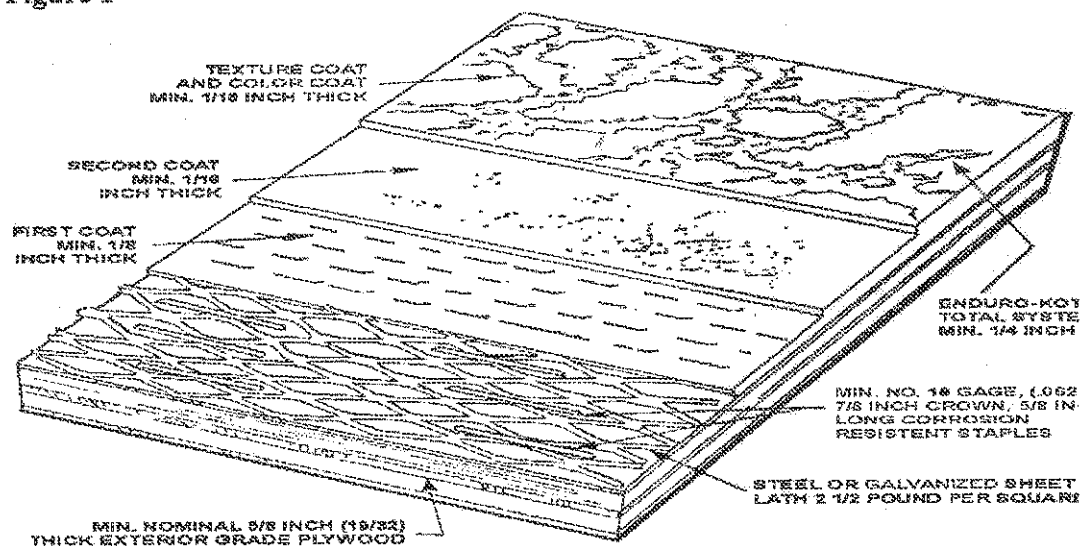
R.H. Adcock will use Enduro-Kote as a representative example as to the conditions of the balcony at High Noon. Figure 1 below shows the type of waterproof system installed at the balconies.
