SWIMMING POOL

In summary, we consider this home to be in somewhat above average condition. Good quality materials and workmanship are evident throughout. While there is some work to do, as we have discussed in this report, in general, you should consider this home to be of good quality. It should serve you well for quite some time.

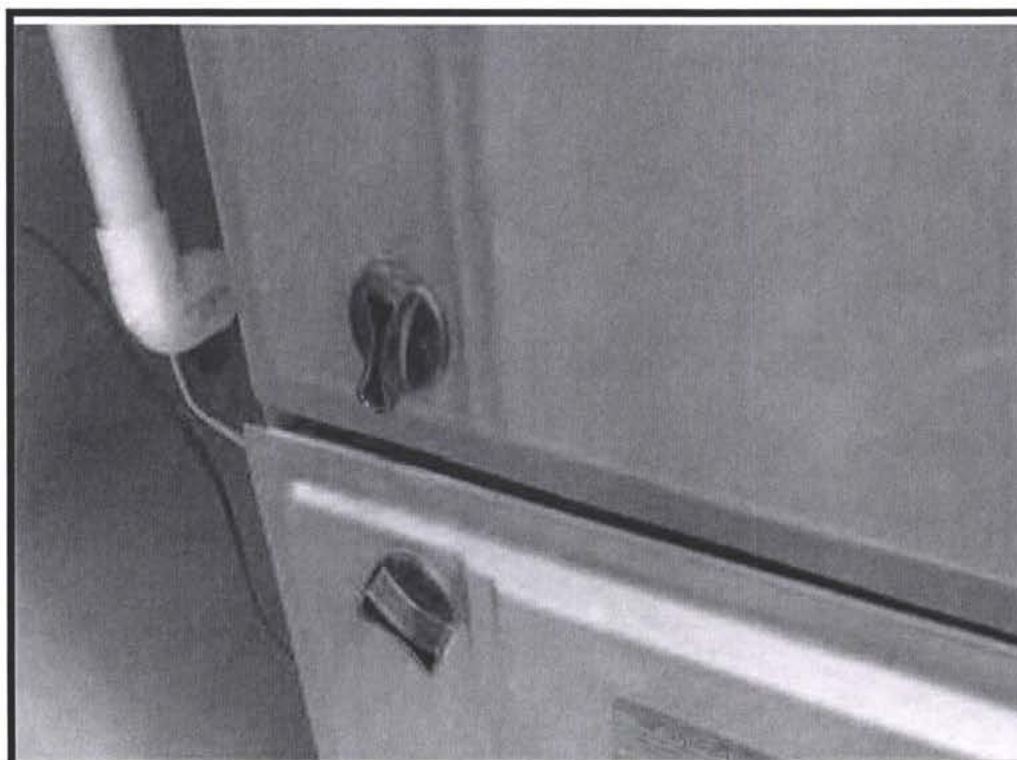
The door is not secure at the right side air handler.

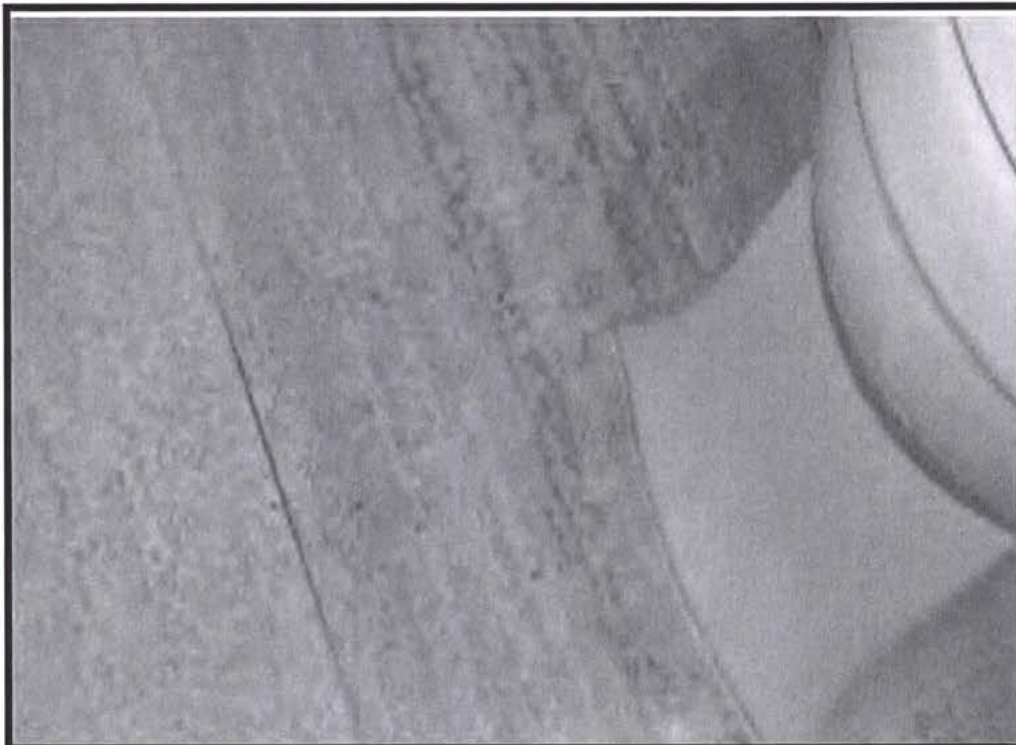
There is a plumbing leak at the ceiling of the basement bathroom. This is the water on the floor under the drip.

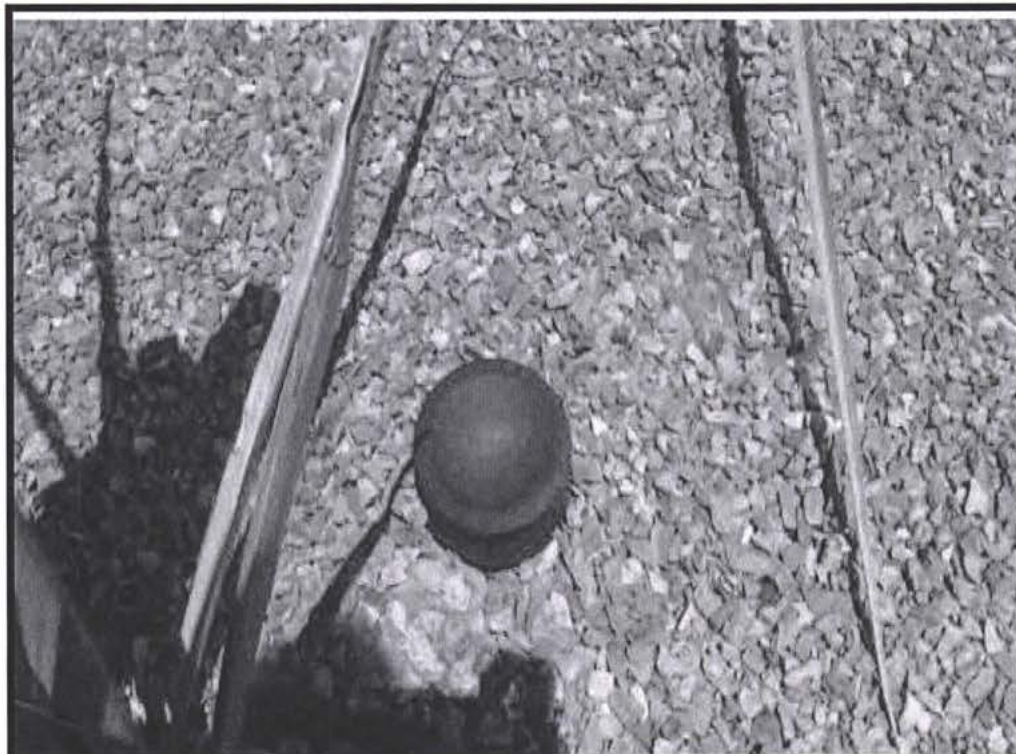
Photo Number
7

The drain clean-outs should have permanent screw type caps.

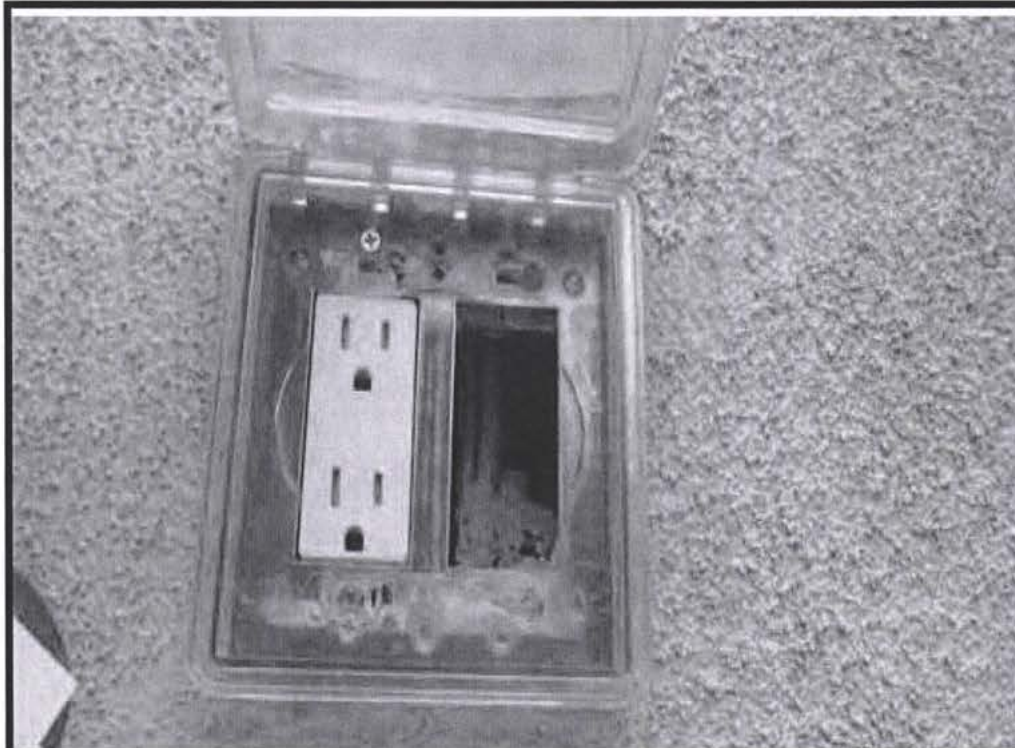
Photo Number
11

There is an incomplete outlet at the wall of the lower patio.

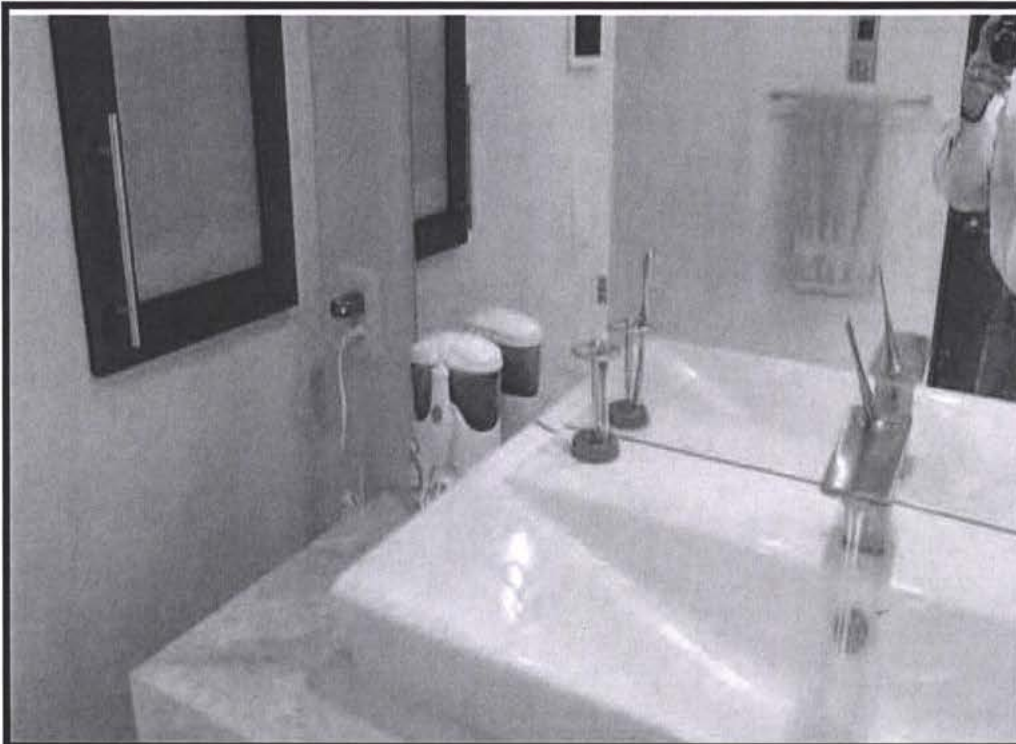
The outlets at the master bathroom sinks are not GFCI protected.

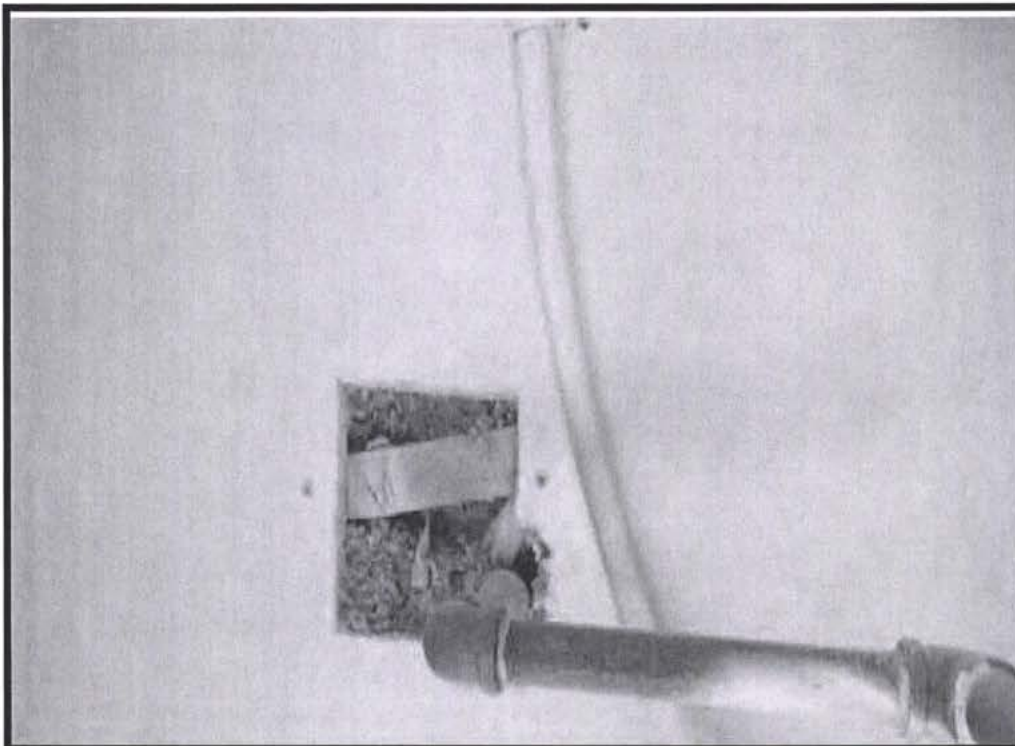
The drywall is damaged at the right side exterior mechanical closet.

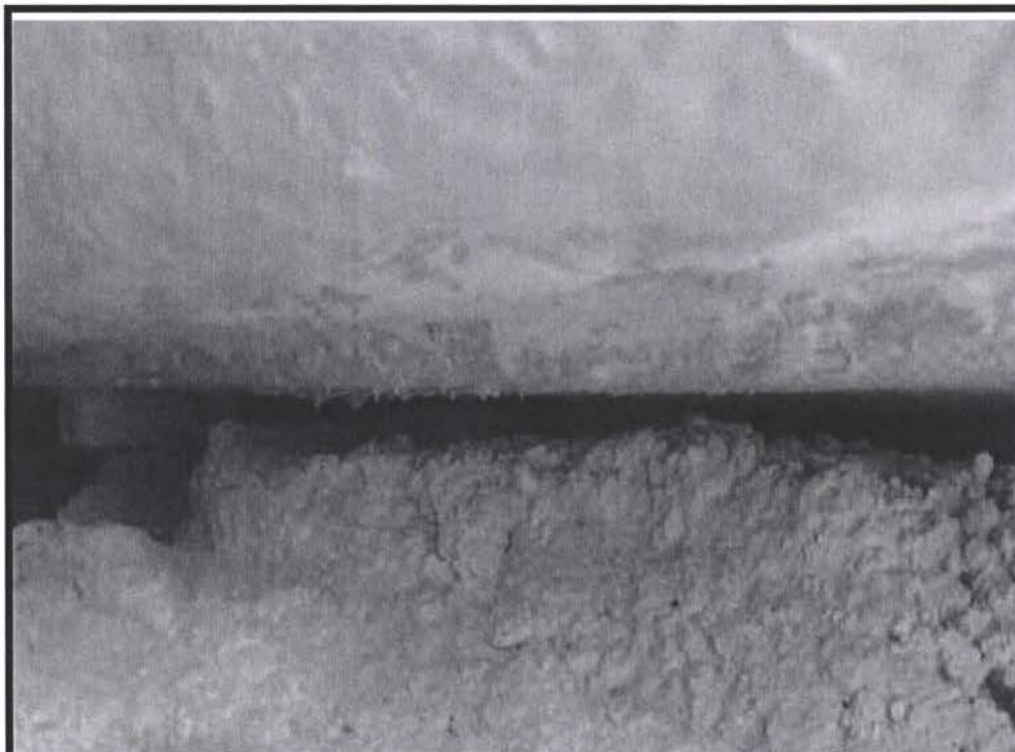
Photo Number
17

The whirlpool tub is not supported from the floor.

- Maintain/repair the whirlpool bath
 - The jet nozzles are missing. They should be installed.
 - There is no support under the tub, appropriate support should be installed.
- Maintain/repair the swimming pool and equipment
 - The water distribution for the water wall should be adjusted to reduce splashing.

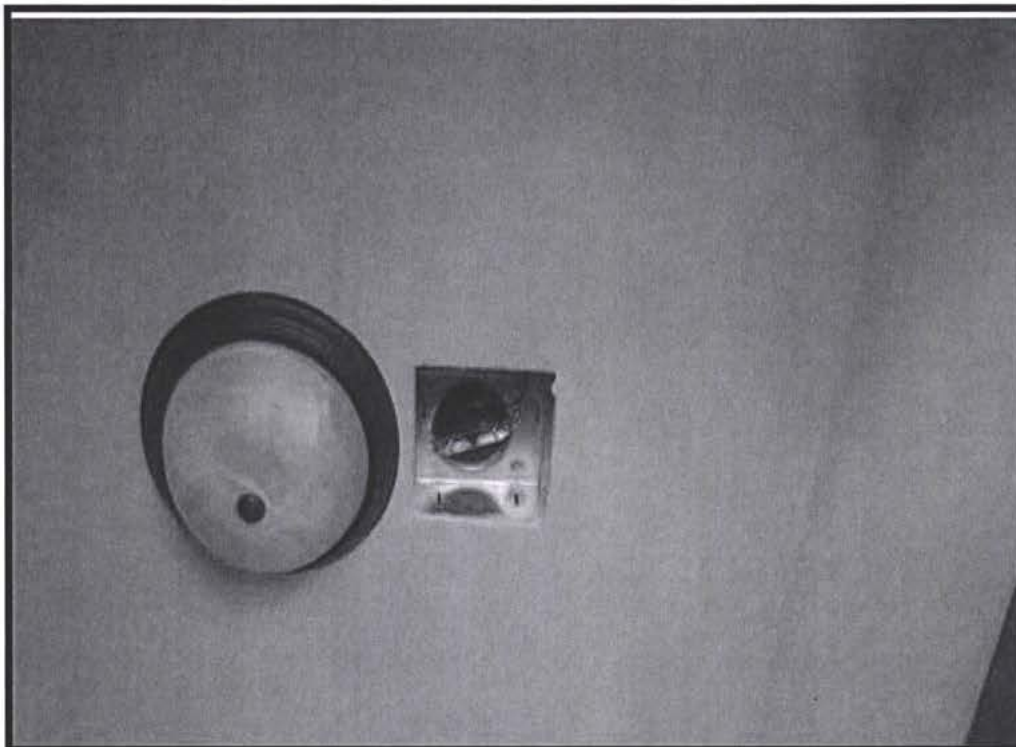
The cover is missing from the vent fan in the media closet.

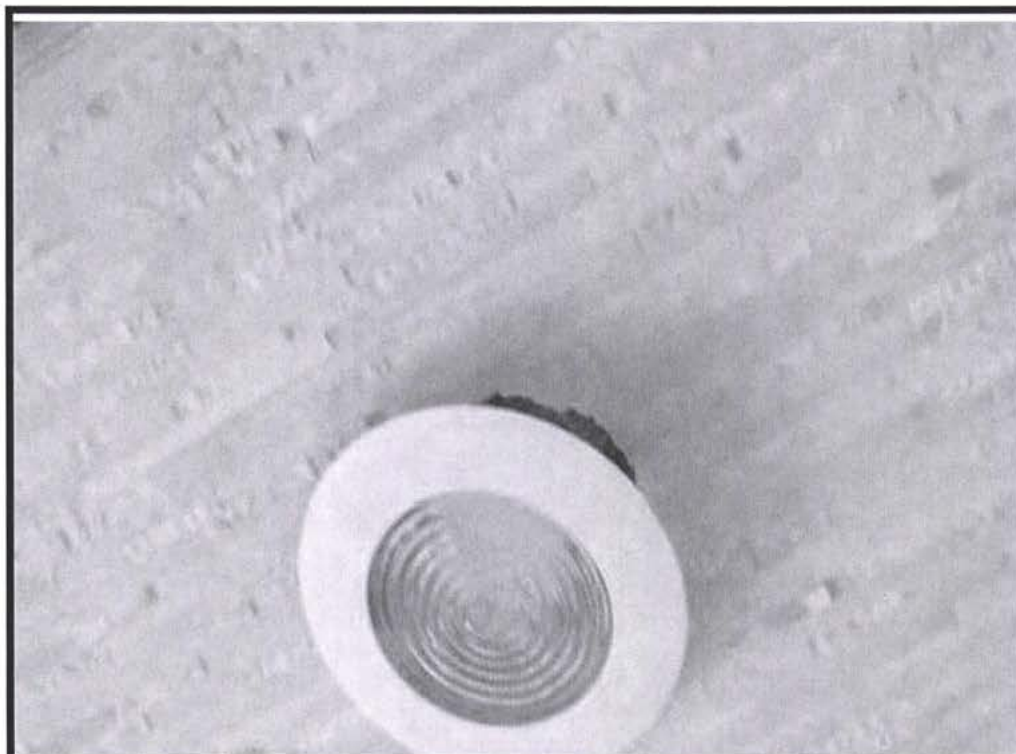
Photo Number
19

There is a loose light in the master shower.

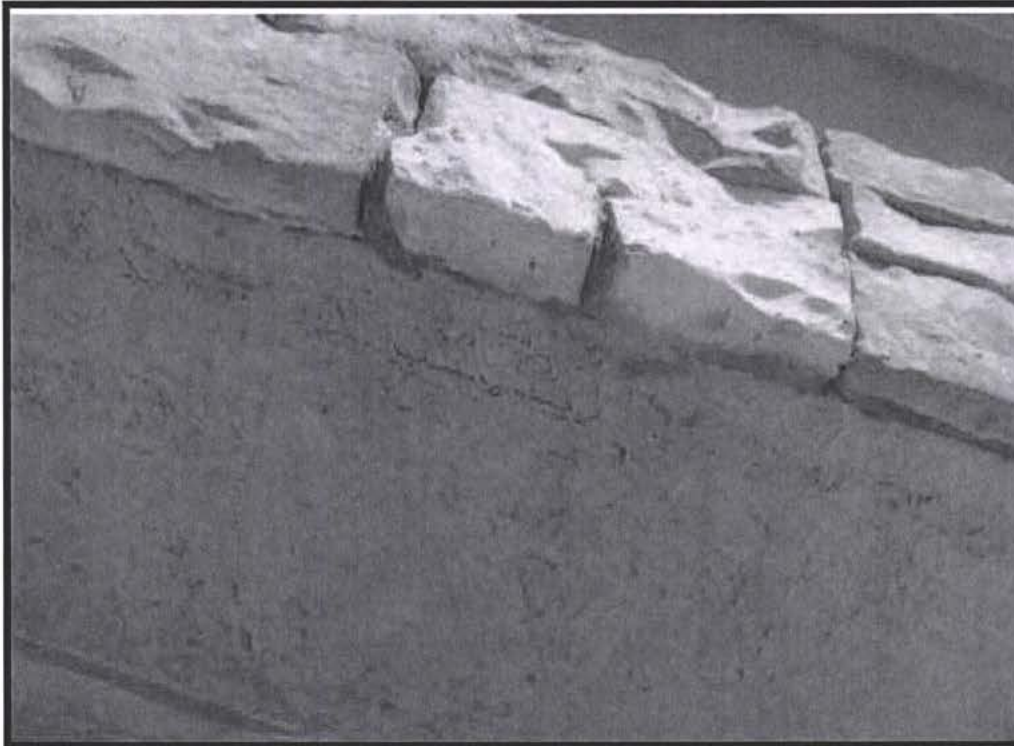
There is unfinished stucco at the roof parapet feature.

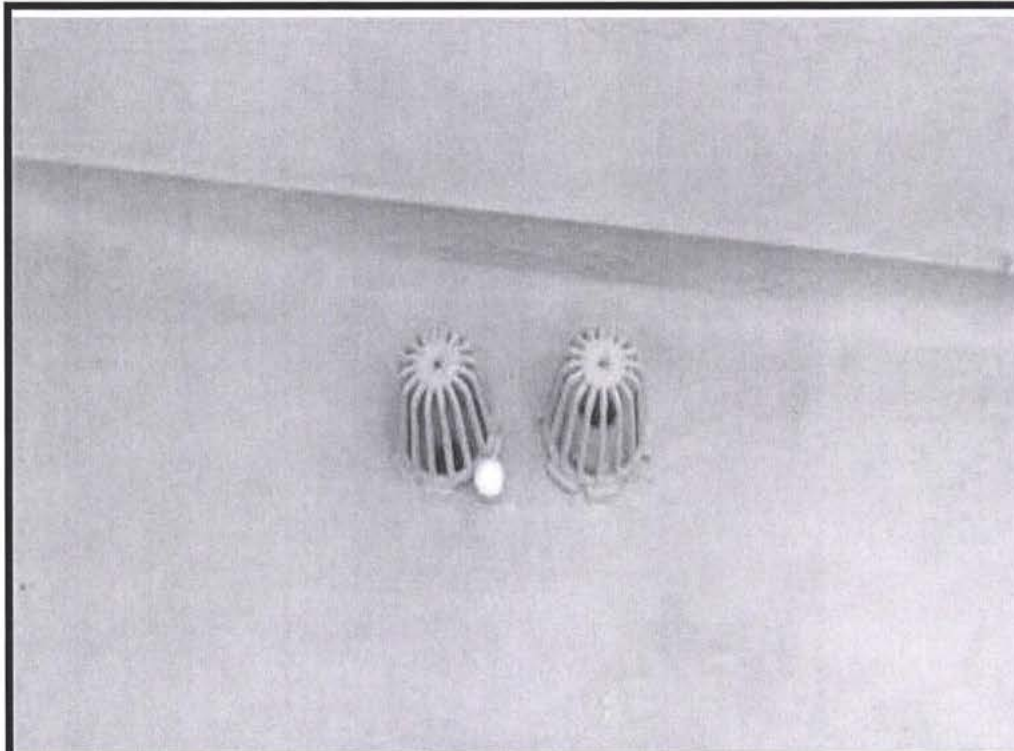
Photo Number
27

The debris guards should be removed from the secondary drains.

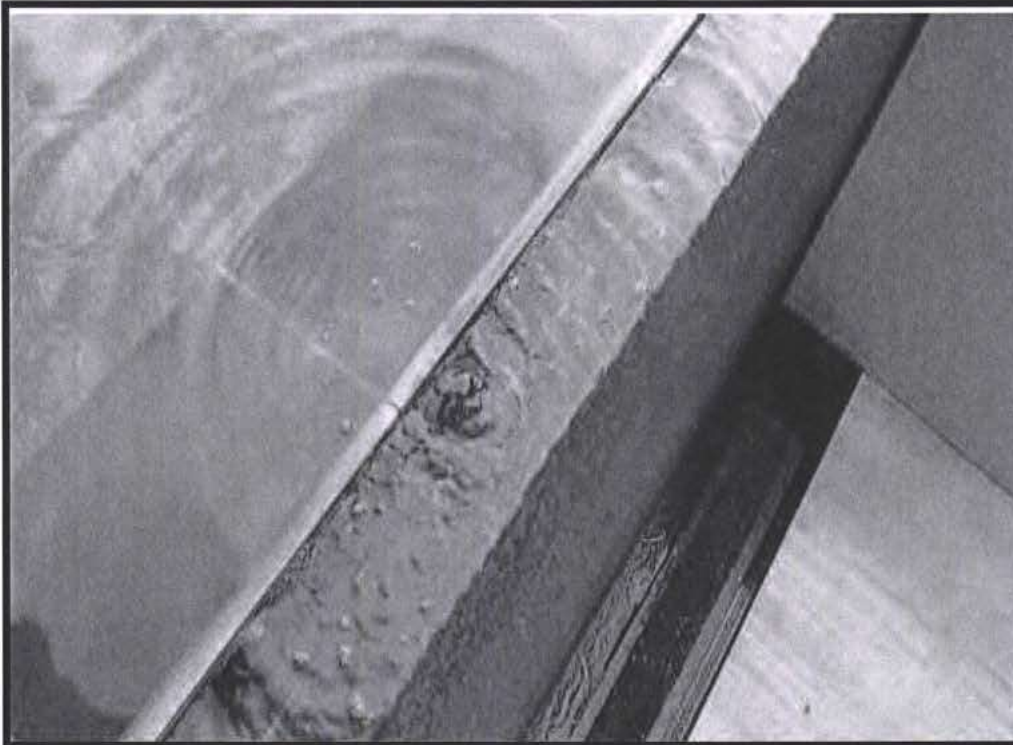
The water flow at the water feature should be adjusted to prevent splashing.
