SWIMMING POOL

The swimming pool consists of an in-ground concrete with pebble aggregate finish surrounded by a stone deck. It is served by a cartridge filtering system. In addition, it has the following equipment:

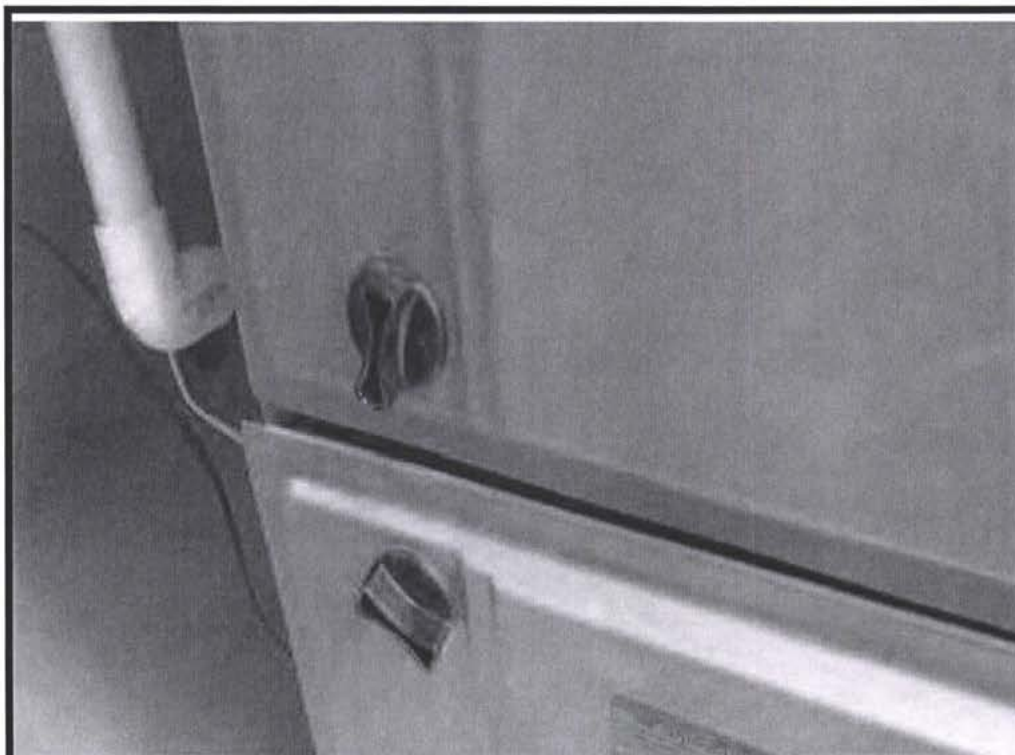
The door is not secure at the right side air handler.

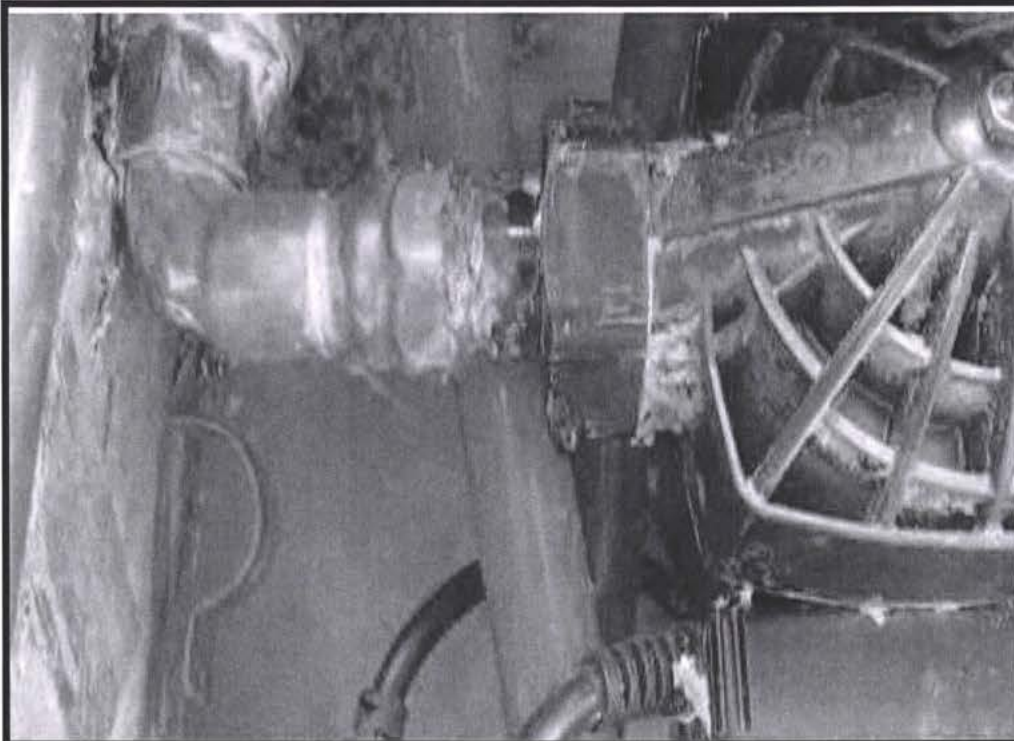
There are leaks at the hot water recirculation pumps.

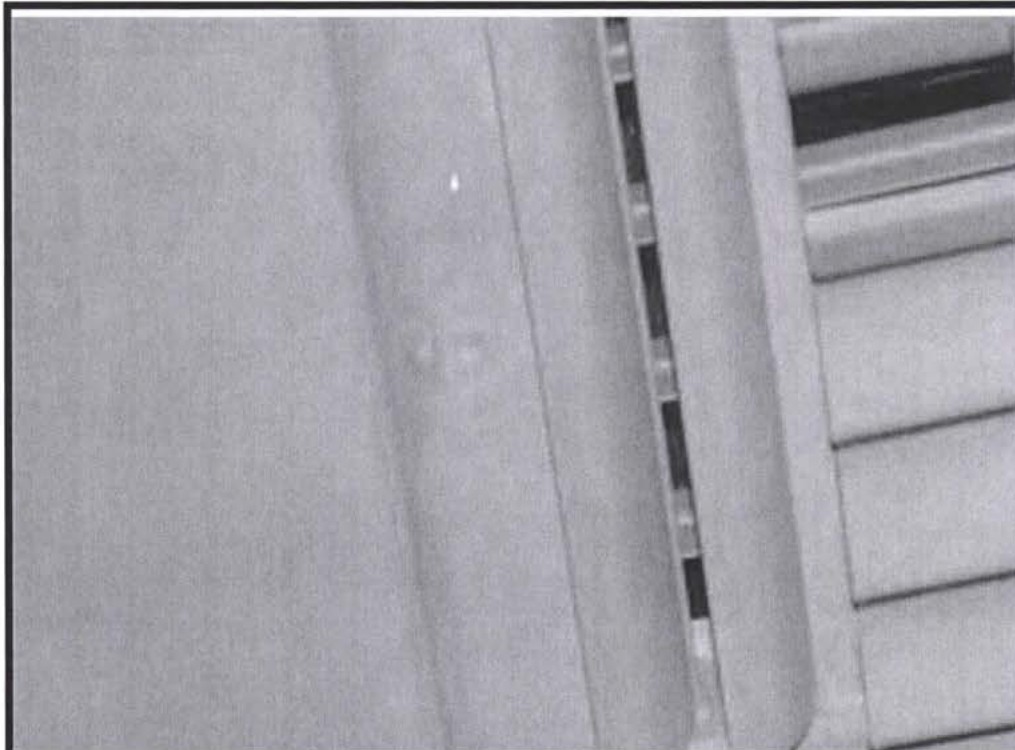
Photo Number
5

There is a plumbing leak at the ceiling of the basement bathroom.

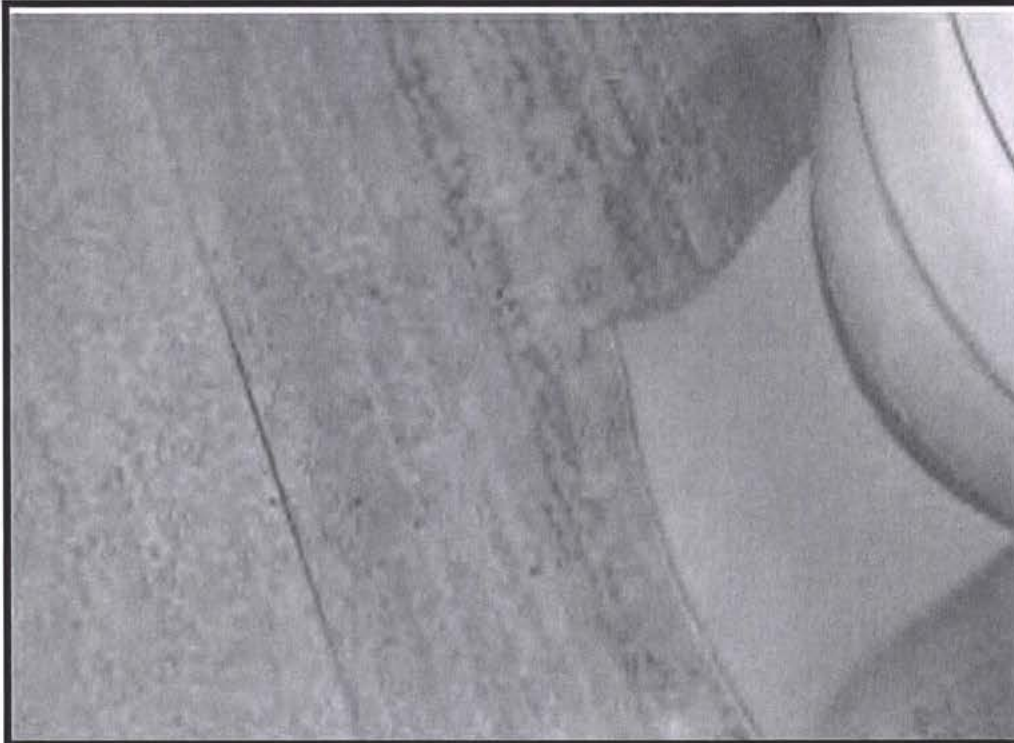
There is a plumbing leak at the ceiling of the basement bathroom. This is the water on the floor under the drip.

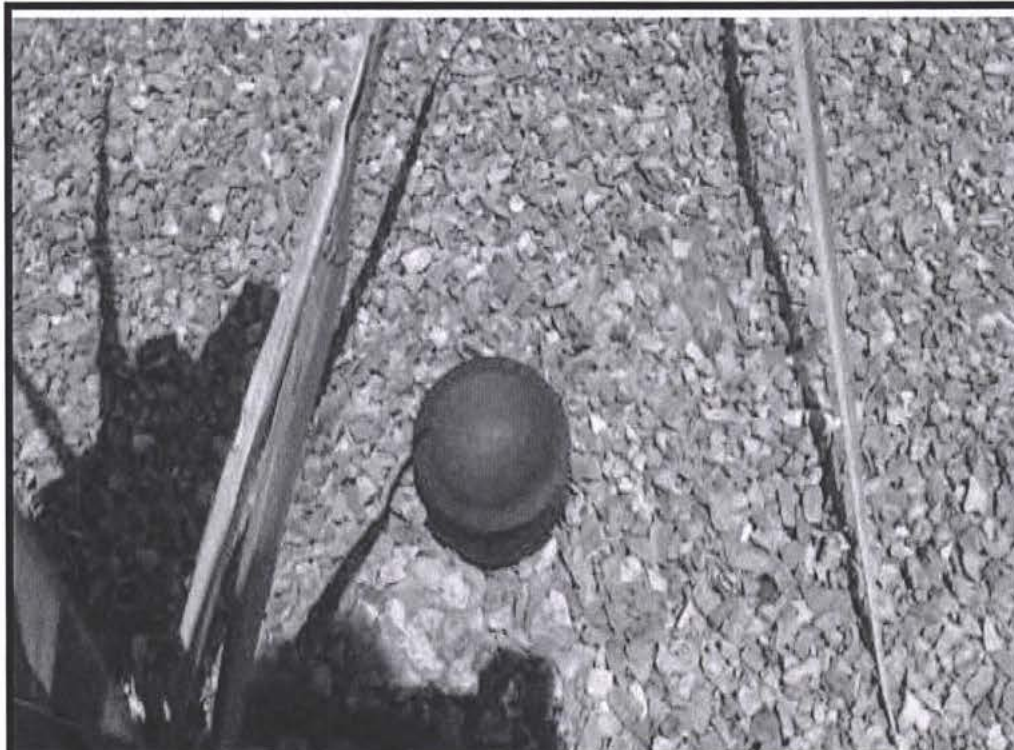
7

The drain clean-outs should have permanent screw type caps.

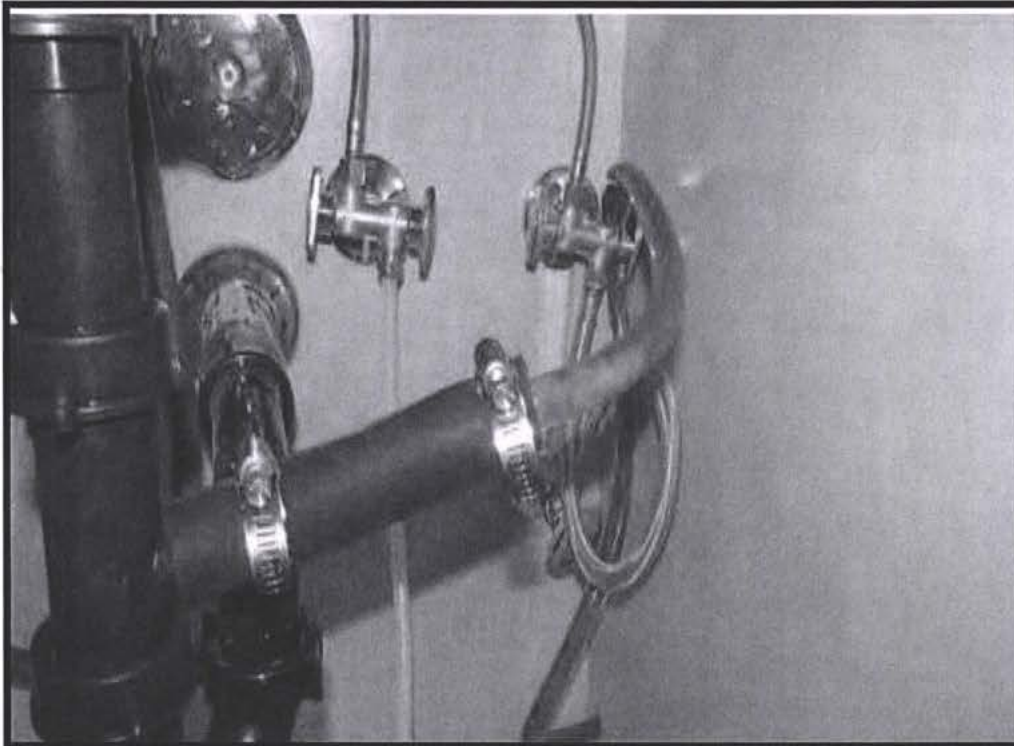
There is no air gap on the ice maker drain line. The discoloration of the drain line should also be investigated.

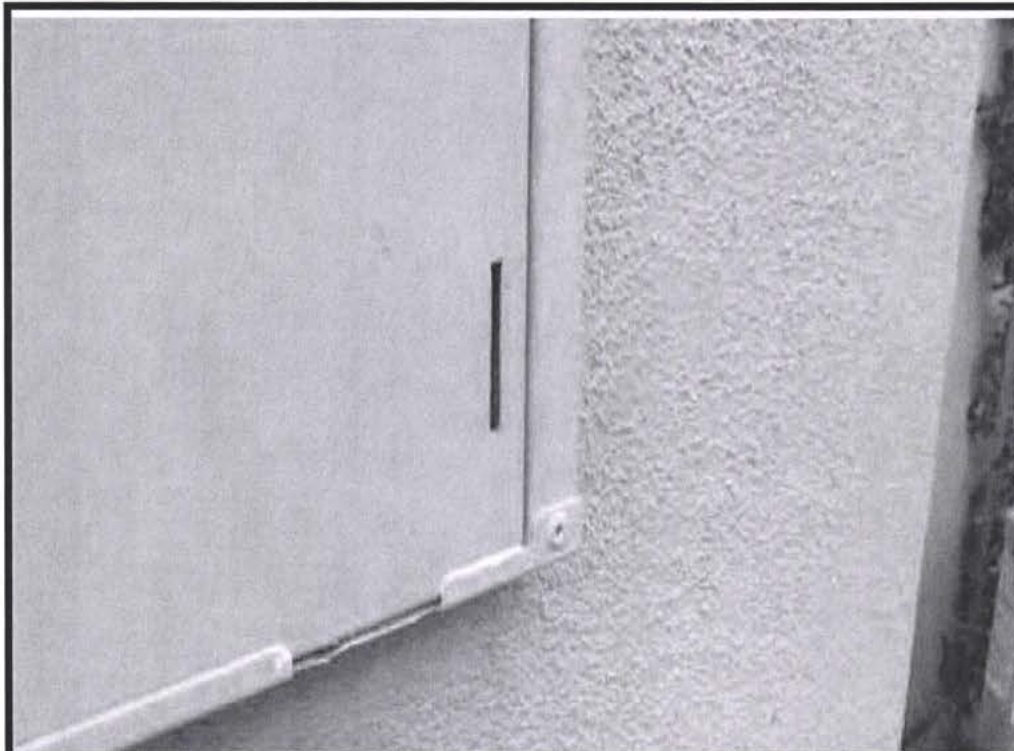
Photo Number
9

The locking mechanism is missing from one water heater cover.

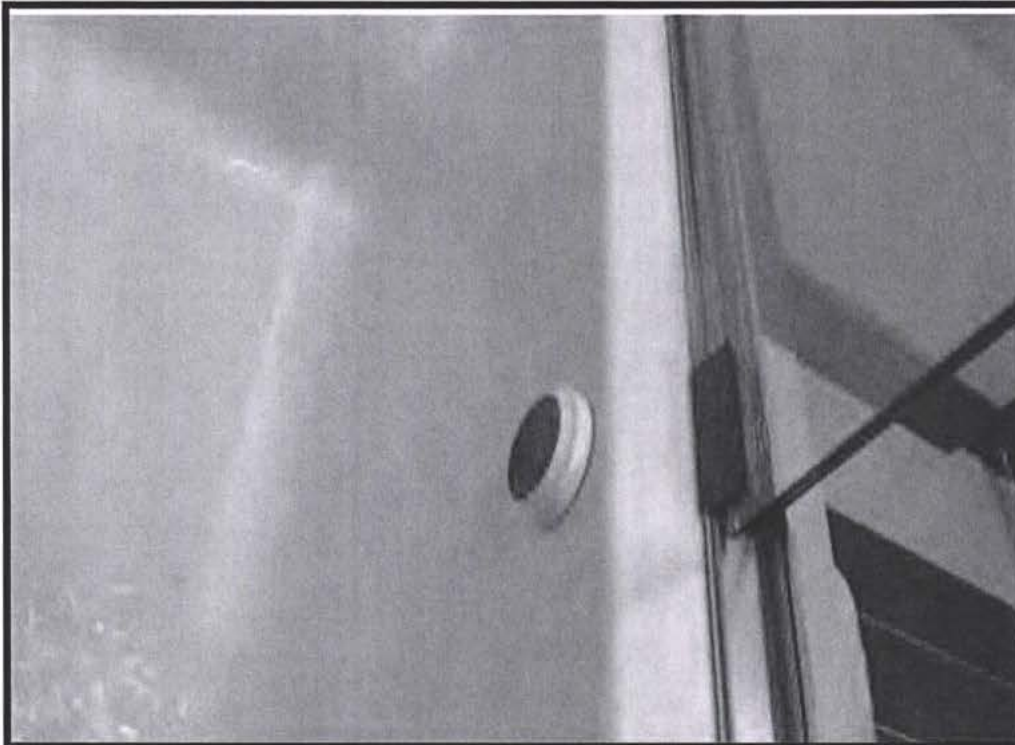
The controls at the second floor tub should be investigated further.

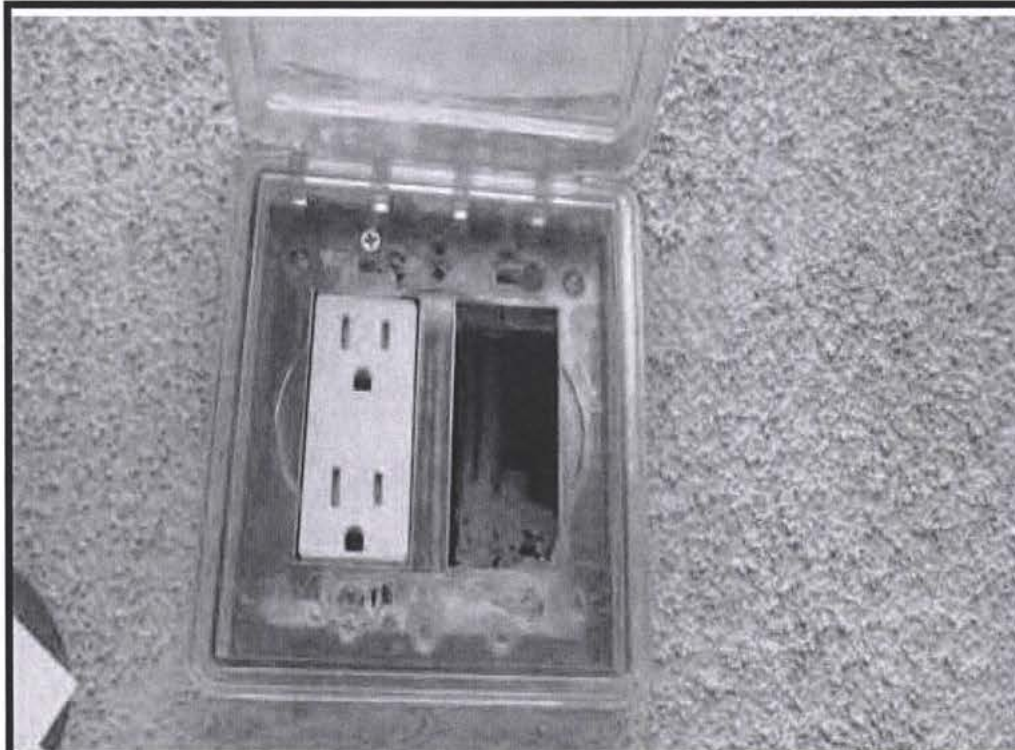
Photo Number
11

There is an incomplete outlet at the wall of the lower patio.

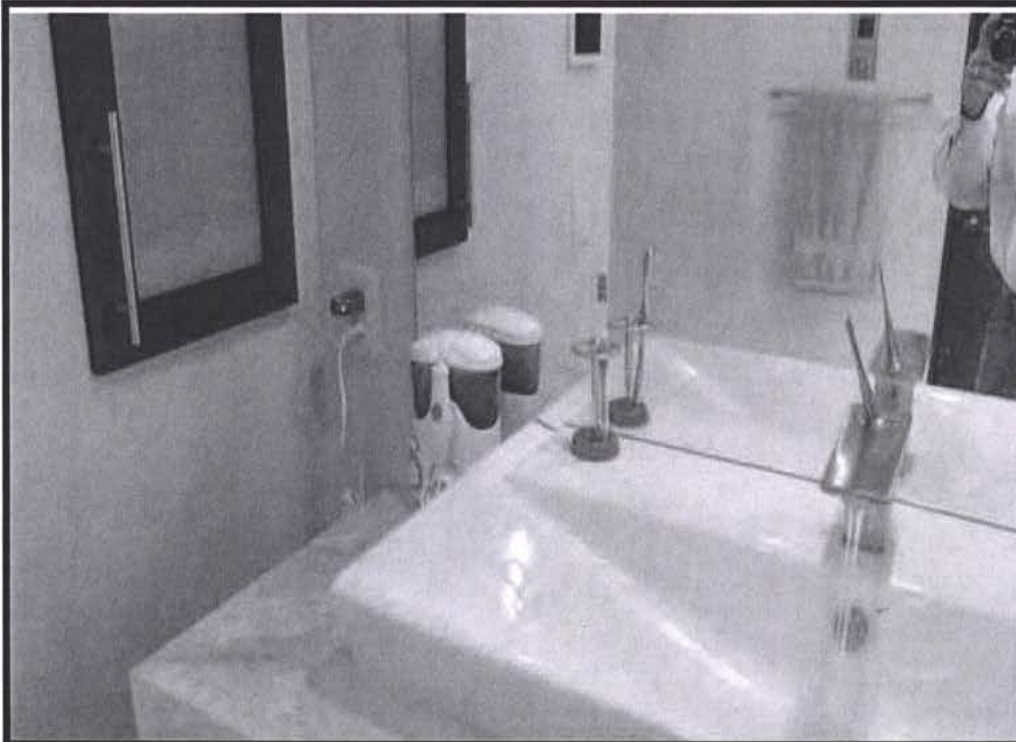
The outlets at the master bathroom sinks are not GFCI protected.

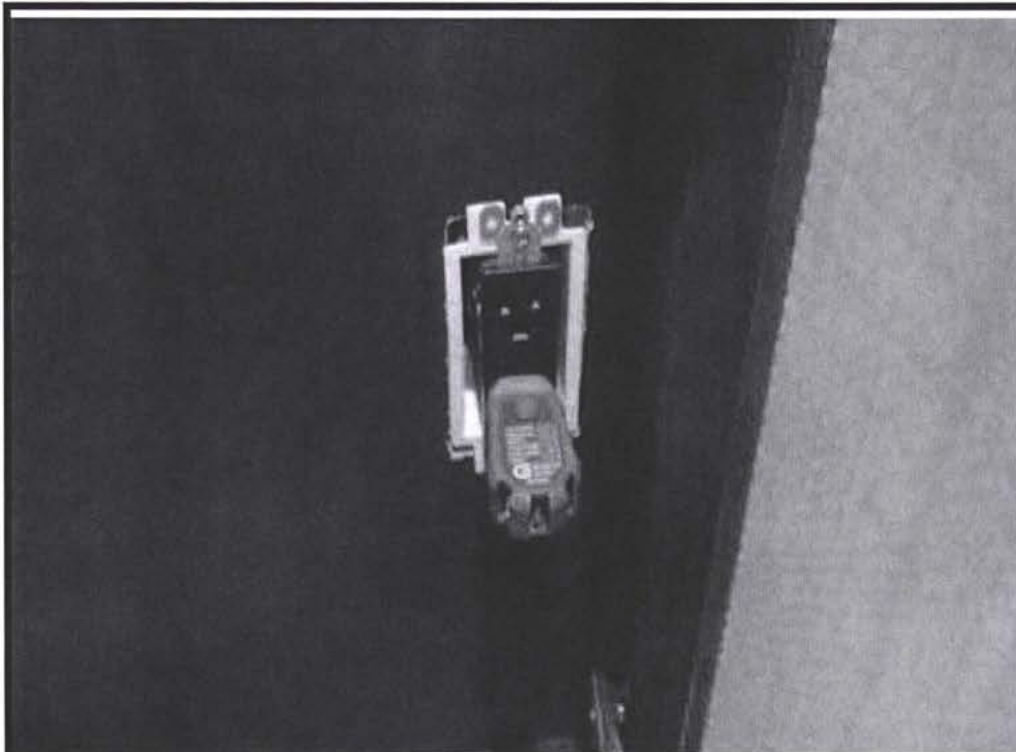
Photo Number
13

One outlet in the master closet does not have power.

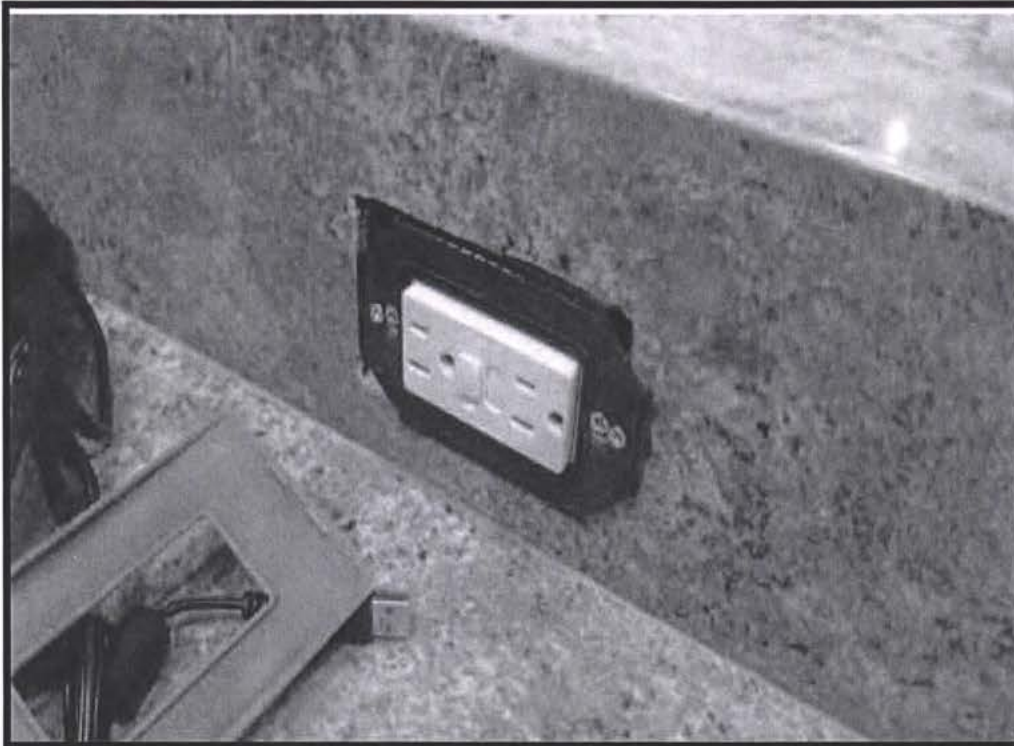
The outlet covers are loose at the media wet bar counter.

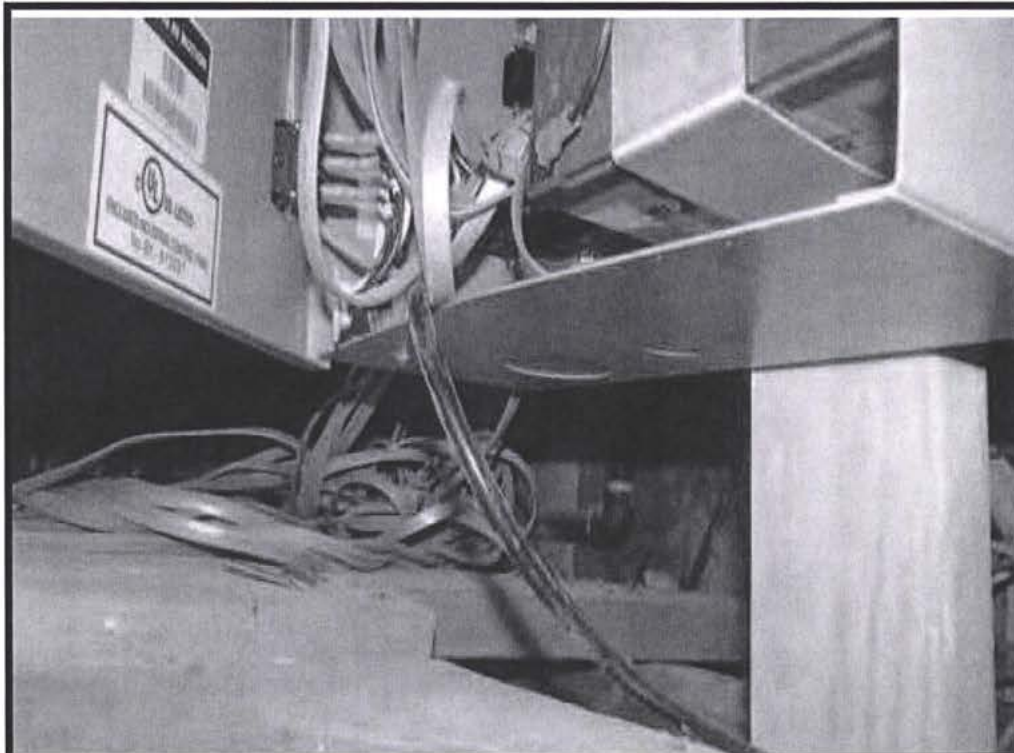
Photo Number
15

The power cord is routed through the door at the panel door controls.

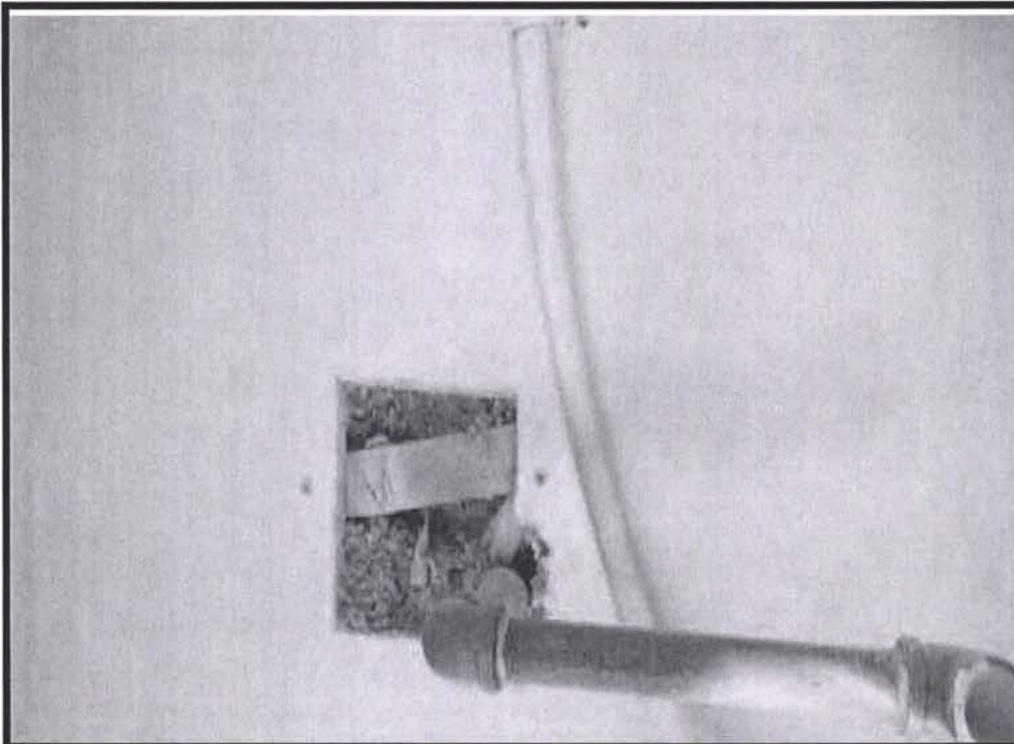
The drywall is damaged at the right side exterior mechanical closet.

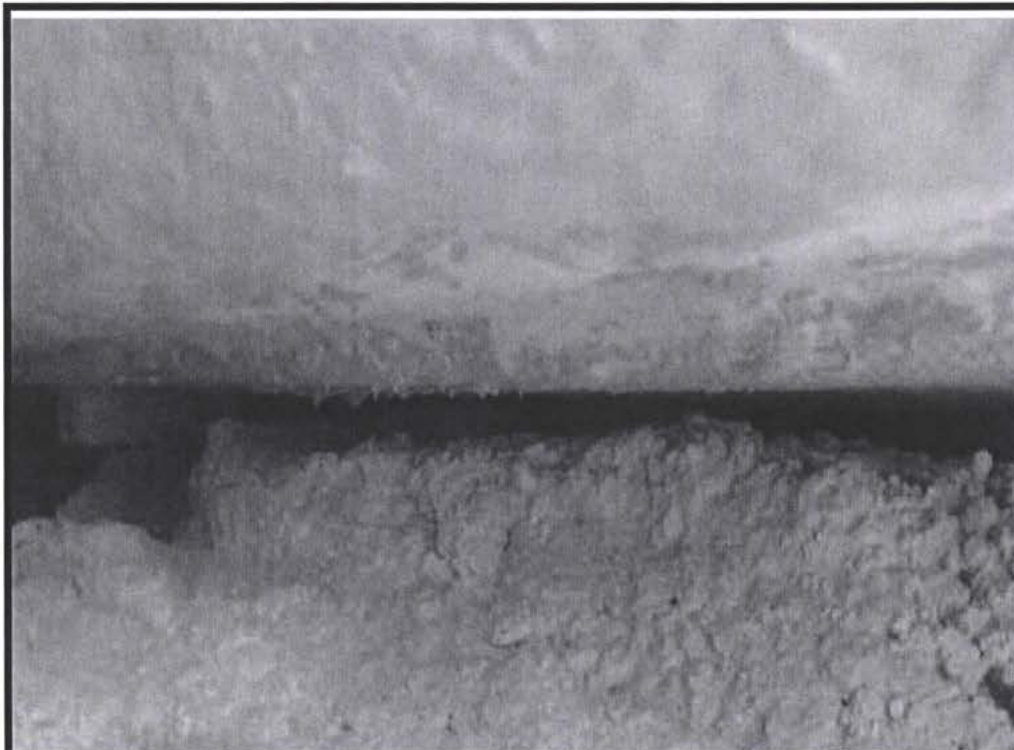
Photo Number
17

The whirlpool tub is not supported from the floor.

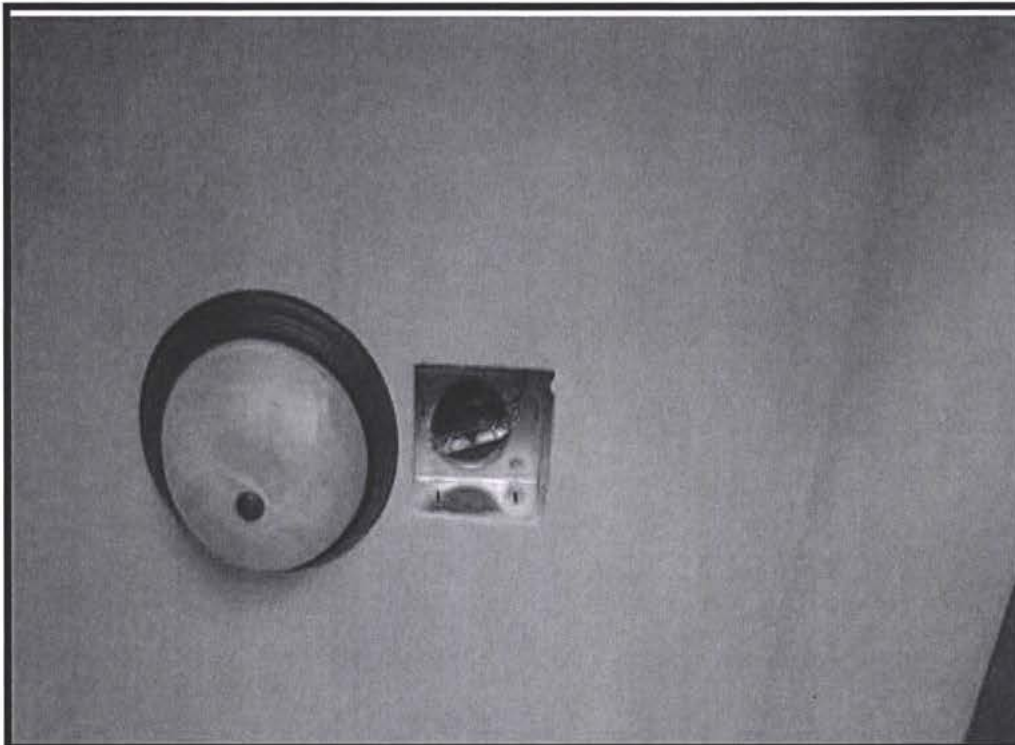
The cover is missing from the vent fan in the media closet.

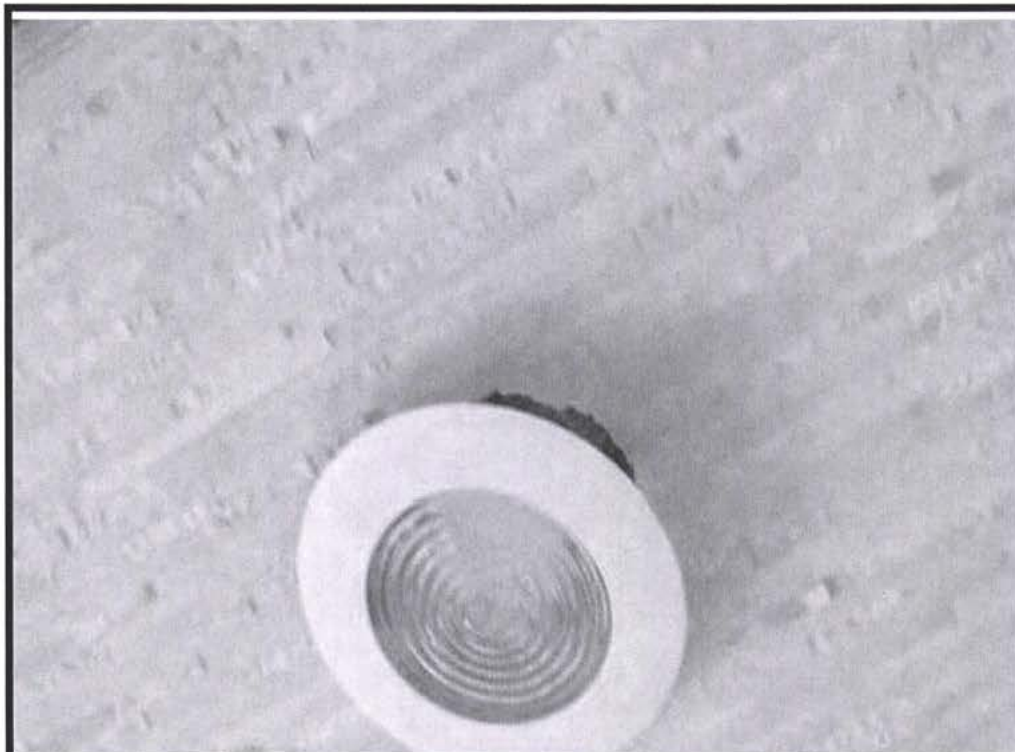
Photo Number
19

There is a loose light in the master shower.

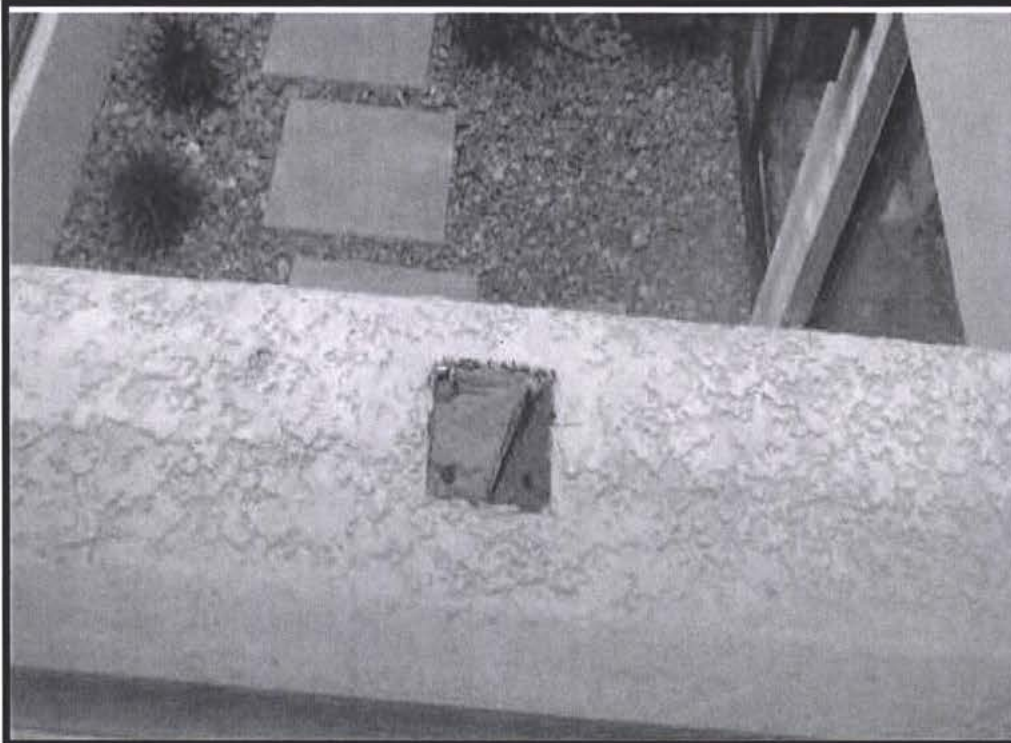
The handrail components at the second floor window should be repaired and sealed.

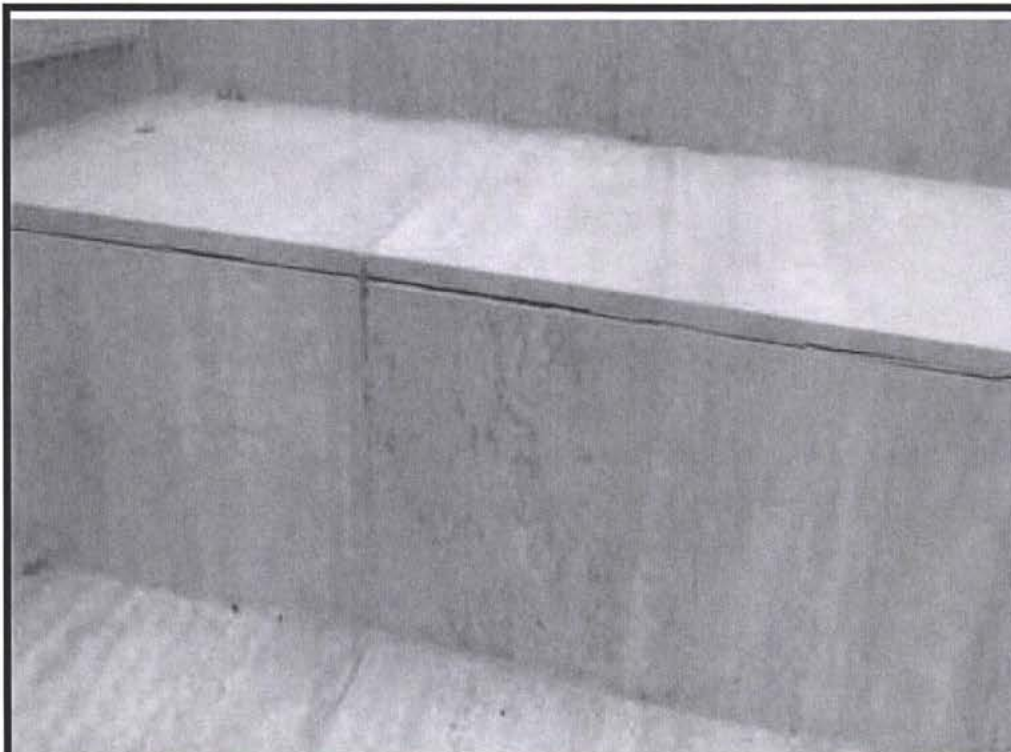
Photo Number
23

There are open grout joints at the steps to the basement.

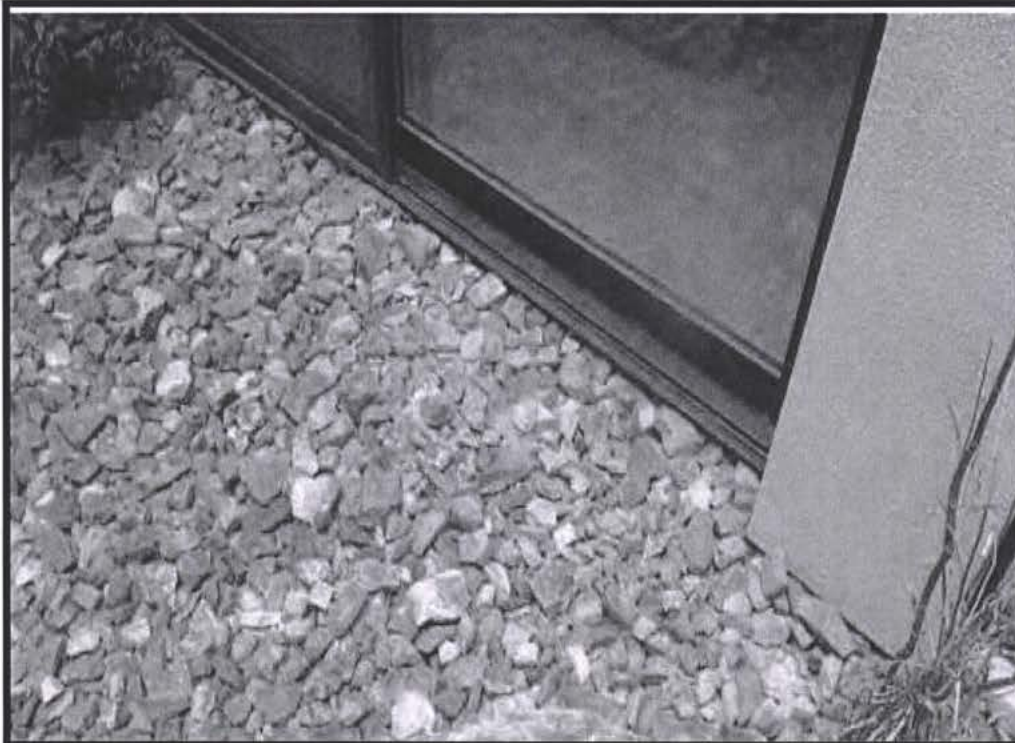
There is no landing
at the exterior door
in the kitchen.

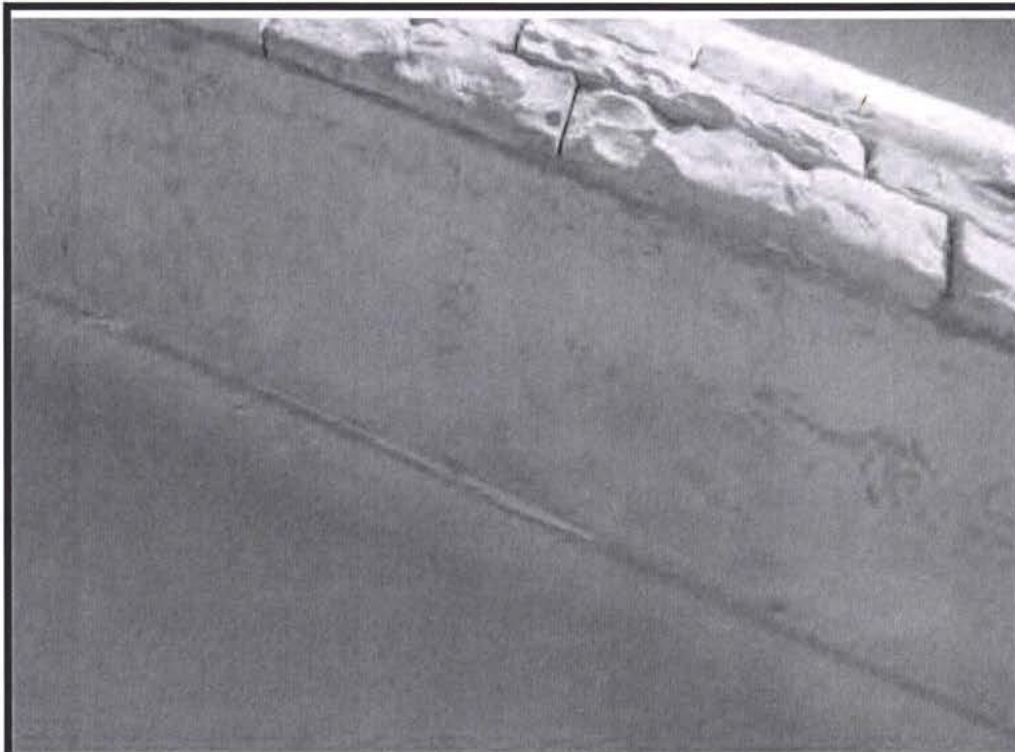
Photo Number
25

There is unfinished
stucco at the roof
parapet feature.

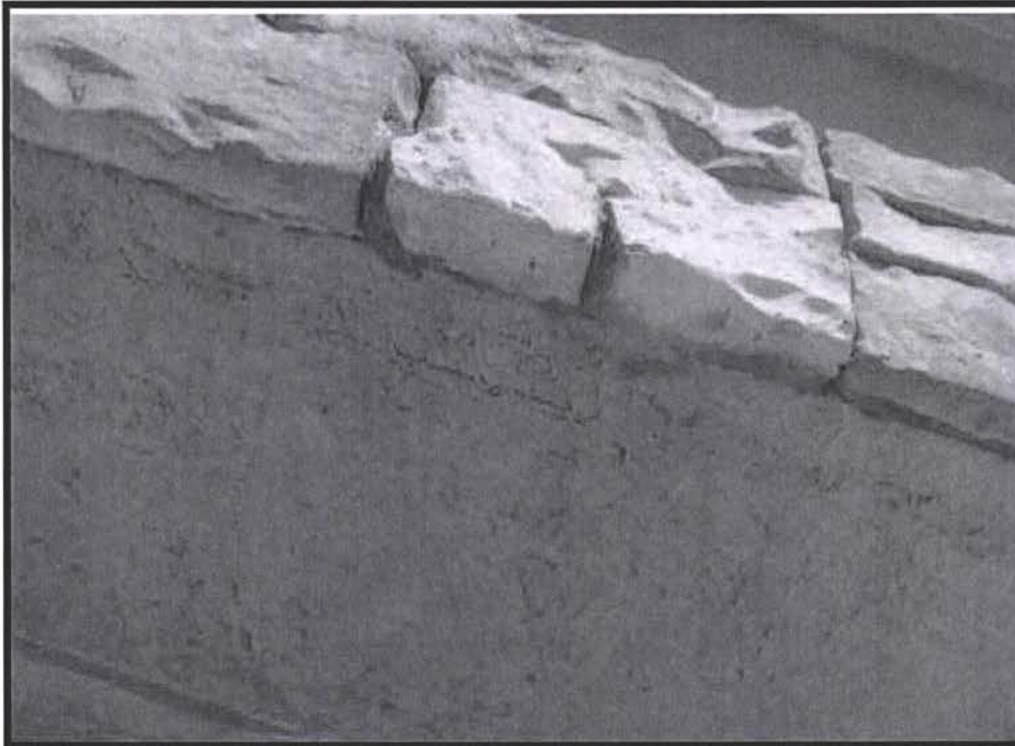
There is unfinished stucco at the roof parapet feature.

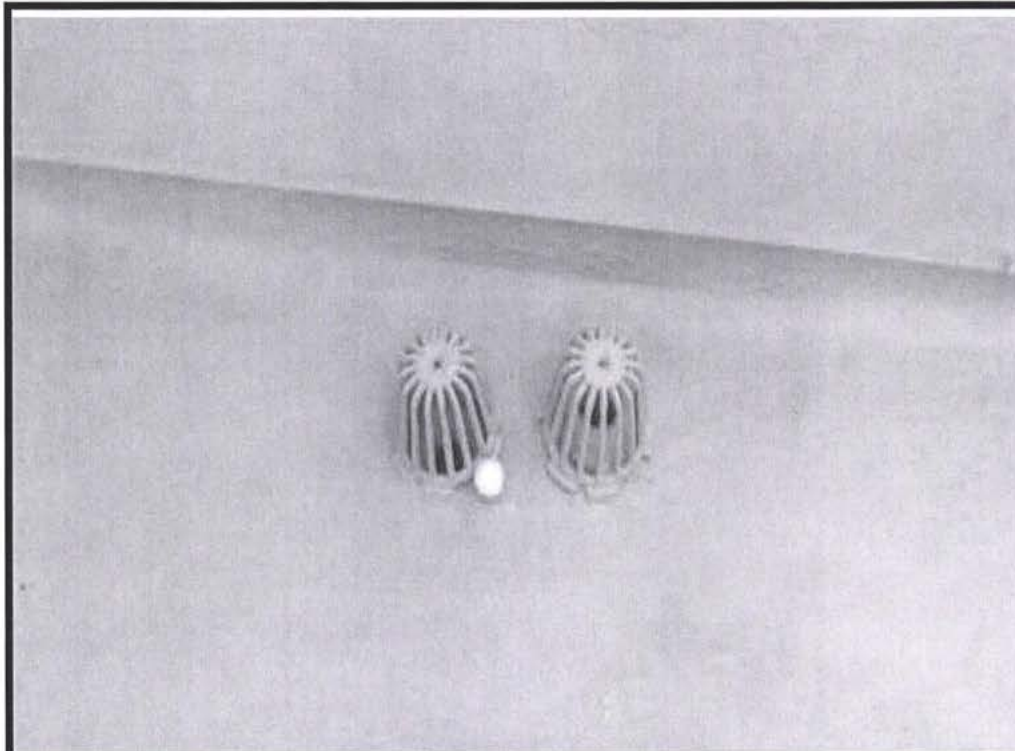
Photo Number
27

The debris guards should be removed from the secondary drains.

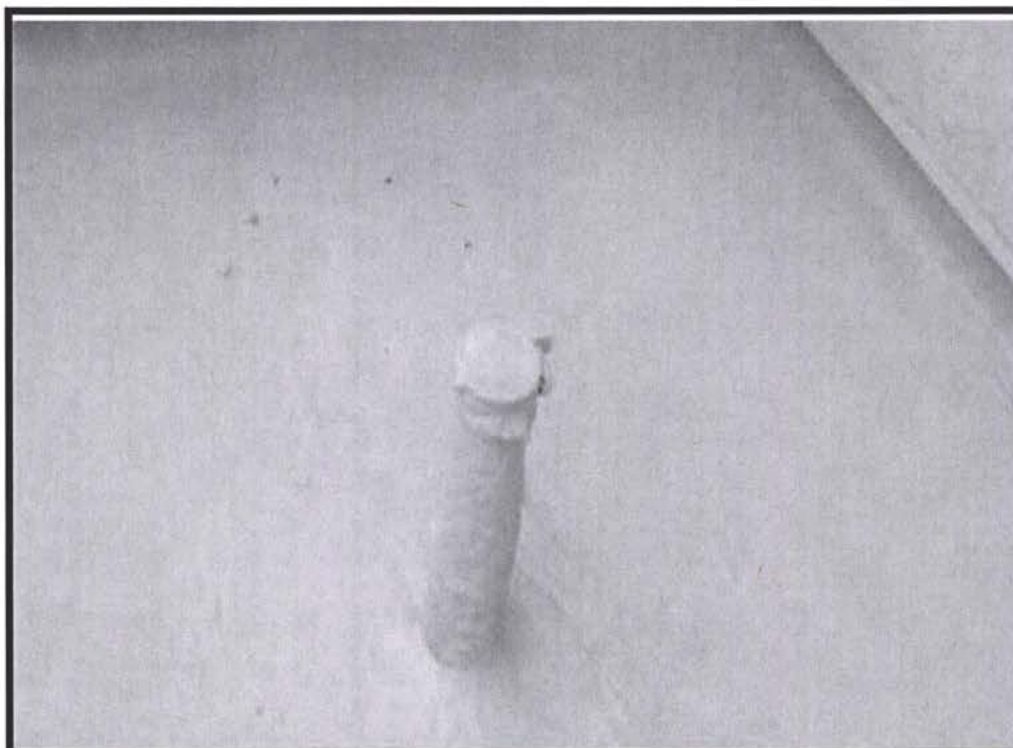
The cap should be removed from the plumbing vent.

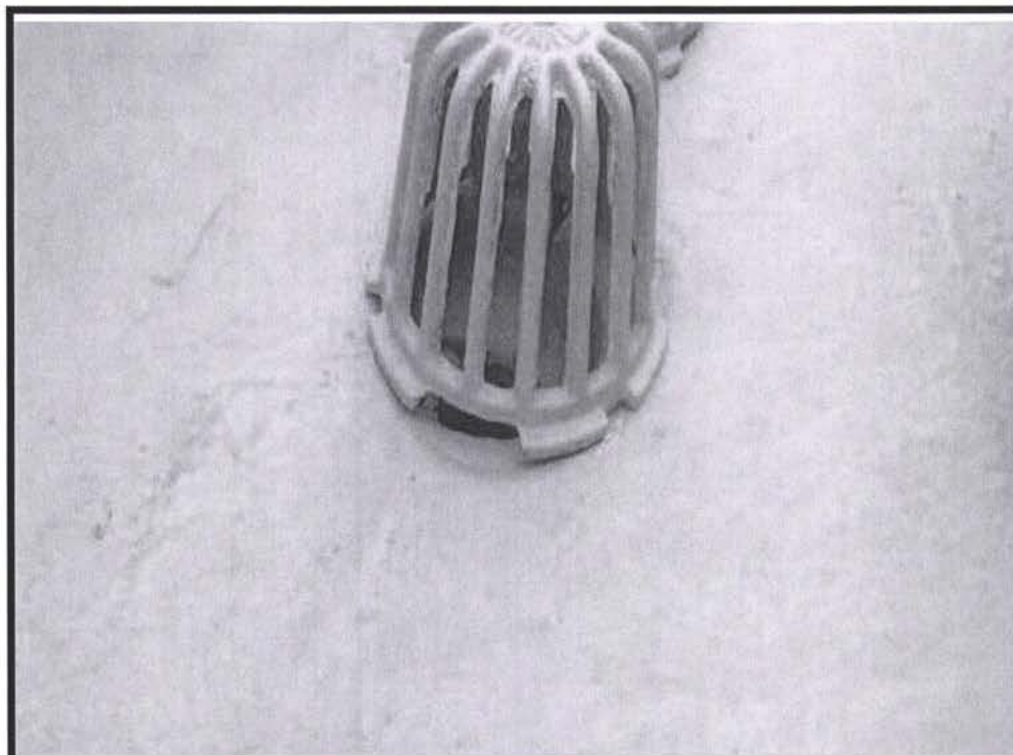
Photo Number
29

The debris guards are not sealed at the roof.

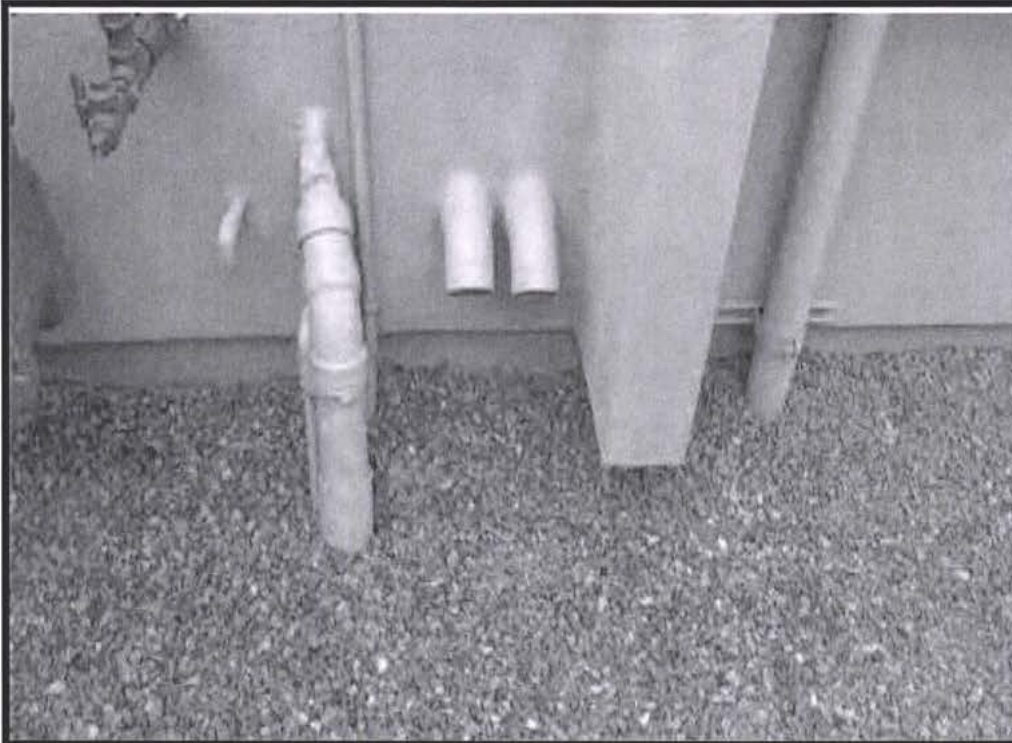
Splash blocks should be placed at all down spouts.

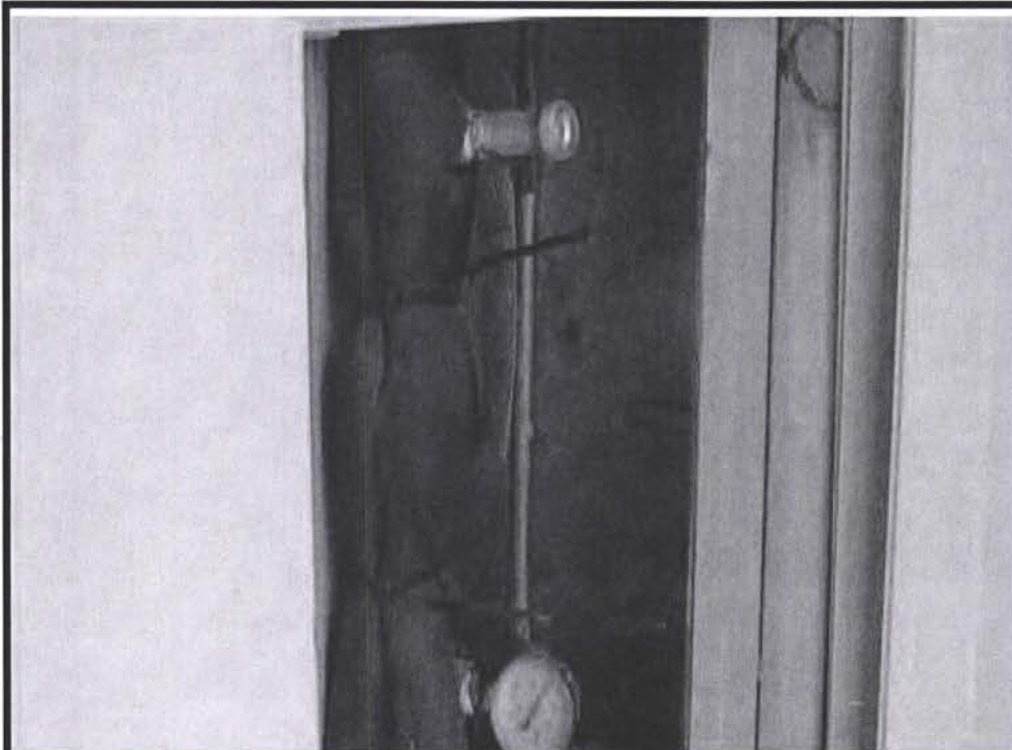
Photo Number
31

The configuration of the sprinkler controls is not what is typically found.

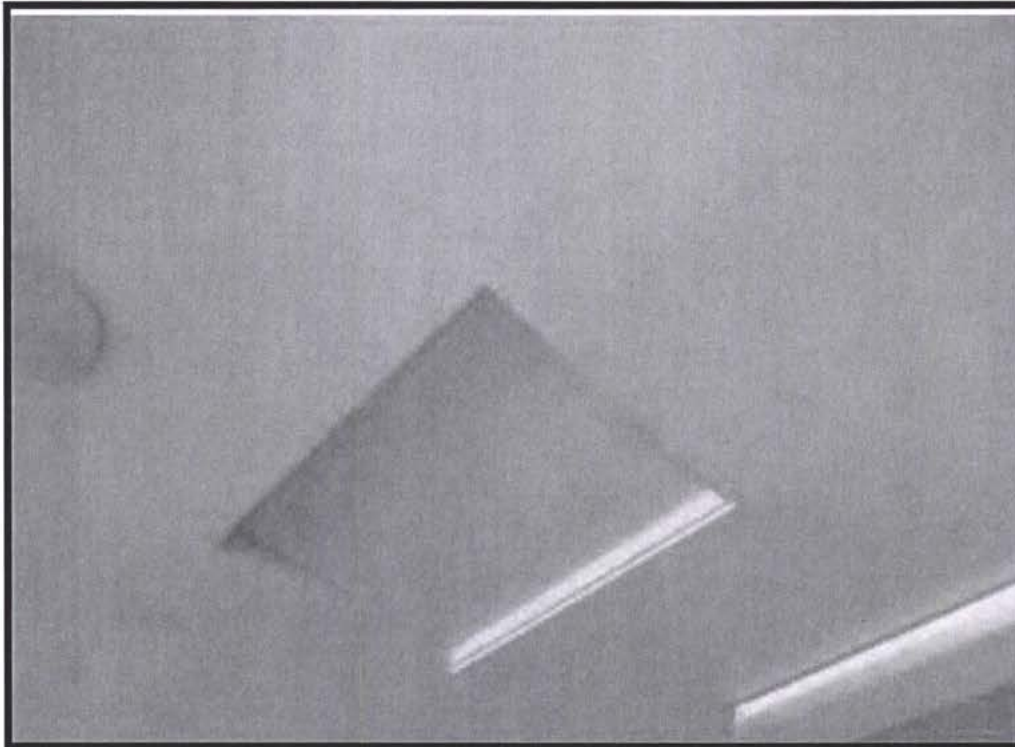
The attic access and speaker at the garage ceiling violate the garage firewall.

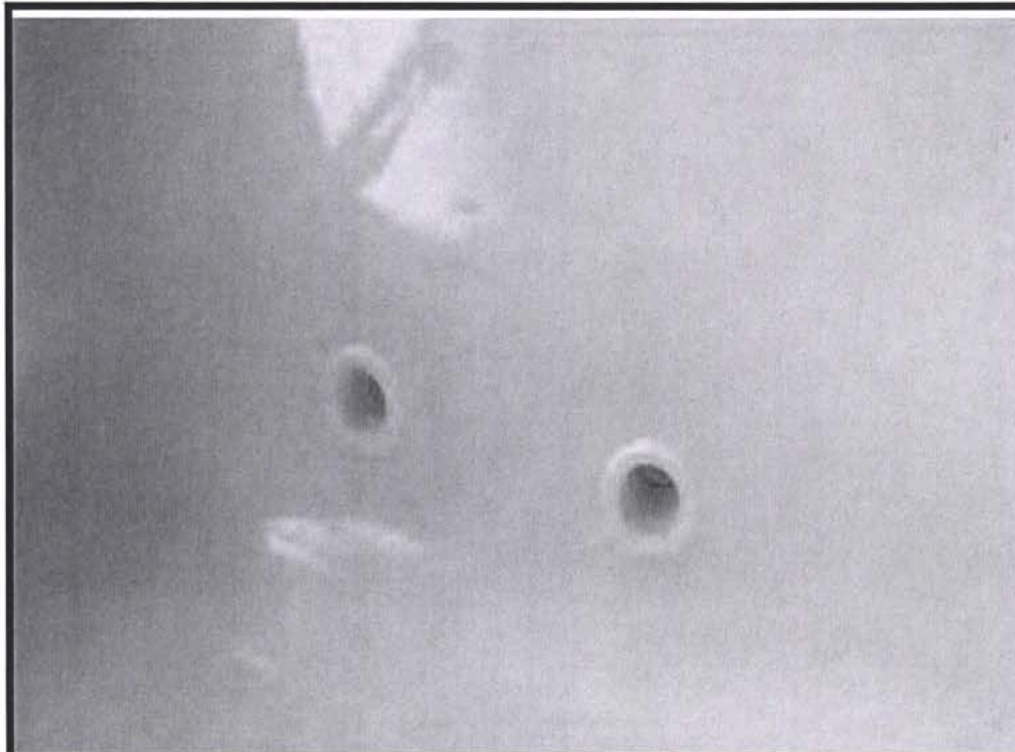
Photo Number
33

There are no jet nozzles at the whirlpool tub.

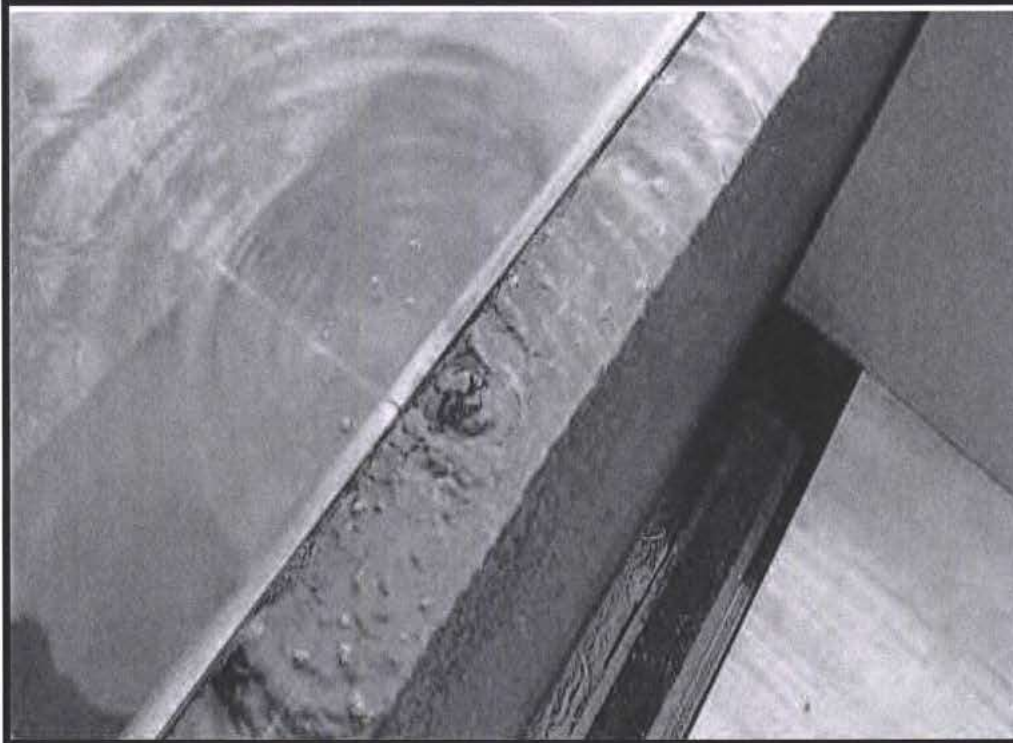
The water flow at the water feature should be adjusted to prevent splashing.
