SWIMMING POOL

The swimming pool consists of an in-ground concrete with pebble aggregate finish surrounded by a stone deck. It is served by a cartridge filtering system. In addition, it has the following equipment:

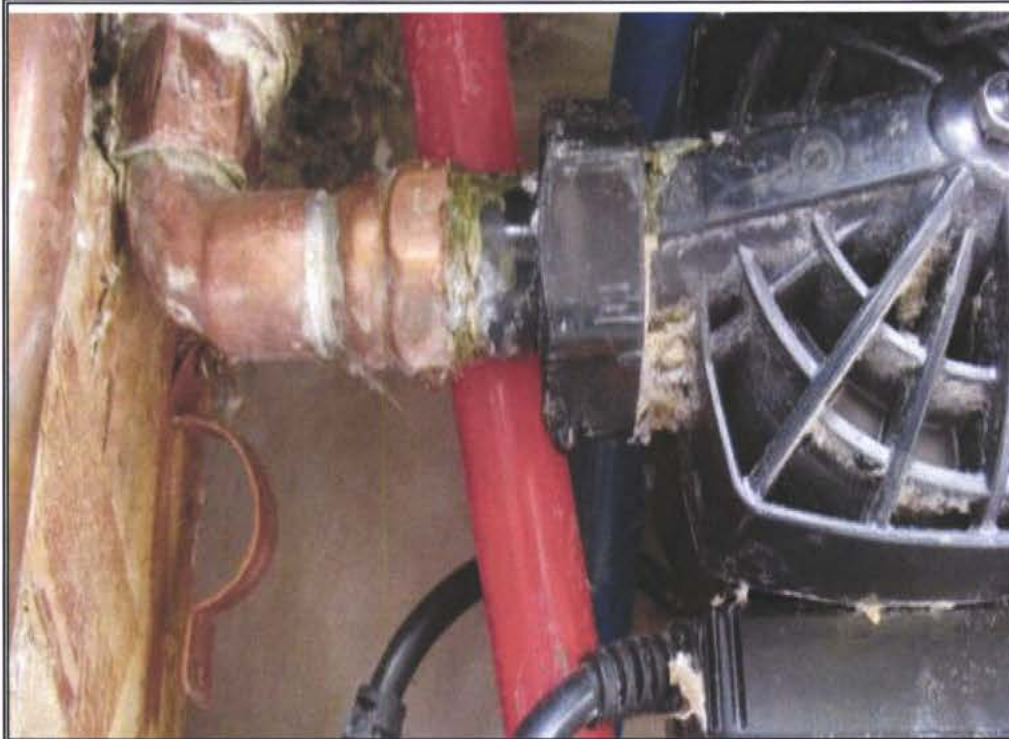
There are leaks at the hot water recirculation pumps.

Plumber to address

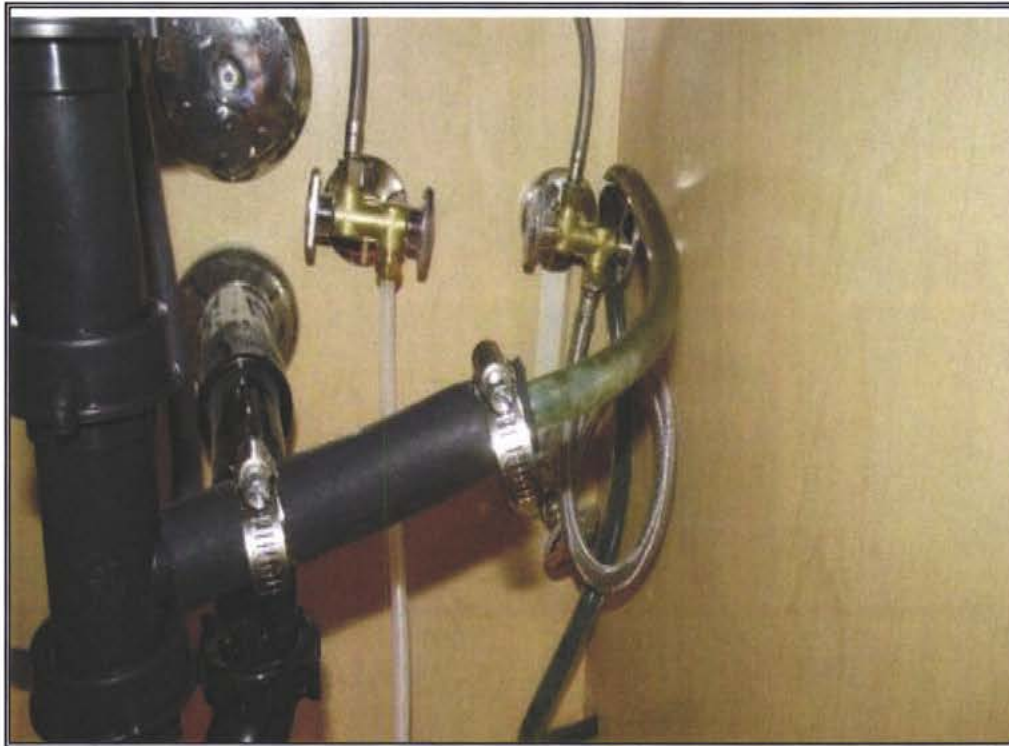
There is no air gap on the ice maker drain line. The discoloration of the drain line should also be investigated.

Henry will investigate with plumber

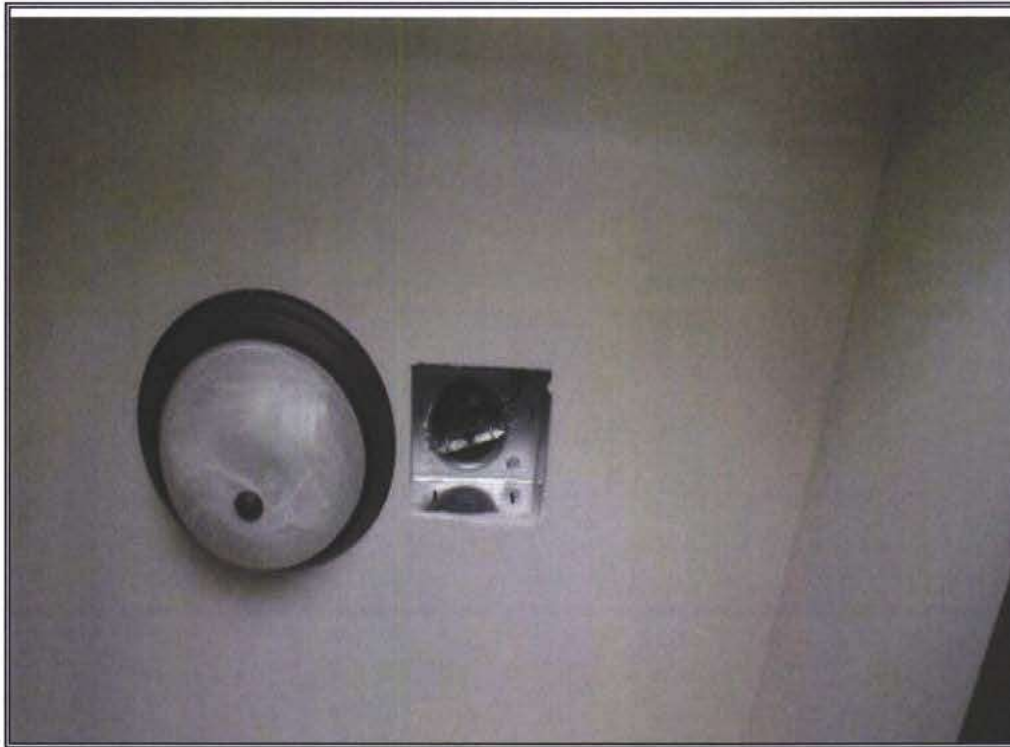
The cover is missing from the vent fan in the media closet.

Electrician to address

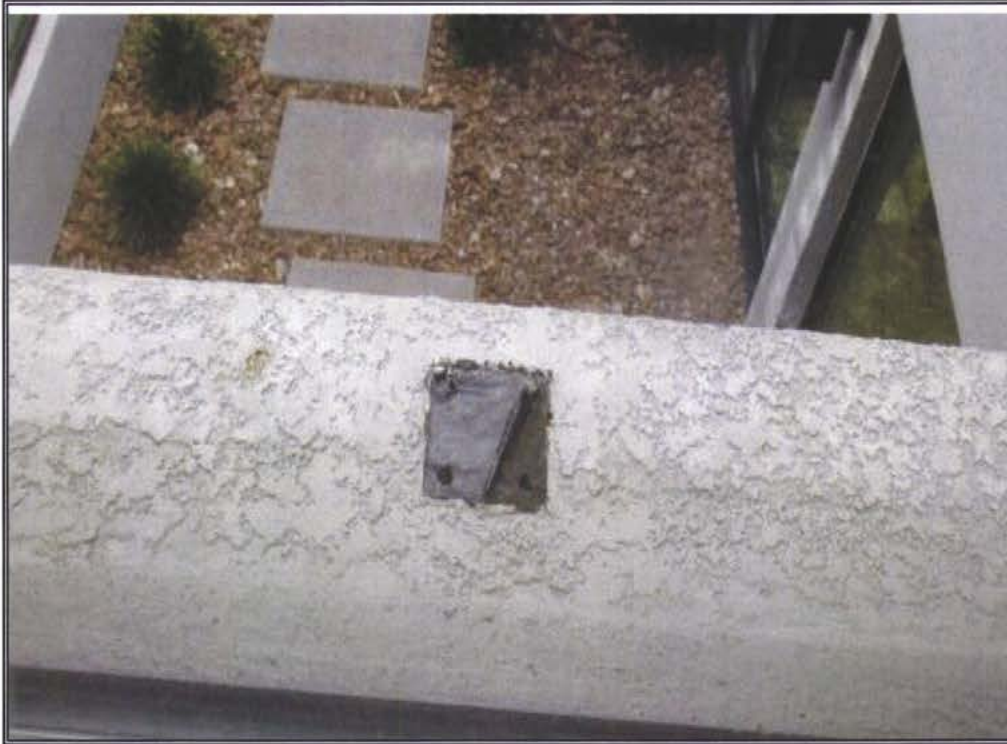
The handrail components at the second floor window should be repaired and sealed.

Henry will have hand rail replaced

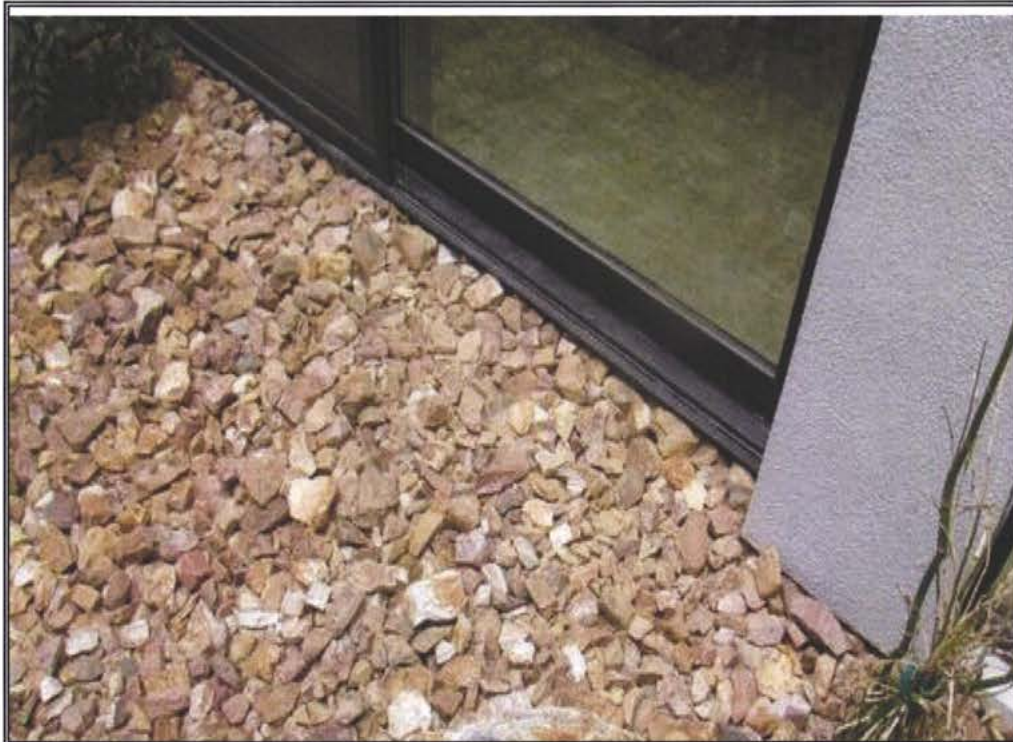
There is no landing
at the exterior door
in the kitchen.

Not necessary per code
per Henry
