**IN THE SUPREME COURT OF THE STATE OF NEVADA**

**APPELLANTS' APPENDIX VOLUME X**

This report was prepared in general accordance with Fannie Mae Selling and Servicing Guide and Form 4099, Instructions for Performing a Multifamily Property Condition Assessment as well as updated Appendix C, Structural Risk Evaluation Questionnaire.

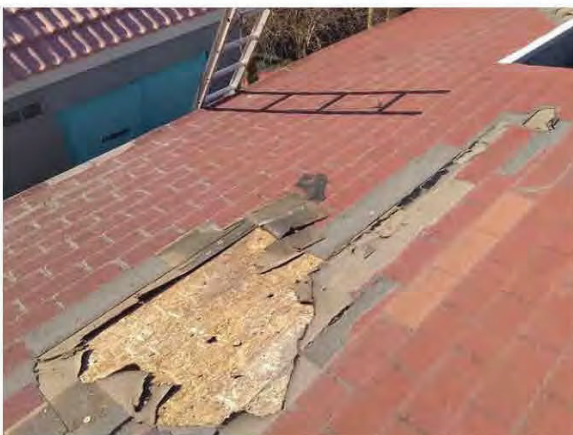
17. View of damaged composition asphalt shingled mansards.

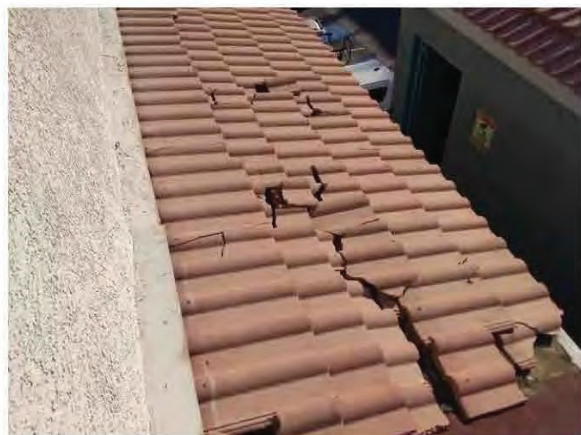
18. View of damaged concrete tiled mansards.

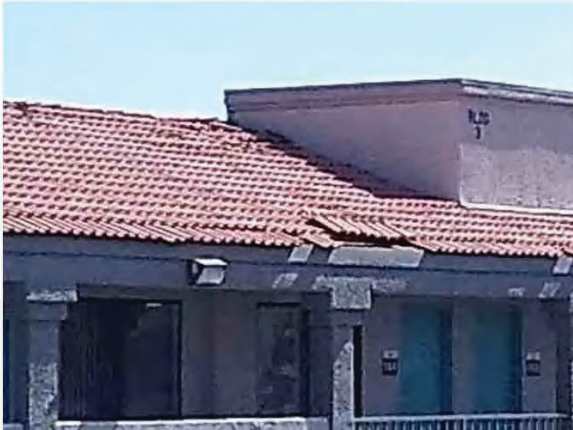
19. View of damaged concrete tiled mansards.

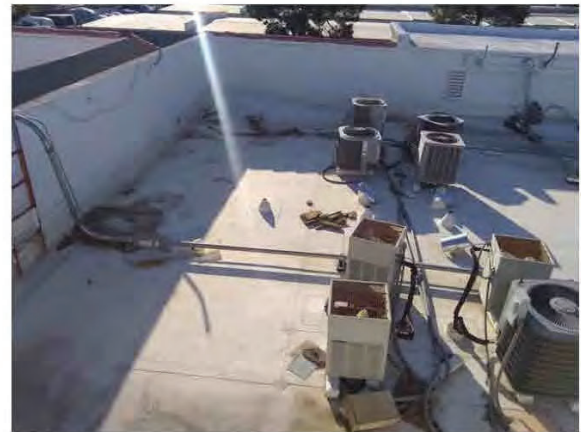
34. Cooling to the dwelling unit is provided by roof-mounted A/C condensers. Approximately half of the condensers are over 20 years old.

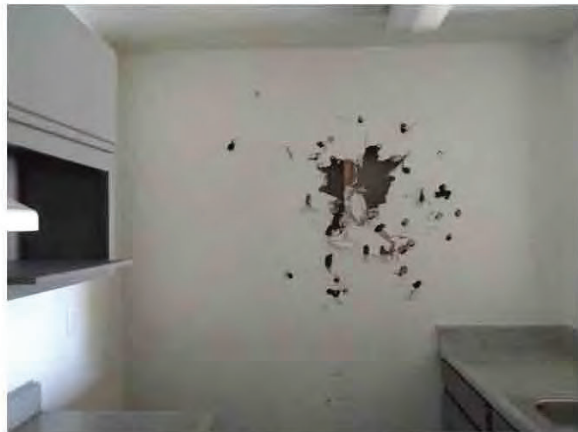
f3 inspected the interiors of 49 vacant units, 6 of which are in rent ready condition (1 is utilized as a model), and 6 of which are "down" (unleasable). Thirty-seven (37) vacant units have missing/damaged appliances, missing/damaged floor coverings, kitchen cabinets, countertops, and sinks, and require cleaning and painting. The 6 "down" units have missing/damaged appliances, damaged concrete subflooring, floor coverings, HVAC systems, cabinets/countertops, and/or drywall walls and ceilings, and require cleaning and painting.

46. View of damaged wallboard in a vacant unit.

f3 recommends 43 vacant/down units be renovated and returned to rent ready condition. Renovation activities will include all or some of the following: repair/replacement of appliances, concrete subflooring, floor coverings, HVAC systems, cabinets/countertops, drywall repairs, cleaning and painting. A complete listing of units inspected and estimated repair/replacement costs required to return each unit to rent ready condition is attached to this report (total estimated cost is \$111,450).

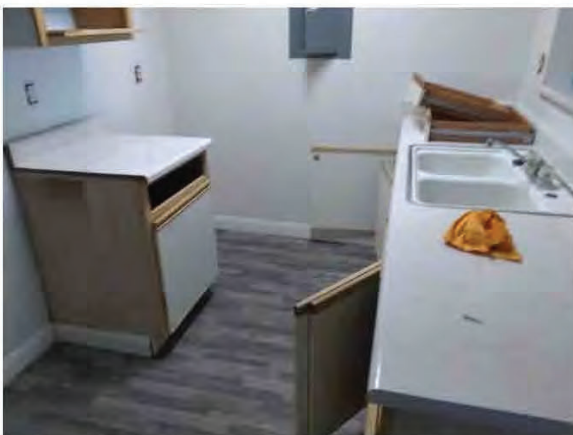
47. View of missing appliances in a vacant unit.

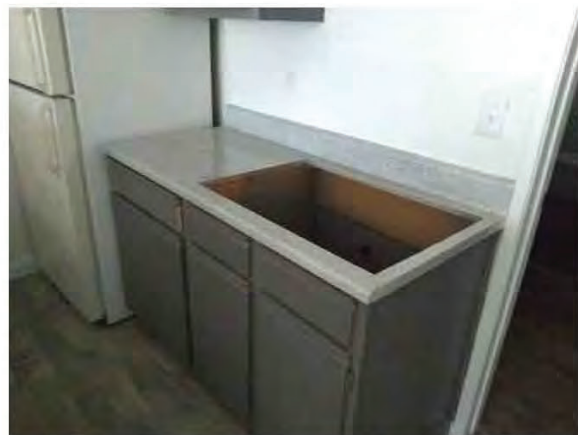
48. View of a missing kitchen sink in a vacant unit.

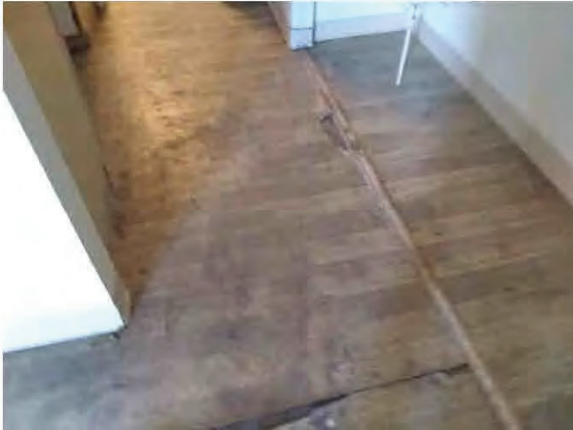
49. View of damaged flooring in a vacant unit.

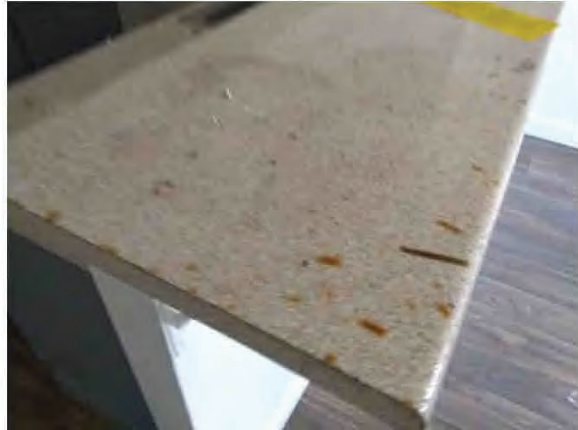
50. View of a damaged kitchen counter in a vacant unit.

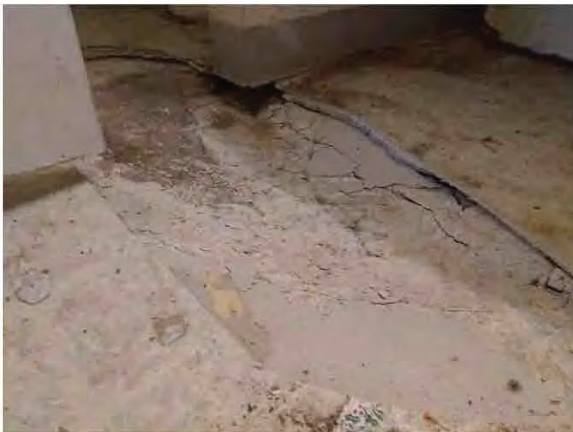
51. View of damaged floor in down unit 136.

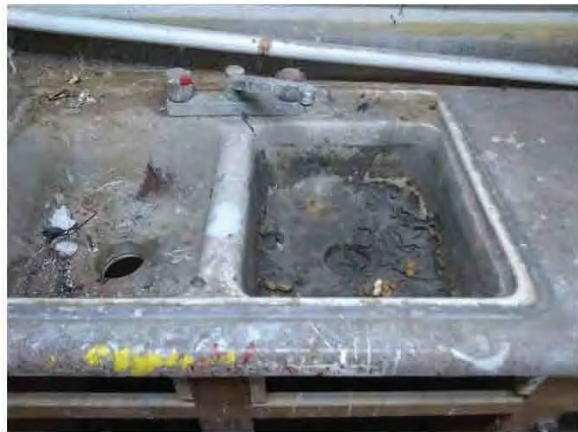
52. View of the kitchen sink in down unit 173.

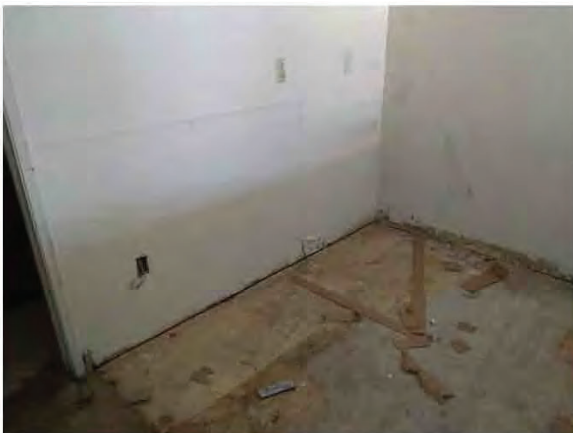
53. View of missing kitchen cabinets and appliances in down unit 163.

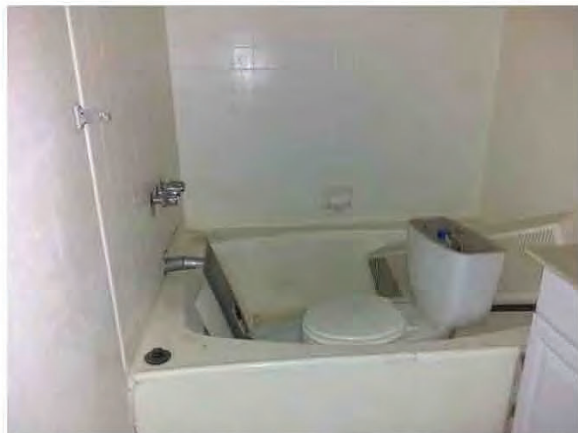
54. View of disconnected commode in down unit 105.
