APPELLANTS' APPENDIX VOLUME XII

Our survey of the Property was conducted by Jeff Roden on March 04, 2021 & March 5, 2021. The weather at the time of our survey was sunny and 70 degrees. At the Property, we met with Asset Manager Ruth Garcia. Ms. Garcia escorted us through the vacant dwelling units and the common areas. Ms. Garcia has been with the Property for approximately 5+ years and had a thorough knowledge of the history of the physical asset. Due to current health concerns (COVID-19 Virus) f3, inc. observed vacant and/or down units, and common areas. Occupied units were not inspected. f3, inc. enacts all the rules of social distancing per the guidelines implemented by the CDC. No additional limitations or constraints prevented the PCA Consultant from performing the entire required scope of the PCA as set forth in the instructions.

1.1.1 Overall Condition Assessment

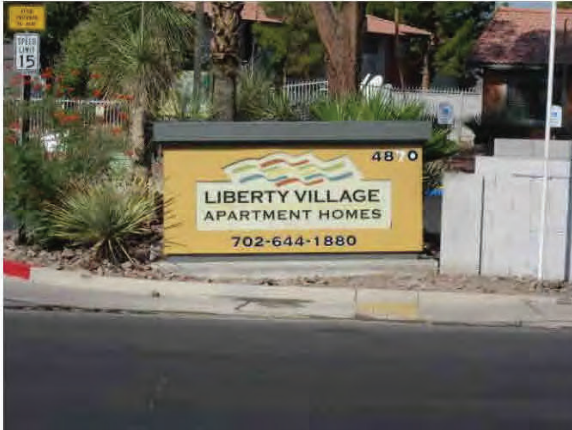
1. View of Property signage at the entrance from North Lamont Street.

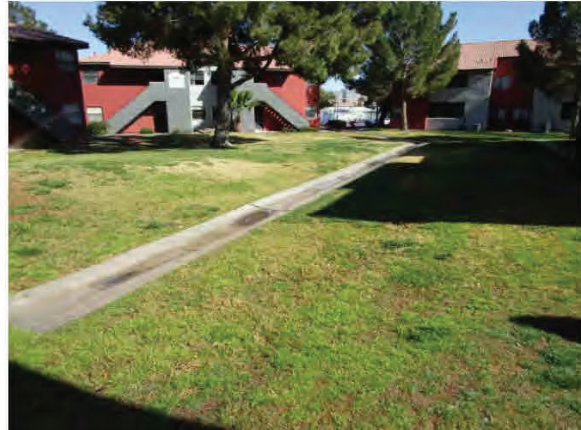
2. View of lawn areas and trees.

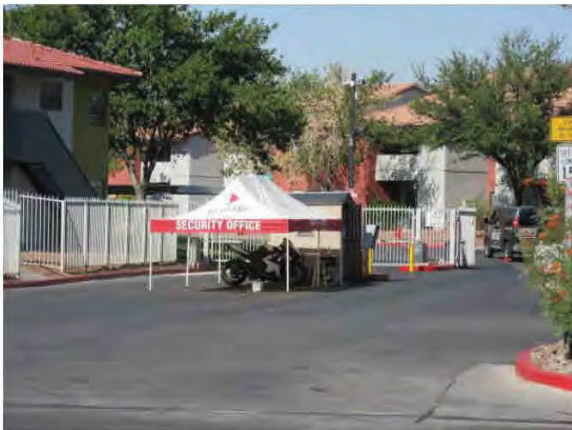
3. The Property is protected by 24 hour security guards. Security gates are visible in the background.

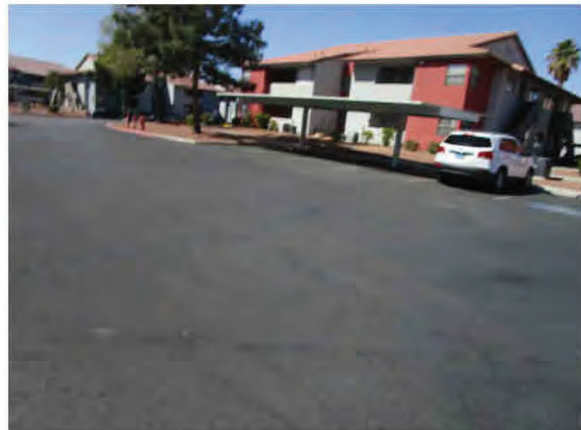
4. Driveways and parking areas are paved with asphalt.

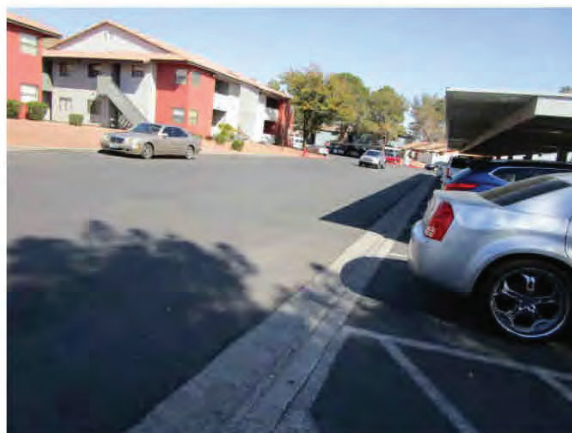
5. View of asphalt paved driveways and parking areas.

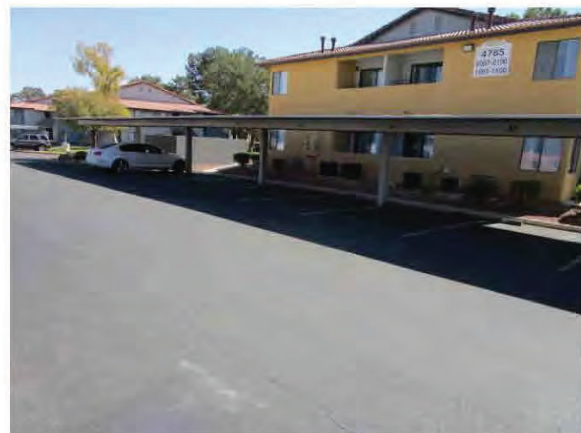
6. Steel-framed carports are installed throughout the Property parking area.
