ARLINGTON RANCH Preliminary Defect List & Repair Recommendations January 7, 2008

ARLINGTON RANCH Preliminary Defect List & Repair Recommendations January 7, 2008 4.0 ONE-COAT STUCCO SYSTEM

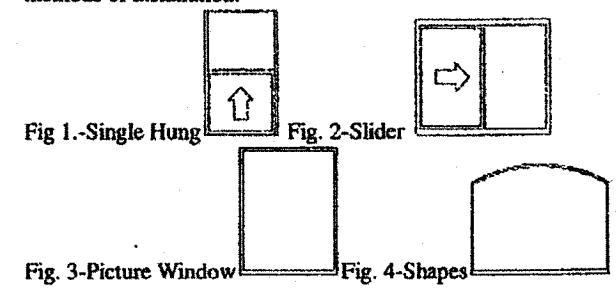
R.H. Adcock inspected 719 windows visually at 91 units and invasively tested 25 windows at 25 units throughout the High Noon at Arlington Project.

It was determined at High Noon at Arlington Ranch, the windows in all plan types, is the Alenco 3700 Series Aluminum Window. This window is a "nail on flange" type window and comes in four basic configurations all of which require the same materials and methods of installation:

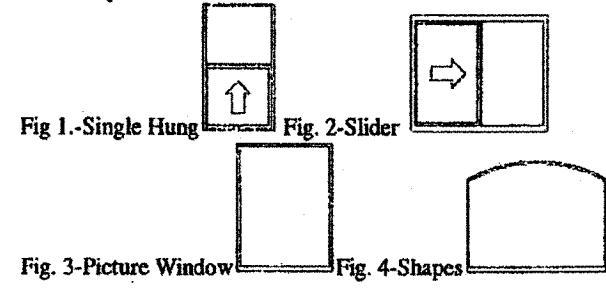
At High Noon at Arlington Ranch, the fenestration product (windows) chosen by the Developer in all plan types, was the Alenco 3700 Series Aluminum Window. This window is a "nail on flange" type window and comes in four basic configurations all of which require the same materials and methods of installation:

These configurations can also be installed by stacking a Picture Window or Shape Window on top of a Single Hung Window or Slider Window which requires the juncture or intersection of where the two window meet to be sealed.

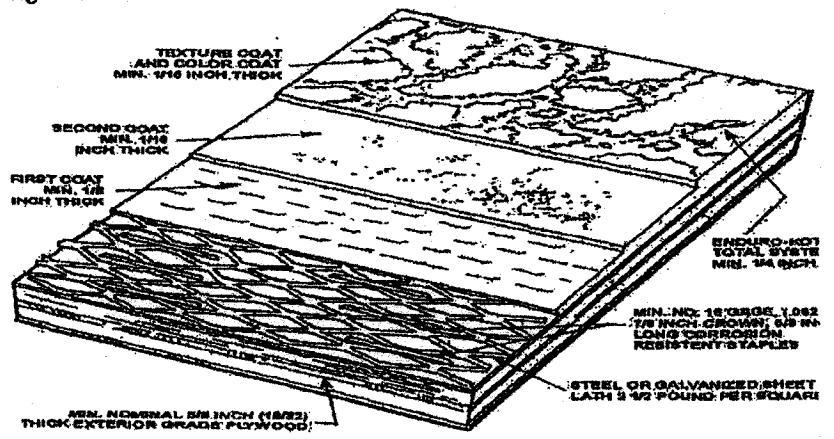
R.H. Adcock will use Enduro-Kote as a representative example as to the conditions of the balcony at High Noon. Figure 1 below shows the type of waterproof system installed at the balconies.
