SUPPLEMENTAL JOINT APPENDIX
INDEX

IN THE MATTER OF THE COURT
ORDER OF MAY 17, 2010, ISSUED BY
THE 6TH JUDICIAL DISTRICT COURT
OF THE STATE OF NEVADA IN AND
FOR THE COUNTY OF DOUGLAS
UNDER CASE NO. 08-CV-0363-D FOR
SHERIDAN CREEK LOCATED WITHIN
CARSON VALLEY, DOUGLAS
COUNTY, NEVADA.

REPORT OF
FIELD INVESTIGATION
NO. 1130

**REPORT OF
FIELD INVESTIGATION
NO. 1130-A**

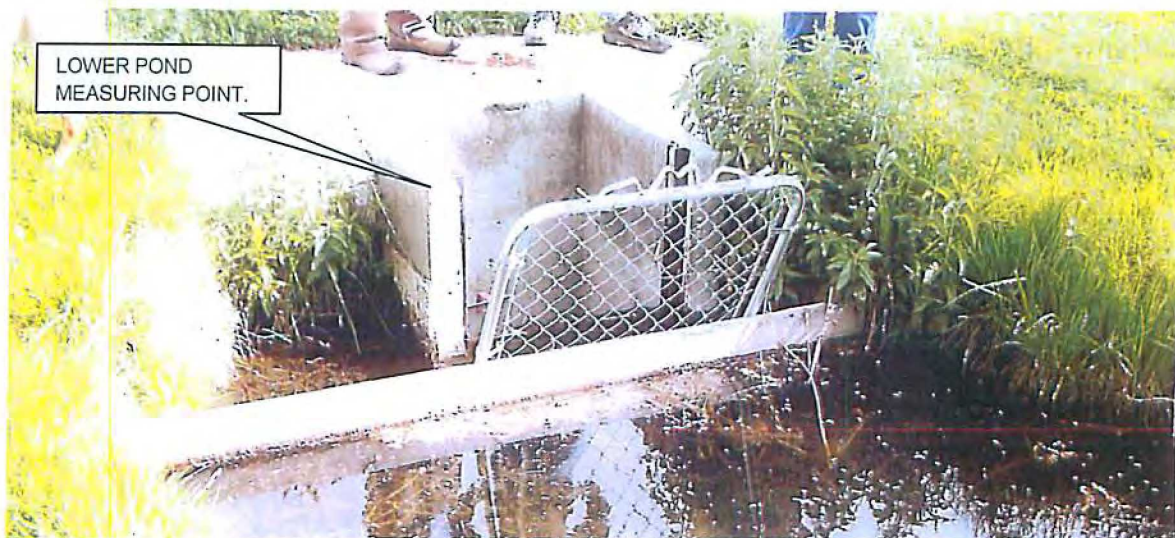
The lower pond is somewhat smaller than the upper pond and has two separate outlets. The northern outlet is comprised of a concrete drop inlet (Figure 4) that transfers water by pipeline to the north/northwest to a concrete diversion box located approximately 300 feet east of the northwest corner of APN 1219-14-001-013 along the north property line of said parcel. This box (Figure 5) directs water to a sub-grade storage tank and pump station on the Forrester parcel, Douglas County APN 1219-14-001-012. The diversion box to the Forrester pump station is located along the northern

Figure 4. Northern outlet from lower (eastern) pond on the Bentley property. Photo taken looking to the northeast

The northern outlet proved to be more problematic in achieving an instantaneous water tight seal. After adding an additional section of 1" x 1½" board to the top of the flash boards and closing the sluice gates to the outlet pipes we were able to stem the leakage from this drop-outlet structure. Worst case scenario was that this outlet continued to leak less than a pint a minute throughout the seepage test. This would only yield a volume of 360 gallons over the entire 48-hour period of the test.

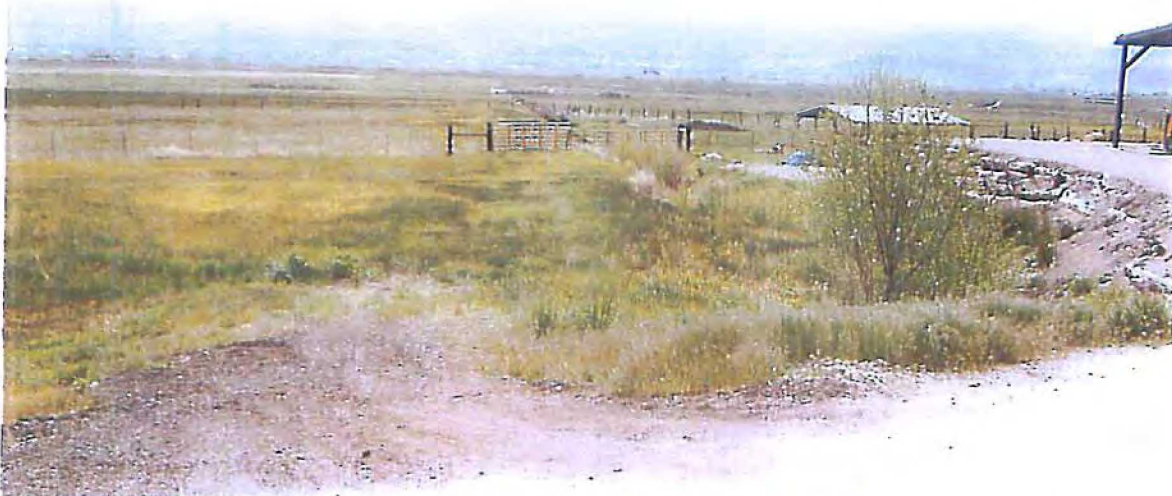
After viewing the northern outlet from the lower pond we walked to the easterly outlet from the pond. This second outlet is controlled by flashboards and is located at GPS location, NAD 83, N.38.90325°, W.119.82222°. Water from this outlet flows into a ditch (Figure 6) in an easterly direction toward the Park and Bull Ditch through the parcel owned by Forrester, APN 1219-14-001-012, and along the south boundary of the Mitchell parcel, APN 1219-14-001-011.

Figure 6. Looking east from the eastern diversion from the lower Bentley pond

The first outlet to cease flowing water over its crest was the east outlet of the lower pond. Once water quit flowing over the top of this structure staff of the State Engineer's Office sealed the pond side of the flashboards with plastic sheeting and sand bags to prevent any leakage from this gate from affecting any probable decline of the relative level of the pond. The outlet on the north side of the lower pond was the next to be sealed with the plastic sheeting and sand bags.

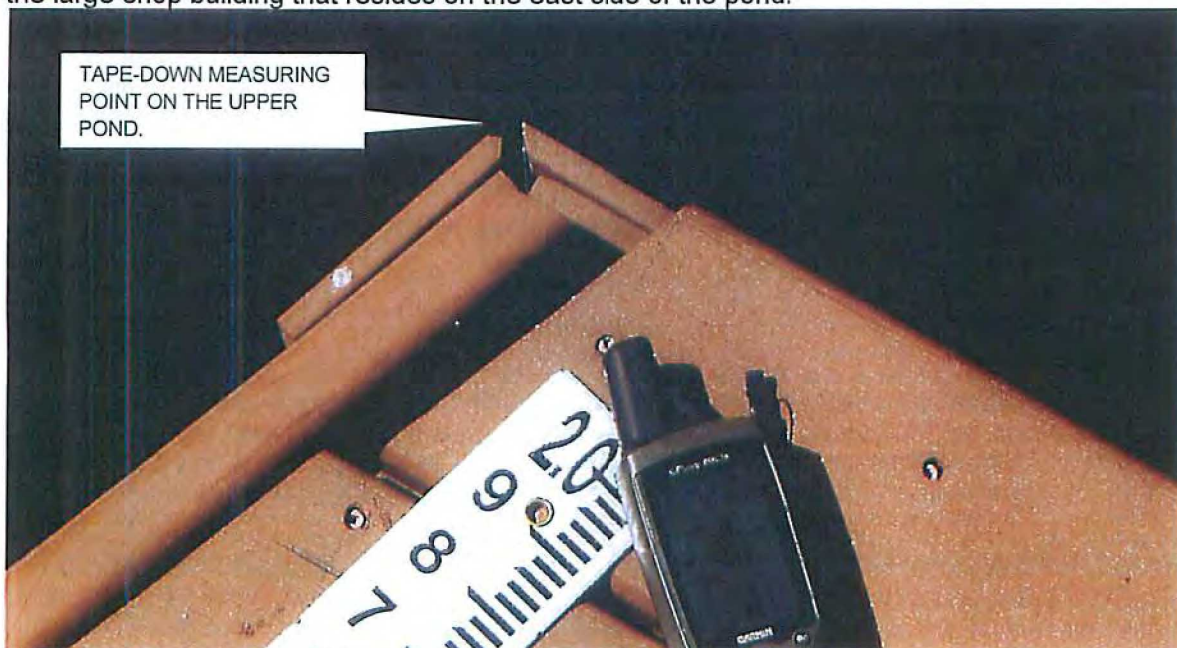
The tape-down point to monitor the Upper Pond surface elevation was established at the southwest corner of the deck that overhangs the pond. The deck is located on the west side of the large shop building that resides on the east side of the pond.

Figure 7. Southwest corner of the deck that overhangs the east side of the pond

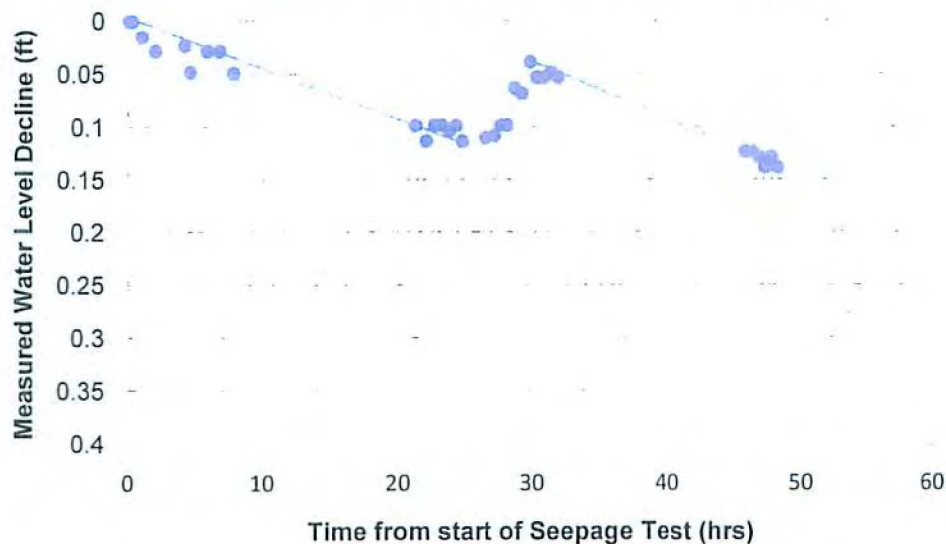
Water level measurements over the period of measurement are shown in Figure 8 and Figure 9. Points represent actual measured values. Lines are drawn through the data points from the highest measured water surface to the lowest measured water surface to show cumulative loss rates for each test. These cumulative loss rates are summarized in Table 1.

In the upper pond two distinct periods of measurement were defined to account for a 4-hour period (approximately hr 25 to hr 29) during which the inflow gate to the pond was accidentally opened by a neighbor. Though this interruption prevented a constant 48-hour test, data from the two measurement periods is advantageous because the actual water surface during the test period is closer to where the pond surface is routinely maintained, and the measurements provide a replication of the analysis.

Figure 8: Water Level in Upper Pond
Bentley Pond Seepage Test at Sheridan, NV

Scatter in the data that deviates from the trend line for both ponds may be caused by wind creating ripples and slight superelevation of the water surface from one side of the pond to the other, and/or precision in the data collection. For both ponds the diurnal pattern of evapotranspiration (ET) rates on cumulative loss is not apparent in the data, due to the relatively low proportion of ET losses and the precision of the measured data.

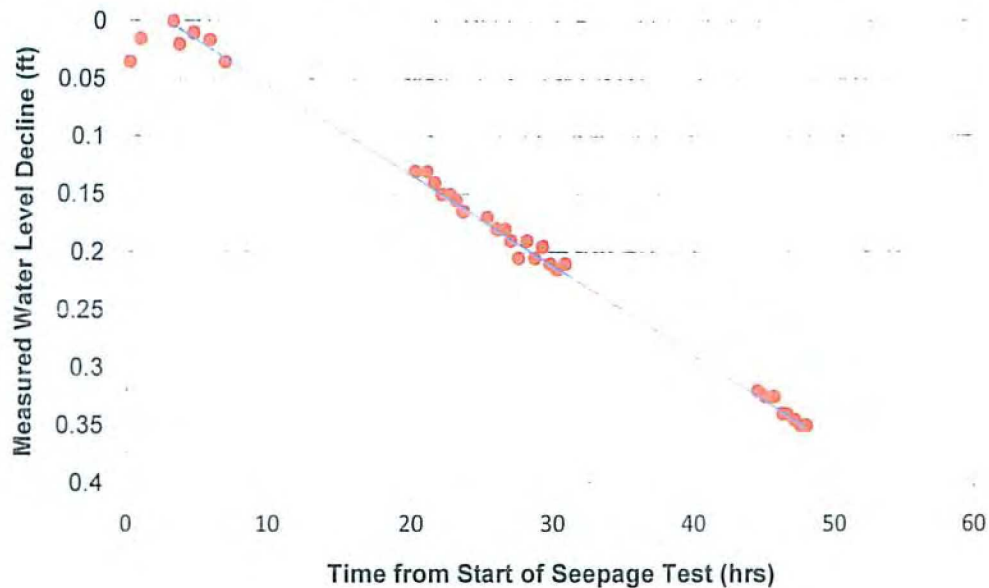
The lower pond shows a consistent decrease in water surface over the period of measurement with the exception of the first two data points. This initial rise in the measured water surface may be due to bank storage draining into the pond in response to the abrupt drop in water surface required to lower the pond elevation below the weir crest, or other initial adjustments to water surface as the pond came to an equilibrium state. Regardless of the actual cause, these two initial data points do not accurately represent seepage and were not included in the analysis. No water flowed into the lower pond during the four-hour period when the gate to the upper pond was accidentally opened.

Figure 9: Water Level in Lower Pond
Bentley Pond Seepage Test at Sheridan, NV

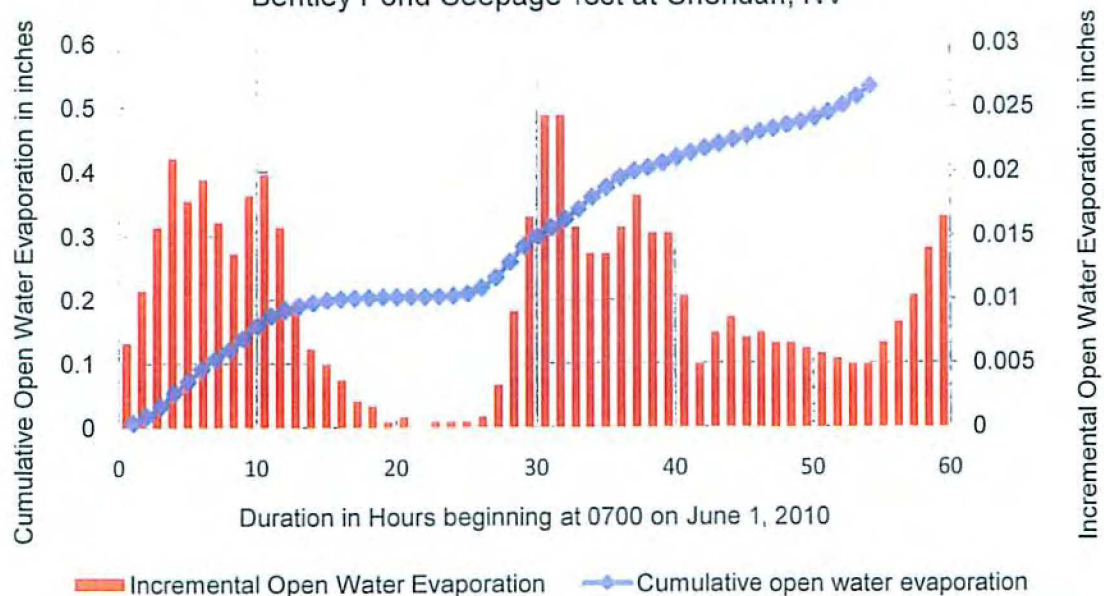
Evaporation from the surface of the ponds was calculated using the Penman-Monteith equation for grass reference evapotranspiration with an hourly time step, consistent with FAO Irrigation and Drainage Paper No. 56 (FAO 56). Shallow open water evaporation was determined by multiplying reference ET by 1.05 following recommendations in FAO 56. Mean hourly data for wind speed, temperature and relative humidity were obtained from a weather station at the Bentley property, with adjustments made for anemometer height also consistent with FAO 56 recommendations. Mean hourly data for solar radiation was obtained from pyranometer data at Western Nevada College in Carson City. This site is geographically comparable to the Bentley property with regard to elevation and horizon angle. Computed hourly evaporation is shown on Figure 10. Cumulative evaporation over the duration of the testing periods accounts for approximately 8% of total measured loss from the lower pond and 14% from the upper pond.

Figure 10: Computed Open Water Evaporation
Bentley Pond Seepage Test at Sheridan, NV

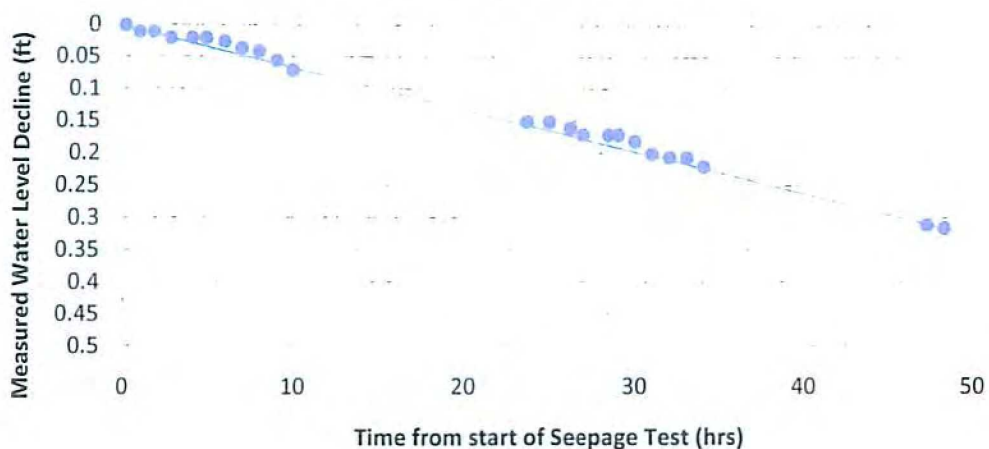
Pond seepage tests were repeated on August 16-18, 2010. Methodology for the seepage test was the same as described for the June 1-3 test, including field methods, measuring points, and ET analysis. In the August seepage test, continuous data over a 48-hour period were collected for both ponds. Measured water level decline was roughly linear for both ponds, with a less rapid decline in the upper pond (Figure 1) than the lower pond (Figure 2).

Figure 1: Water Level in Upper Pond

Bentley Pond Seepage Test at Sheridan, NV

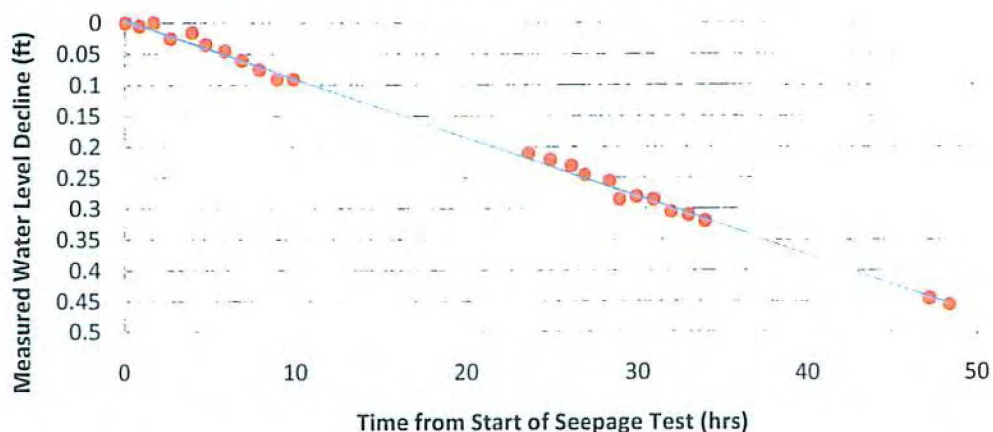
Figure 2: Water Level in Lower Pond

Bentley Pond Seepage Test at Sheridan, NV
