CBRE Property Condition Assessment Report for Village Square Apartments, dated
August 8, 2017

Property Condition Report for Mortgage Financing Purposes

Re: Property Condition Assessment for Mortgage Financing Purposes
Village Square Apartments
5025 East Nellis Oasis Lane
Las Vegas, NV 89115
Project No. PC70736713-101

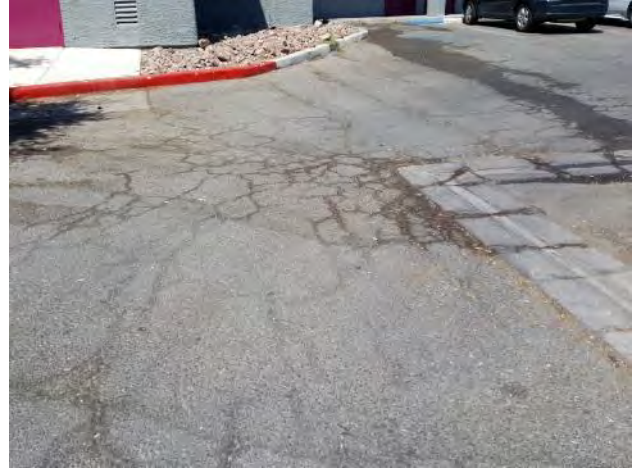
2. Asphalt pavement exhibited excessive alligator cracking, open cracks, potholes and overall surface deterioration throughout the parking lot and interior roadways.

Asphalt Pavement: Asphalt pavement exhibited excessive alligator cracking, open cracks, potholes and overall surface deterioration throughout the parking lot and interior roadways. CBRE recommends crack sealing and minor repairs as needed at this time. Also the parking stalls, handicap parking markings and driveway directional arrows were noted to be faded and worn. All affected areas should be re-striped. These items are a Deferred Maintenance repairs.

Observations/Comments: For the most part, asphalt paved areas were found to be in fair condition. Asphalt pavement exhibited excessive alligator cracking, open cracks, potholes and overall surface deterioration throughout the parking lot and interior roadways. We were provided with a proposal for asphalt repairs by Sunland Asphalt. A copy of this document is included in the Exhibits section of this report. This is a Deferred Maintenance item.

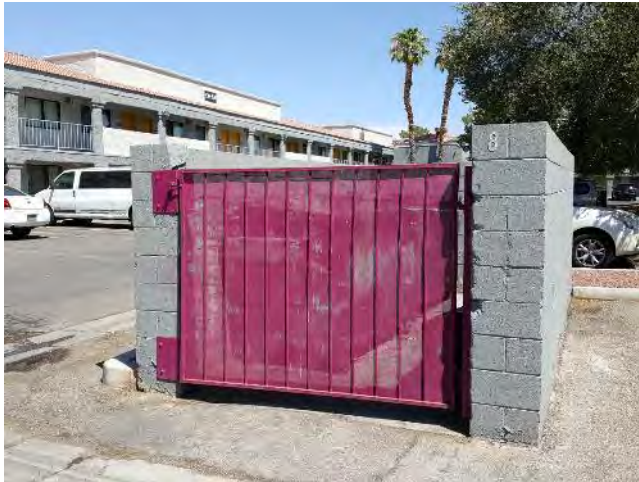
3. CMU refuse container enclosure walls were found with broken and chipped CMU sections.

Refuse Containers: CMU refuse container enclosure walls were found with broken and chipped CMU sections. All broken and chipped CMU sections should be repaired and re-painted to match the existing. This is an Item of Note.

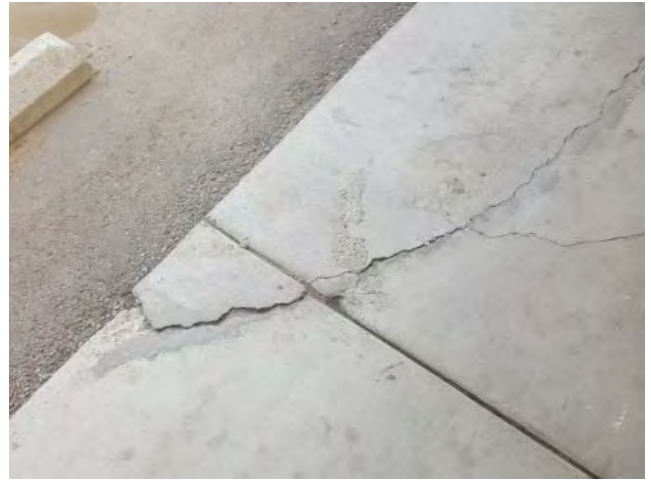
4. Concrete sidewalks and walkways were observed with cracks, surface deterioration and broken sections. (Repaired 10/17/2017)

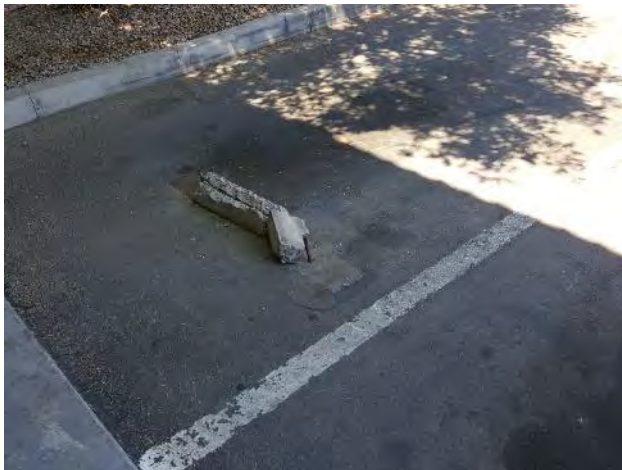
5. Broken concrete wheel stops were observed throughout the parking lot.

Damaged Wheel Stops: Broken concrete wheel stops were observed throughout the parking lot. All broken wheel stops should be replaced at this time. This is a Deferred Maintenance item.

Broken concrete wheel stops were observed throughout the parking lot. All broken wheel stops should be replaced at this time. We were provided with a proposal for concrete curb repairs by Sunland Asphalt. A copy of this document is included in the Exhibits section of this report. This is a Deferred Maintenance item.

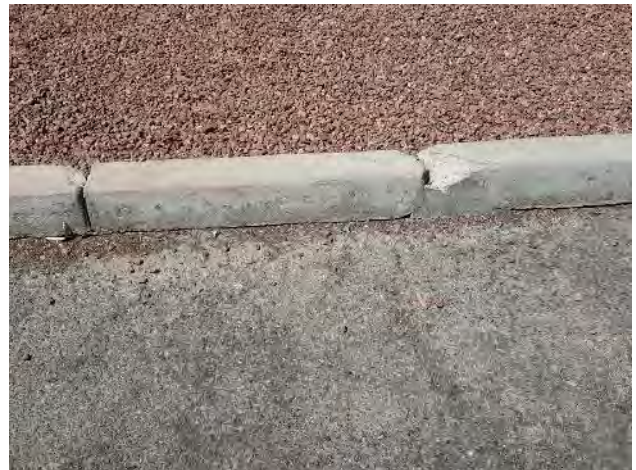
6. Concrete curbs exhibited broken and cracked concrete.

Curbs: Concrete curbs exhibited broken and cracked concrete. We recommend removal of damaged portion and replacement with new curbs to match existing. This is an Item of Note.

Concrete curbing and wheel stops were found to be in fair to poor condition. Concrete curbs exhibited broken and cracked concrete. We recommend removal of damaged portion and replacement with new curbs to match existing. This is an Item of Note.

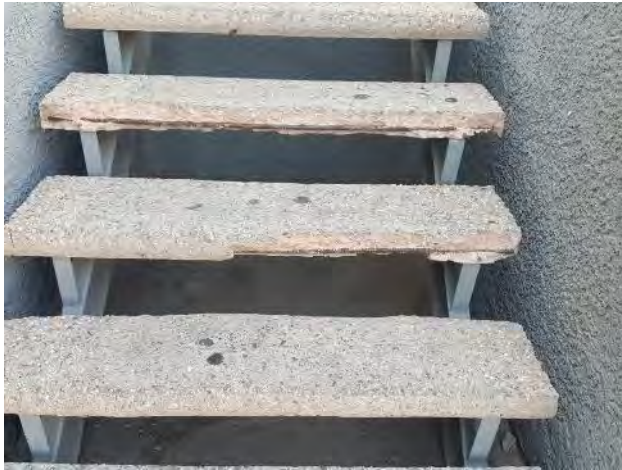
7. Stair systems exhibited excessive damage. Photographed above is an example of broken/missing metal corner boards. (Repaired 10-7-2017)

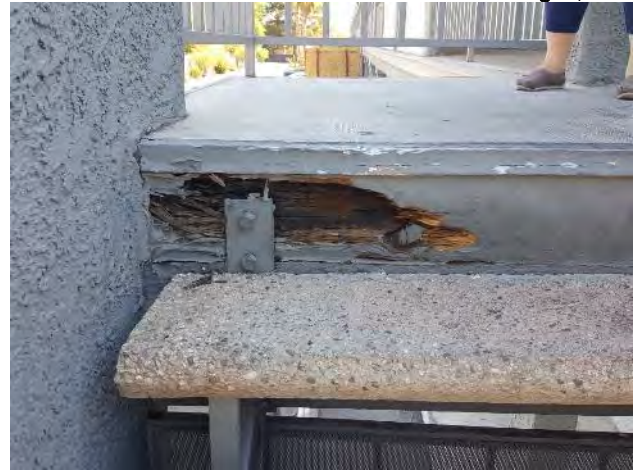
8. Stair systems exhibited excessive damage. Photographed above is an example of dry rot on wood the top risers. (repaired 10-7-2017)

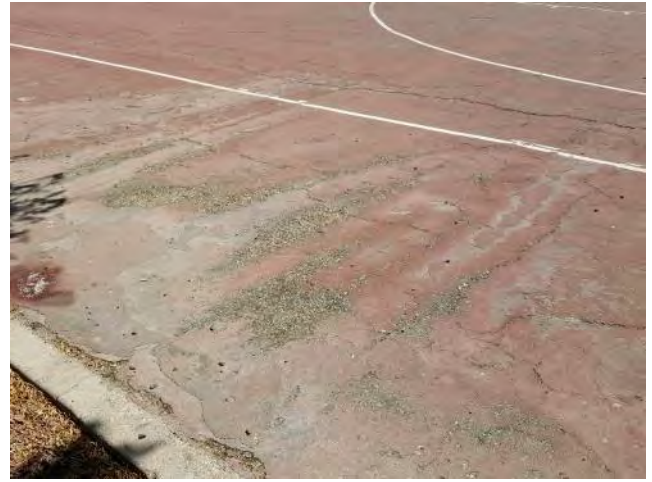
10. The basketball court exhibited surface deterioration and excessive cracks.

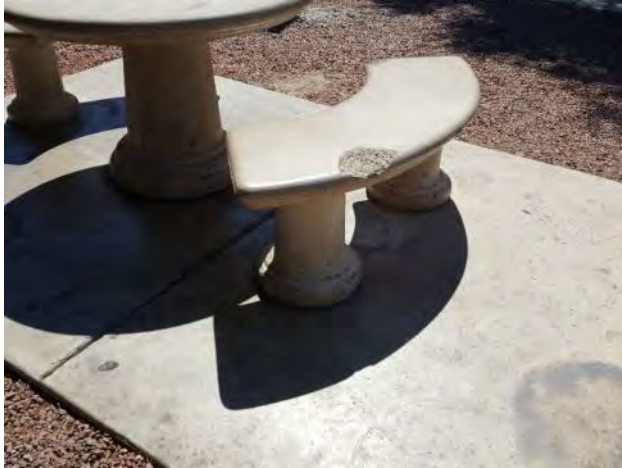
13. A broken concrete bench was observed in the picnic area.

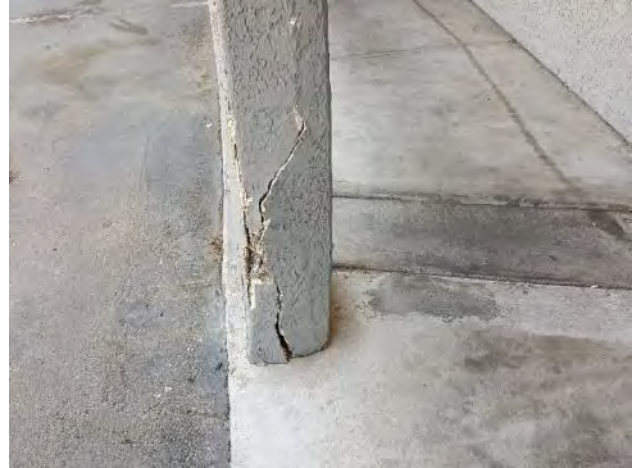
14. Stucco cladded columns were found cracked and severely damaged. This condition was observed near Unit 9 and 377.

Facades: Stucco clad columns were found cracked and severely damaged. This condition was observed near Unit 9 and 377. Test hammer all areas to break-back to sound material, clean cracks of loose material, and re-patch surfaces. Upon completion apply a cementitious coating to all surfaces. These are Critical Repairs.

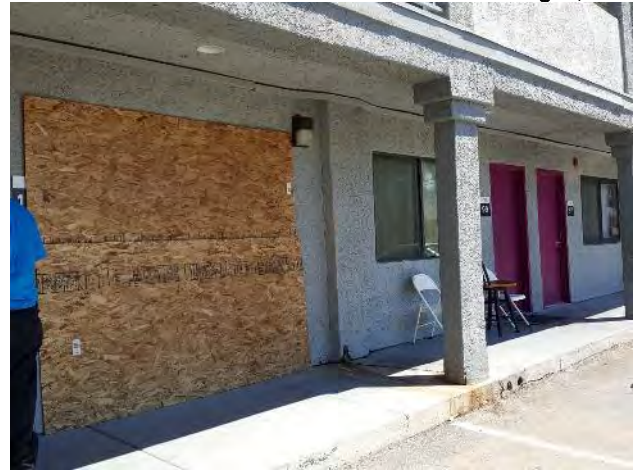
20. Unit 101's stucco clad sidewall exhibited excessive vehicular damage. Reportedly a car drove into the stucco clad sidewall. Plywood was observed over the window and sections of the wall.

Unit 101 Car Damage: Unit 101's stucco clad wall exhibited excessive vehicular damage. Reportedly a car drove into the stucco clad wall. Plywood was observed over the window and sections of the wall, and plastic was draped over the interior sections of wall. Despite conditions, the tenant is still occupying the unit which will eventually be classified as down. Repairs should continue as planned. This is a Critical Repair.

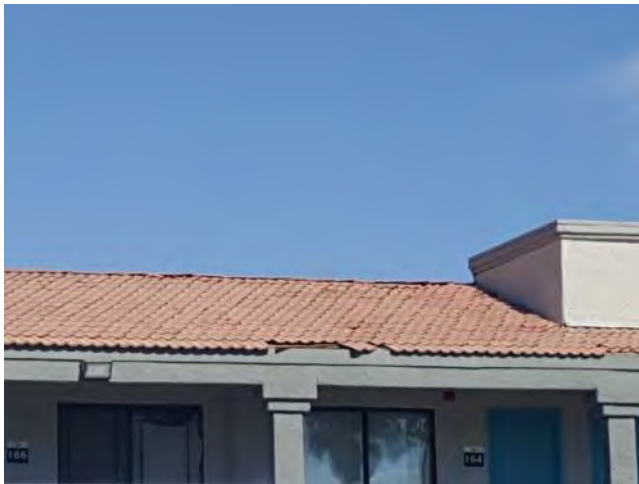
21. Broken and missing Spanish concrete roof tiles were observed near Unit 164.

Roofs: Broken and missing Spanish concrete roof tiles were observed near Unit 164. All broken and missing tiles should be replaced at this time. This is a Critical Repair.

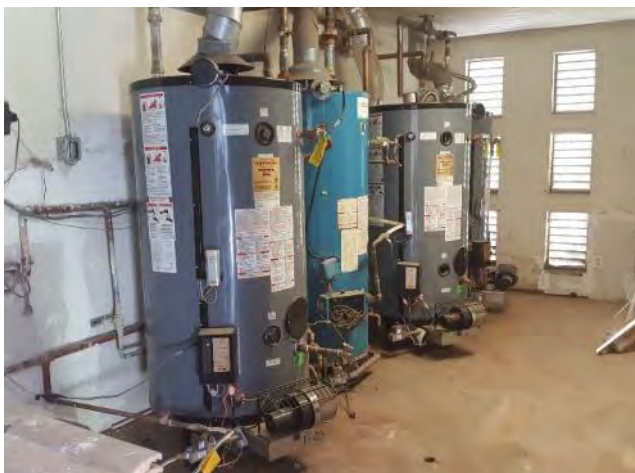
29. The Subject is provided with 6 natural gas-fired DHWHs.

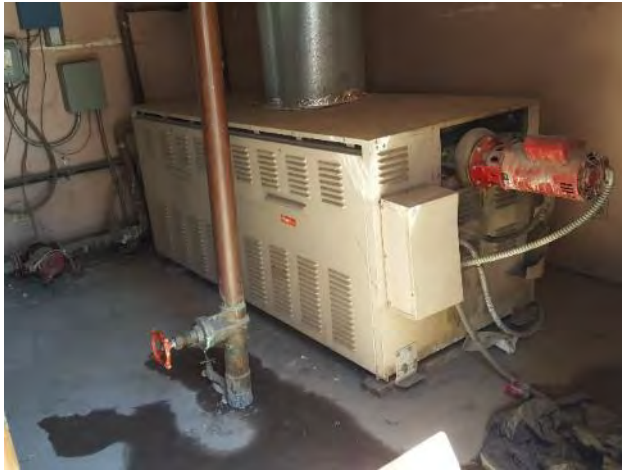
31. The Subject is provided with two natural gas-fired boilers manufactured by Raypak.

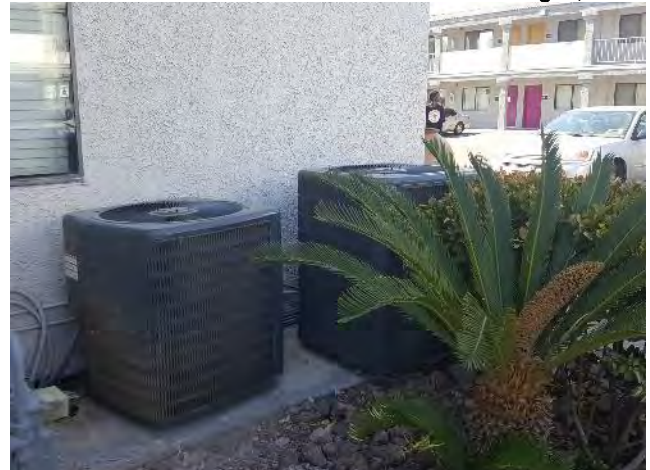
32. Several split system wall mounted air conditioning components were found to be old, not operating properly or not operational.

HVAC: Several split system wall mounted air conditioning components were found to be old, not operating properly or not operational. All non-functioning or damaged systems should be repaired at this time. This is a Deferred Maintenance item.

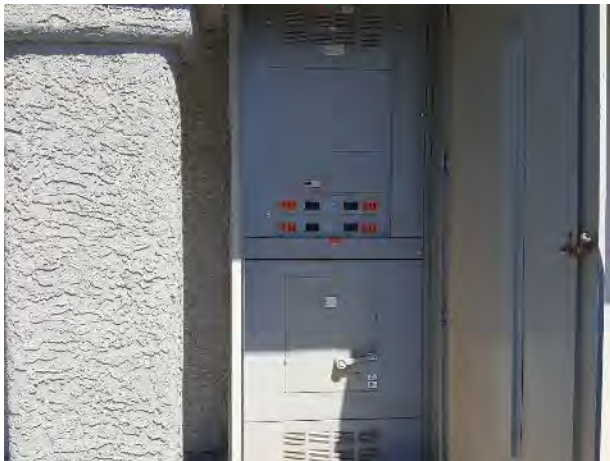
33. Each building is provided with a 600-amp, 240-volt service.
