ARLINGTON RANCH
ARLINGTON RANCH
Preliminary Defect List &
Repair Recommendations
January 7, 2008
16.0 WINDOWS

FOR MEDIATION PURPOSES ONLY.
FOR MEDIATION PURPOSES ONLY.
N.R.S. 48.109 and N.R.S.40.680

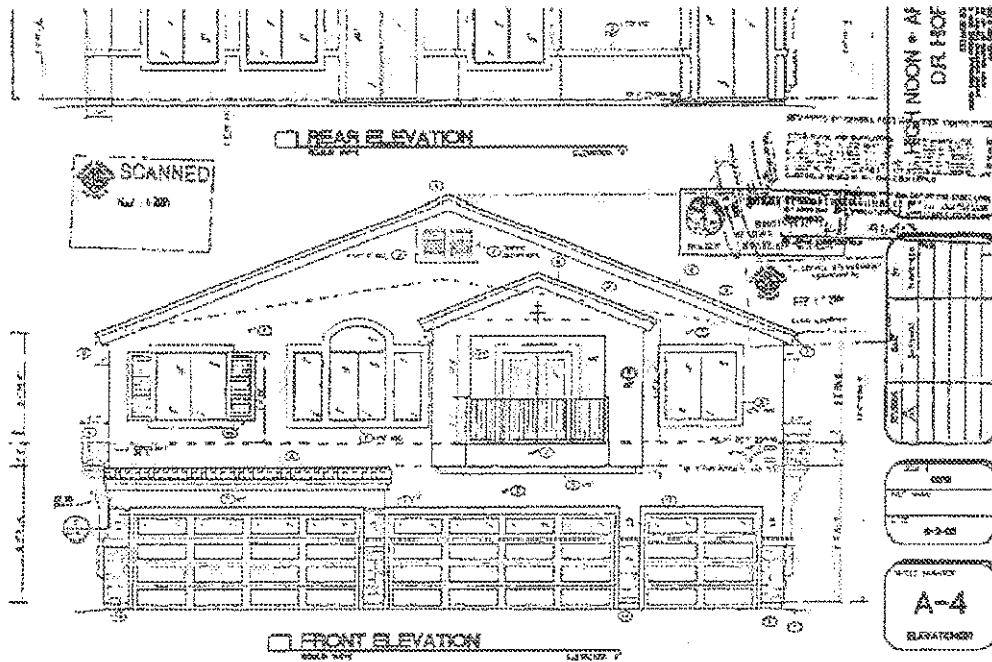
ARLINGTON RANCH
ARLINGTON RANCH
Preliminary Defect List &
Repair Recommendations
January 7, 2008
Elevation 'A'

Building plans and "as-built" construction indicates that there are two variations in roof plans. These alternate conditions are shown in the building plans on sheet A-4, as Elevation 'A', and on sheet A-4.1, as Elevation 'B'. The only difference found between these roof plans and elevations is that Elevation 'A' has "straight" gable ends and Elevation 'B' shows "clipped" gable ends at the front elevation. It should be noted that in the "as-built" construction, the gable in Elevation 'B' is found to only be clipped at the upper roof and not over the balcony projection as shown on sheet A-4.1.
