APPELLANTS' APPENDIX VOLUME XII

Our survey of the Property was conducted by Jeff Roden on March 04, 2021 & March 5, 2021. The weather at the time of our survey was sunny and 70 degrees. At the Property, we met with Asset Manager Ruth Garcia. Ms. Garcia escorted us through the vacant dwelling units and the common areas. Ms. Garcia has been with the Property for approximately 5+ years and had a thorough knowledge of the history of the physical asset. Due to current health concerns (COVID-19 Virus) f3, inc. observed vacant and/or down units, and common areas. Occupied units were not inspected. f3, inc. enacts all the rules of social distancing per the guidelines implemented by the CDC. No additional limitations or constraints prevented the PCA Consultant from performing the entire required scope of the PCA as set forth in the instructions.

1.1.1 Overall Condition Assessment

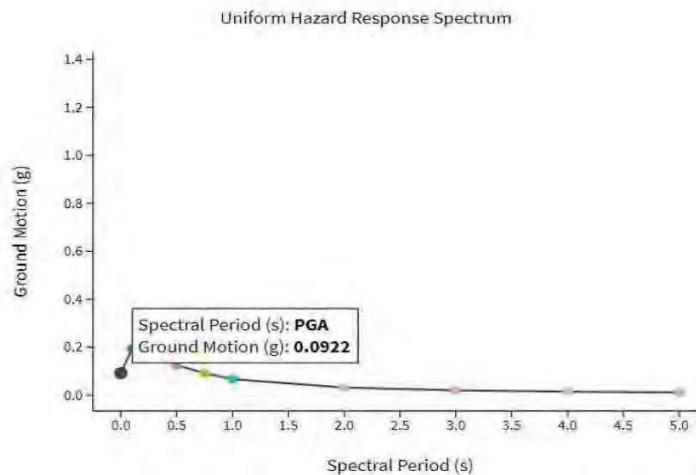
5.1.1 Peak Ground Acceleration

According to the USGS National Seismic Hazard Maps (2008), the Property is not in an area that has a 10% or greater probability of exceeding a Peak Ground Acceleration (PGA) value of 0.15g (or greater) in 50 years. Based on the Property's location, the PGA is 0.0922g. Because of this designation, a Structural Risk Evaluation Questionnaire (Form 4099C) is not required.
