18 FINDINGS OF FACT, CONCLUSIONS OF LAW AND ORDER

ARLINGTON RANCH
Preliminary Defect List &
Repair Recommendations
January 7, 2008
16.0 WINDOWS

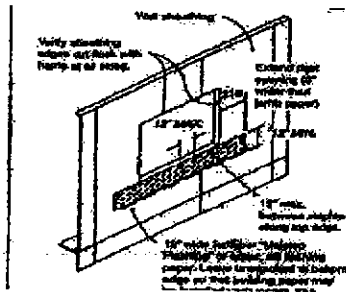
Figure 2

R.H. Adcock found 12 of 25 windows tested to have shear panel surrounding windows. For proper installation of the window flashing system the shear panel edges must continue to window frame opening so as not to create a crease in the window flashing.

16.06 Defect: Shear panels short of nail fin.
Location: At weather exposed windows.
