3. SUMMARY OF ACCIDENT COMBINATION MAINTENANCE RECORDS

**6. ACCIDENT TRACTOR TRIPLE-BOTTOM-DUMP-TRAILER COMBINATION INSPECTION
AND DUMP SITES INSPECTIONS, APRIL 28 & 29, 2016**

9. REMOVED VALVE TESTING, DISASSEMBLY AND EXAMINATION, NOVEMBER 30, 2016

12. SUMMARY OF UNINTENDED DUMP INFORMATION

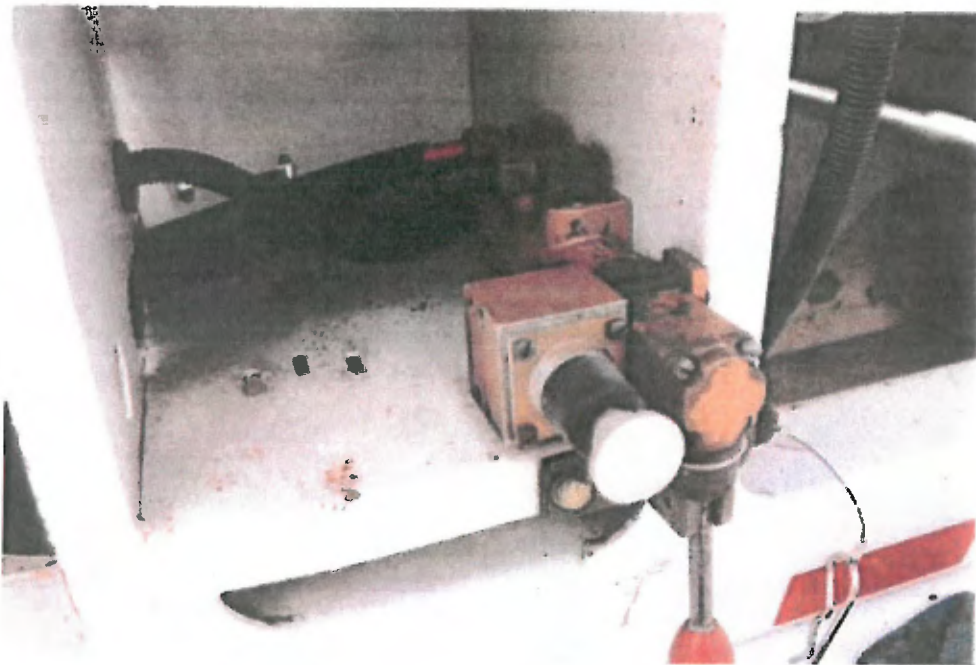
Figure 5-14. Dump Control Valve – Unit #6775

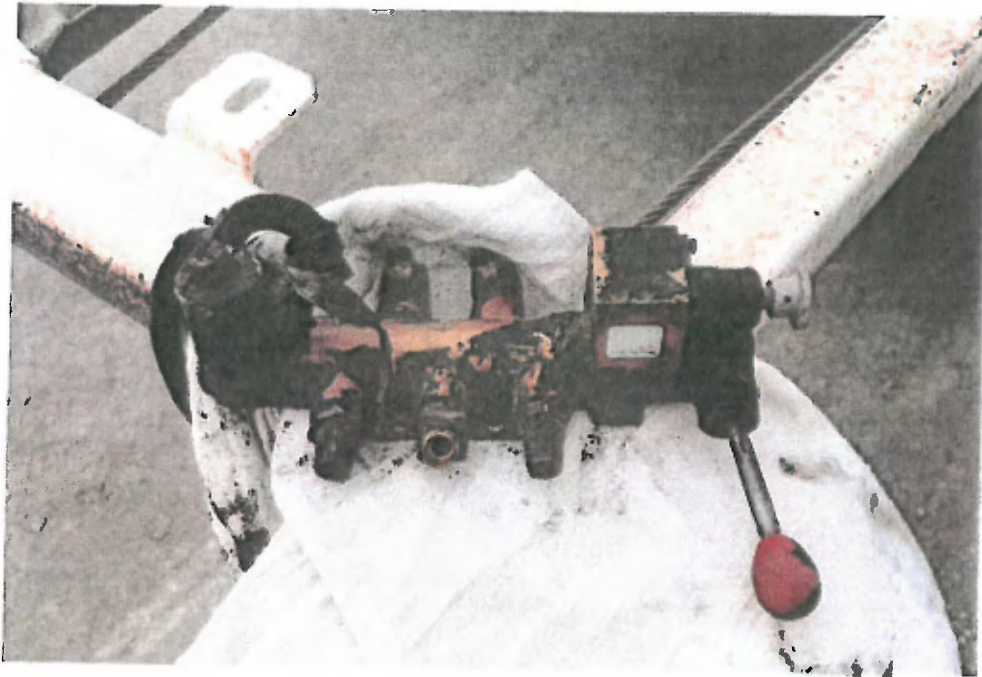
Figure 7-1. Versa Valve Removed from Trailer Unit 6775

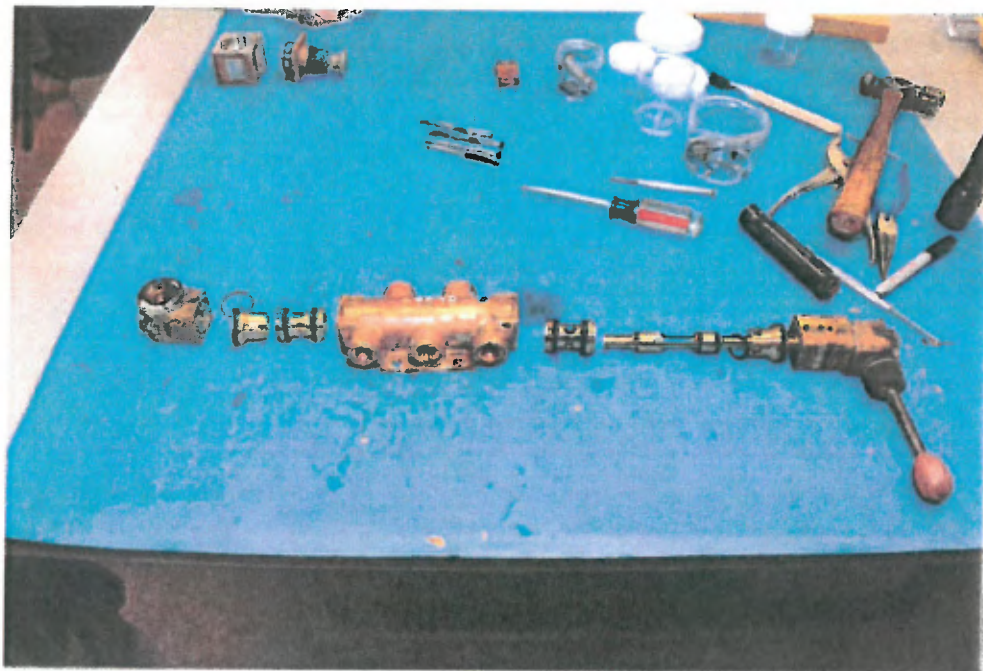
- 9.2.1 Discussion regarding the solenoid activation voltage and current are contained within AEI's report.
- 9.2.2 The electromechanical testing of the valve revealed that the valve functioned as designed.
- 9.2.3 After the electrical and electromechanical testing was completed, debris was removed from the valve.
- 9.2.4 The valve was then disassembled as shown in Figure 9-2.
- 9.2.5 Disassembly of the valve did not reveal an electrical or mechanical issue, or an issue that could cause unintentional activation.

Figure 9-2. Disassembled Valve Removed from Trailer Unit 6778

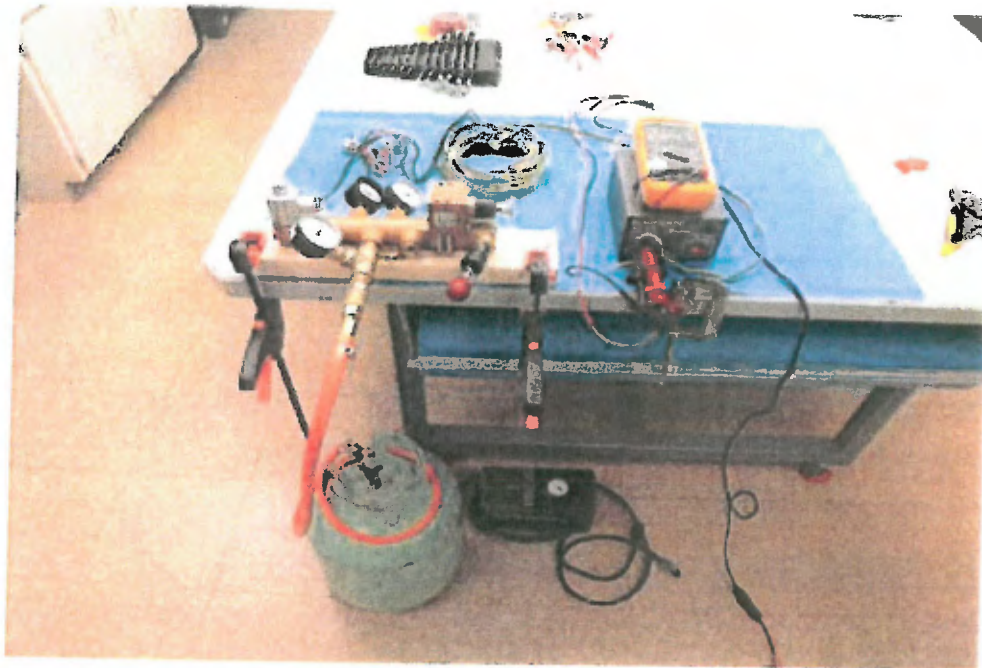
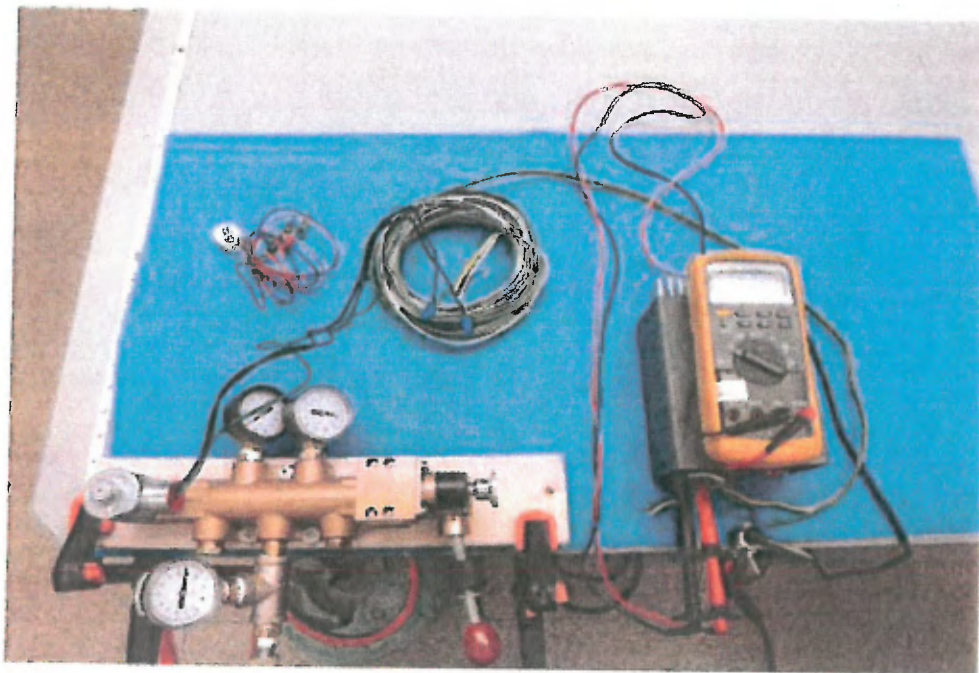
Forensic Engineering fabricated an experimental apparatus to facilitate its investigation regarding the unintended dumps. The apparatus was used with an exemplar valve installed to determine the details of valve function including the solenoid activation and deactivation voltage and current. It was also used to investigate the electrical and/or mechanical conditions that could cause the valve to inadvertently cause the bottom dump gates to open. The experimental apparatus is shown in Figures 11-1 and 11-2.

It was determined that the solenoid that controls the dump valve can be activated by a voltage as low as 8.5 VDC; approximately 4.7 VDC lower than the typical system voltage of 13.2 VDC. Additional information obtained using the apparatus is contained in AEI's report.

Figure 11-1. Experimental Apparatus for Dump Valve and Control System Testing

Figure 11-2. Experimental Apparatus for Dump Valve and Control System Testing

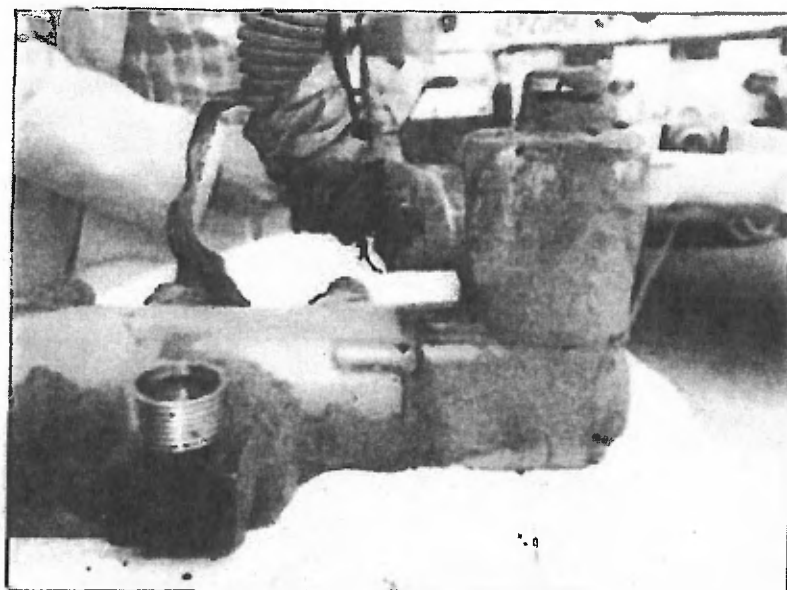
Photograph 10
Solenoid on opposite end of Versa valve assembly from lever.

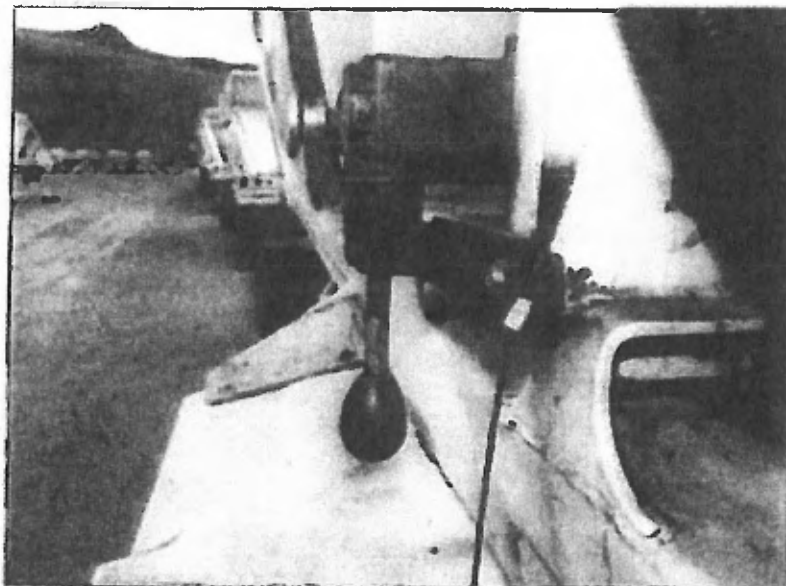
Photograph 26
Typical protrusion of Versa valve lever outside of mounting box.

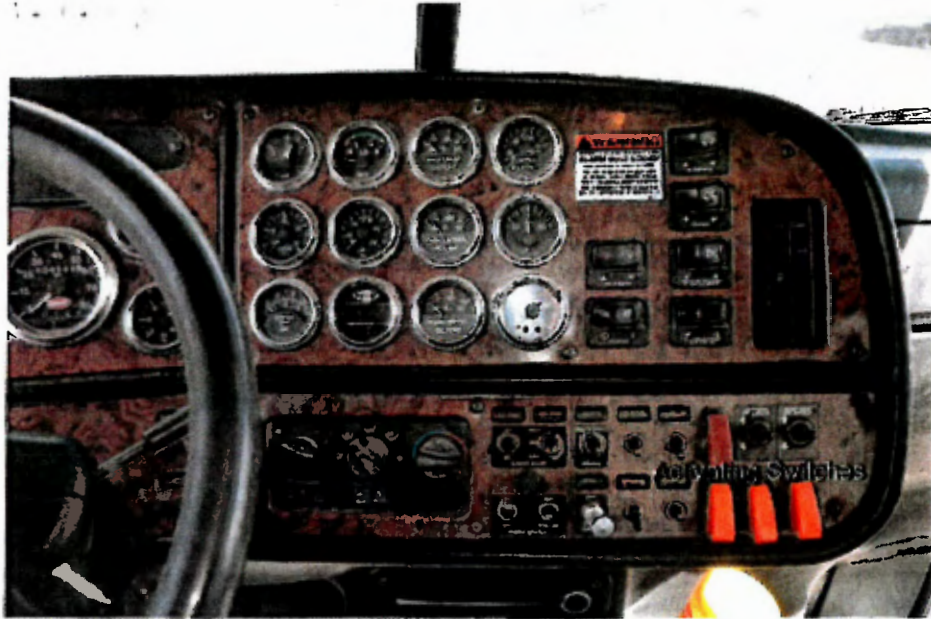
The tractor / trailer combination is approximately 112 feet long. The electrical wiring for the belly dump system of the truck driven by Mr. Koski was found to have been modified after the accidental dumping in July of 2013. The power to the individual solenoids for the Versa valves are switched individually. There are 3 switches that control individually the Versa valve for each trailer. There was an additional master switch incorporated into the system that switches both the hot and ground conductors for the switches that control the individual Versa valves.

Versa Valve Activating Switches.

To operate the Versa valves the master switch must be turned ON before any power is delivered to the individual trailer switches. Switch covers were incorporated for the 4 switches that activate the Versa valves.
