SWIMMING POOL

In summary, we consider this home to be in somewhat above average condition. Good quality materials and workmanship are evident throughout. While there is some work to do, as we have discussed in this report, in general, you should consider this home to be of good quality. It should serve you well for quite some time.

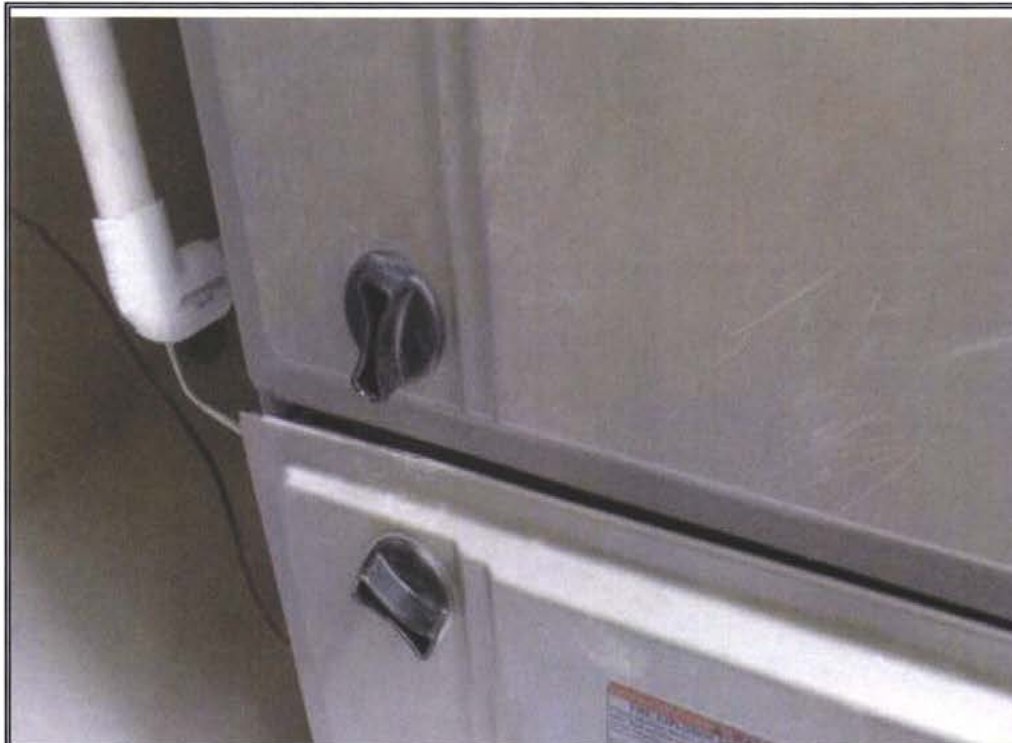
The door is not secure at the right side air handler.

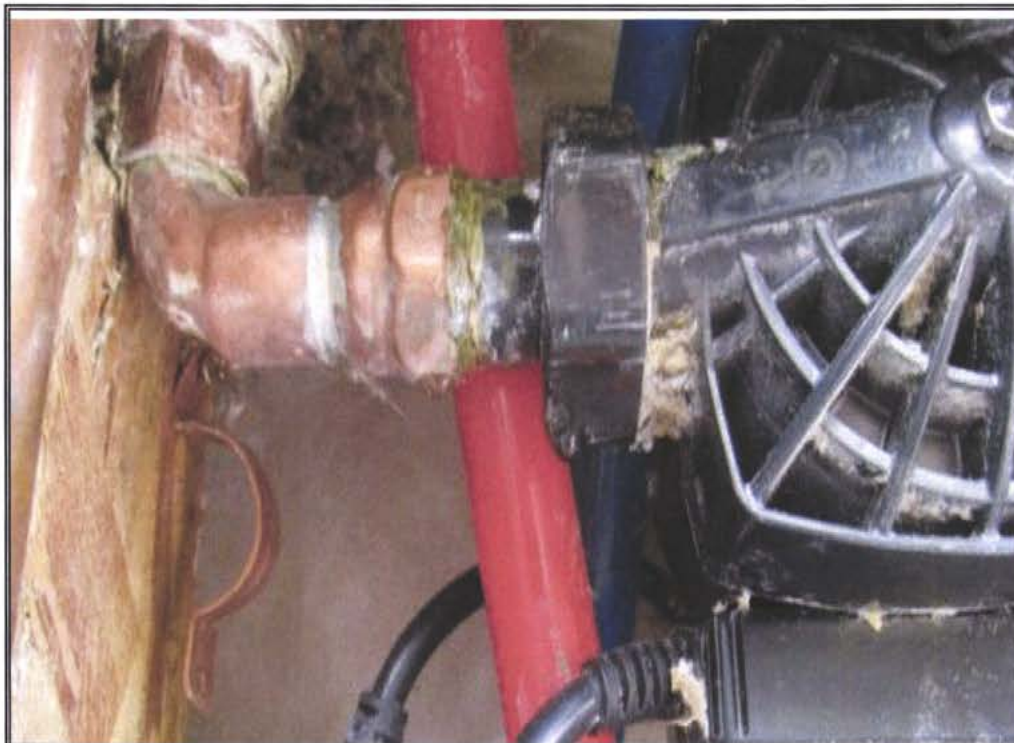
There are leaks at the hot water recirculation pumps.

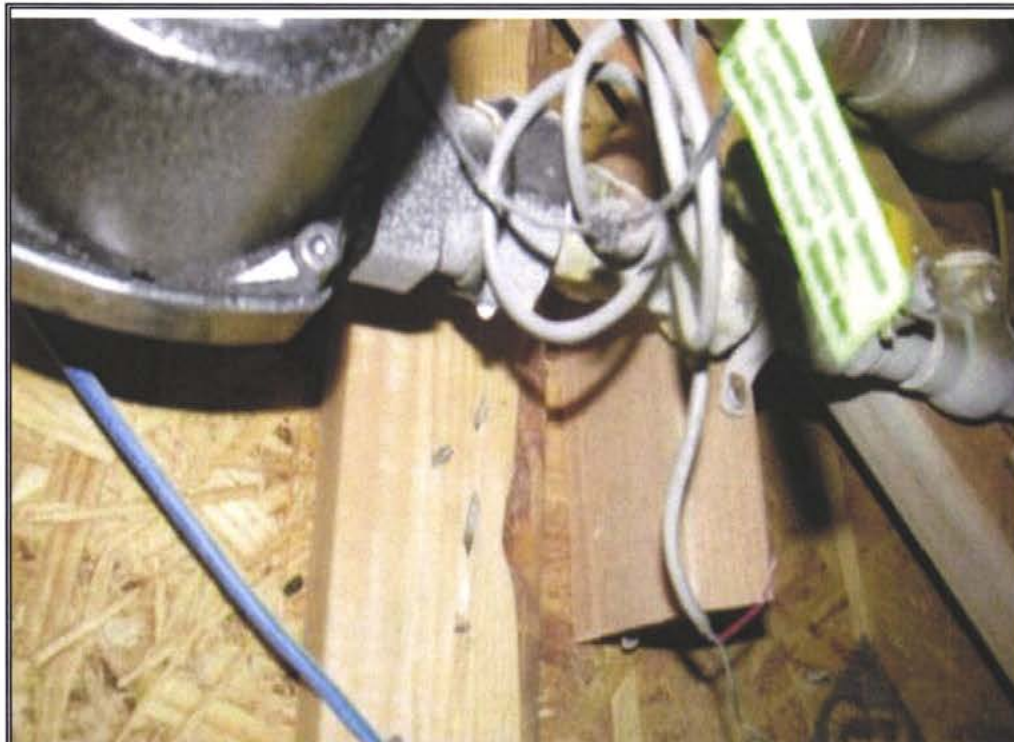
Photo Number
3

There are leaks at the hot water recirculation pumps.

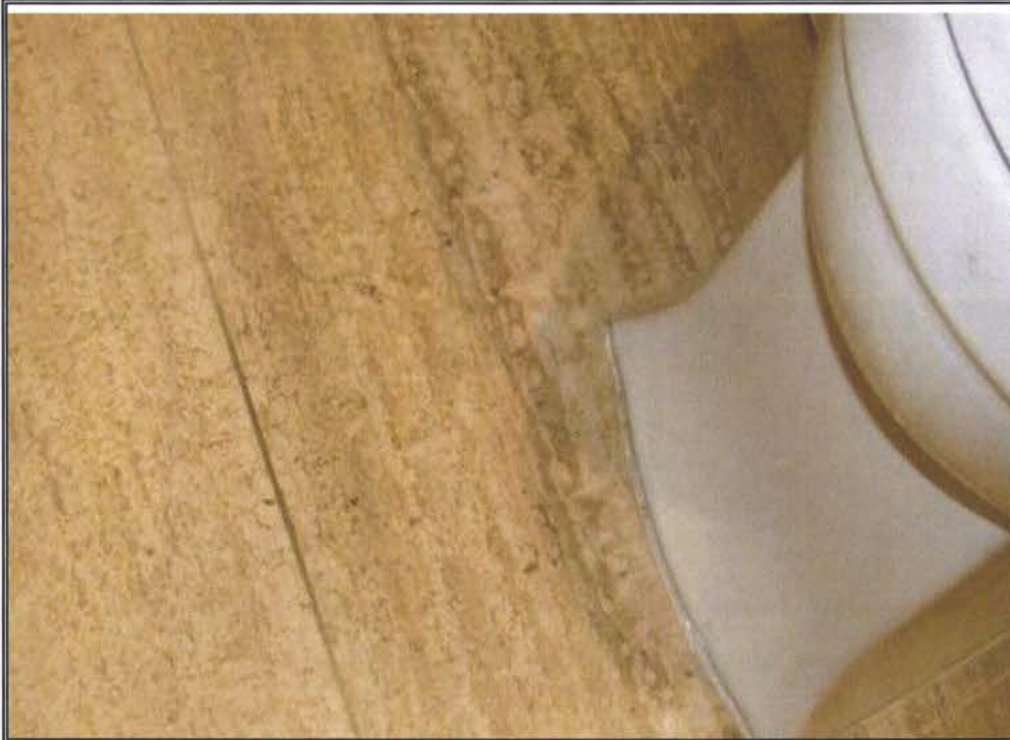
There is a plumbing leak at the ceiling of the basement bathroom. This is the water on the floor under the drip.

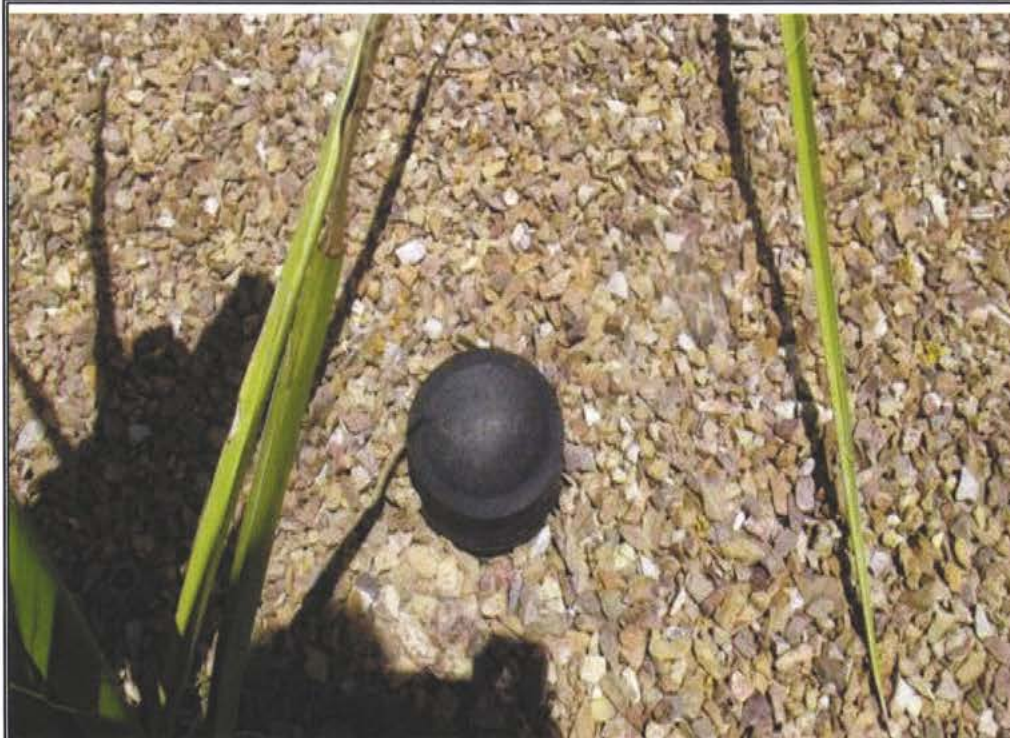
Photo Number
7

The drain clean-outs should have permanent screw type caps.

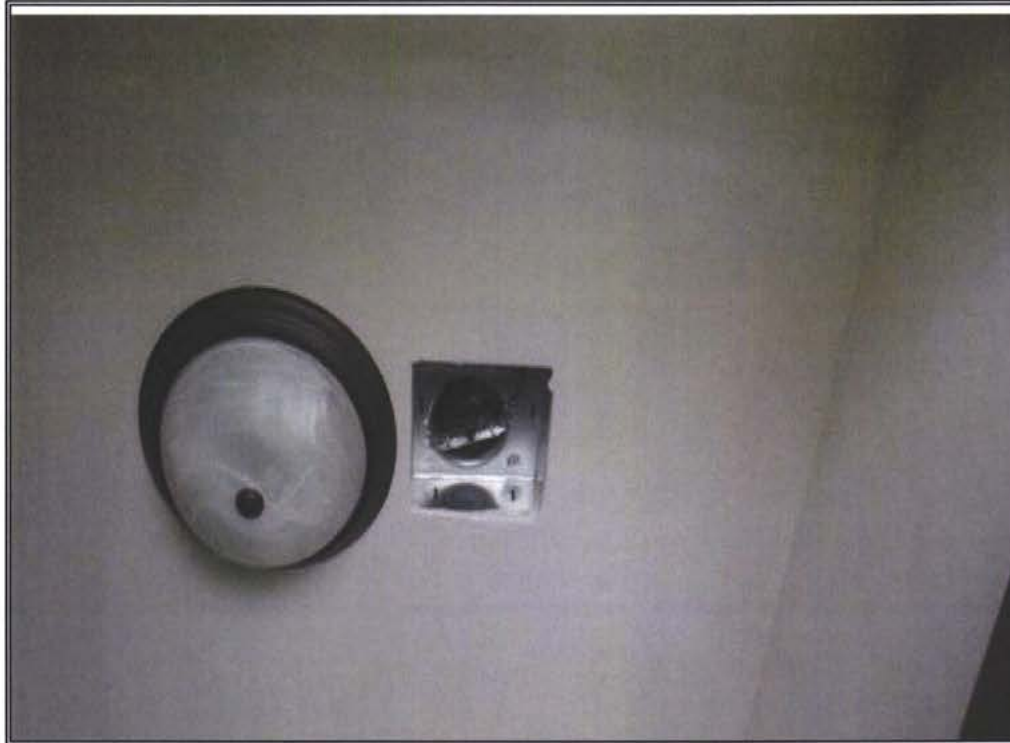
The cover is missing from the vent fan in the media closet.

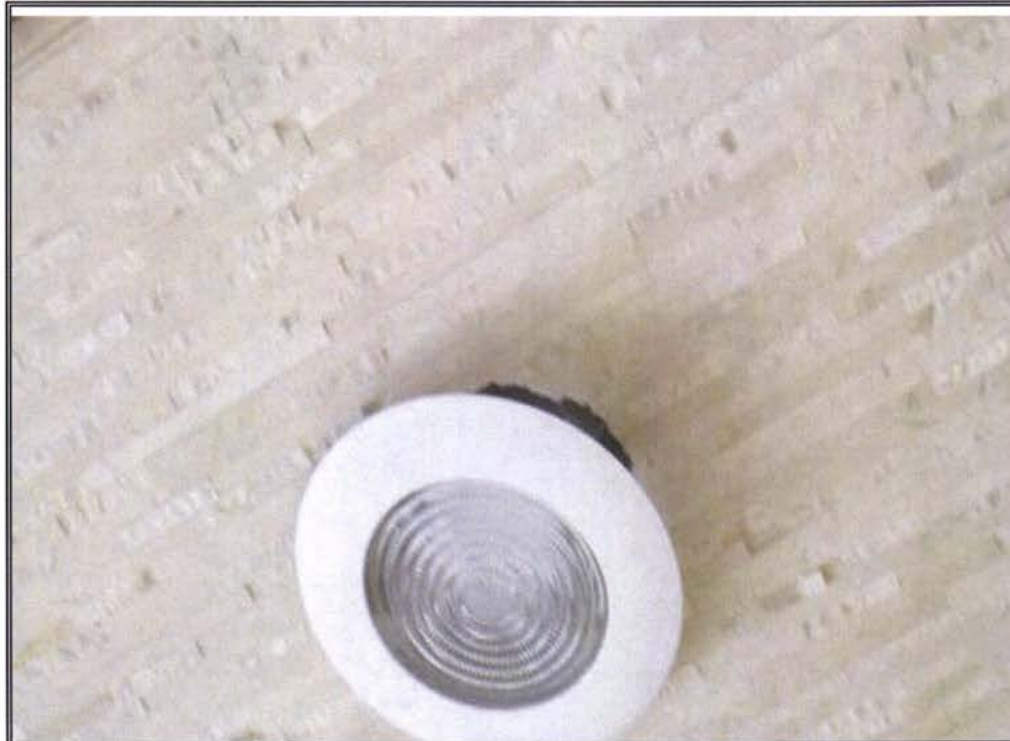
Photo Number
19

There is a loose light in the master shower.

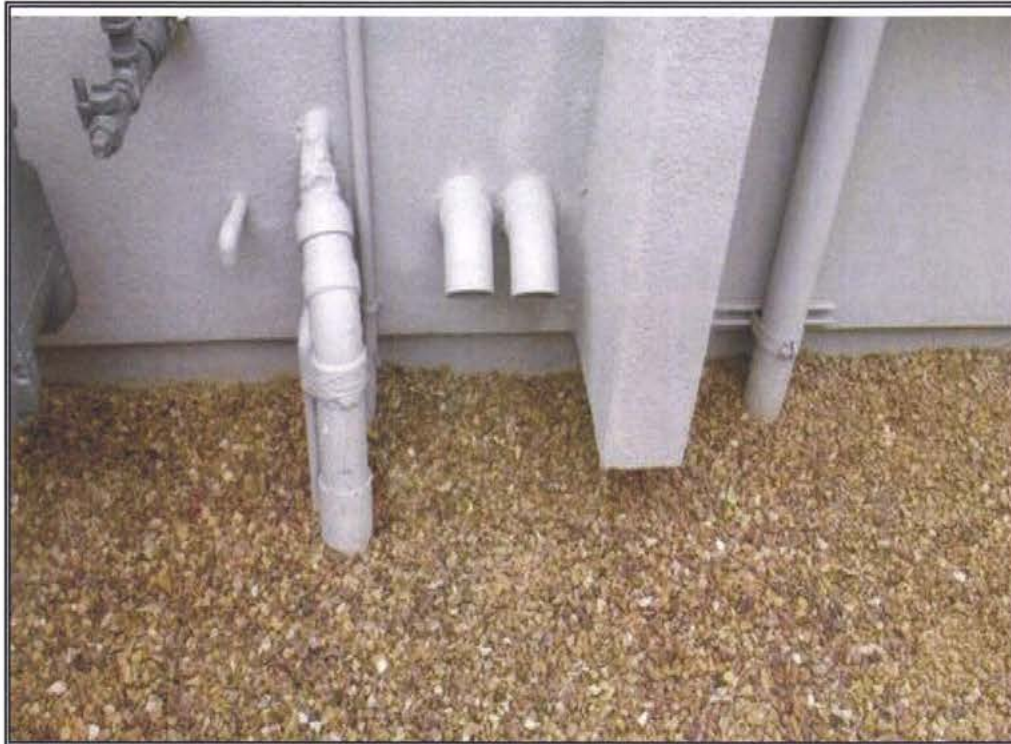
Splash blocks should be placed at all down spouts.

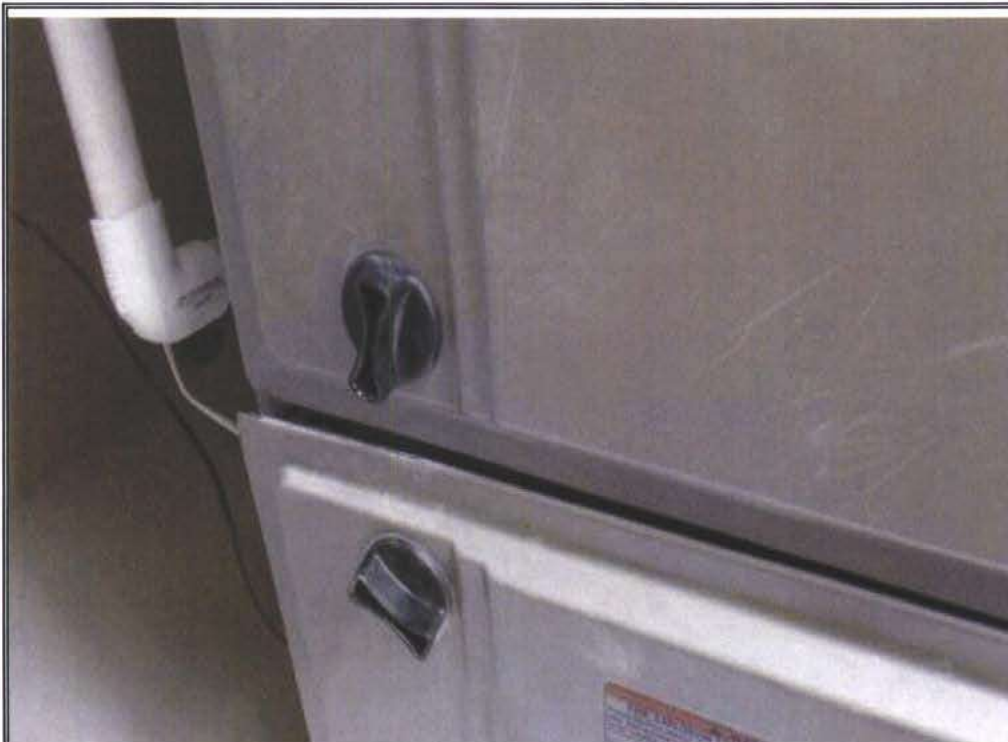
Photo Number
1

The door is not secure at the right side air handler.

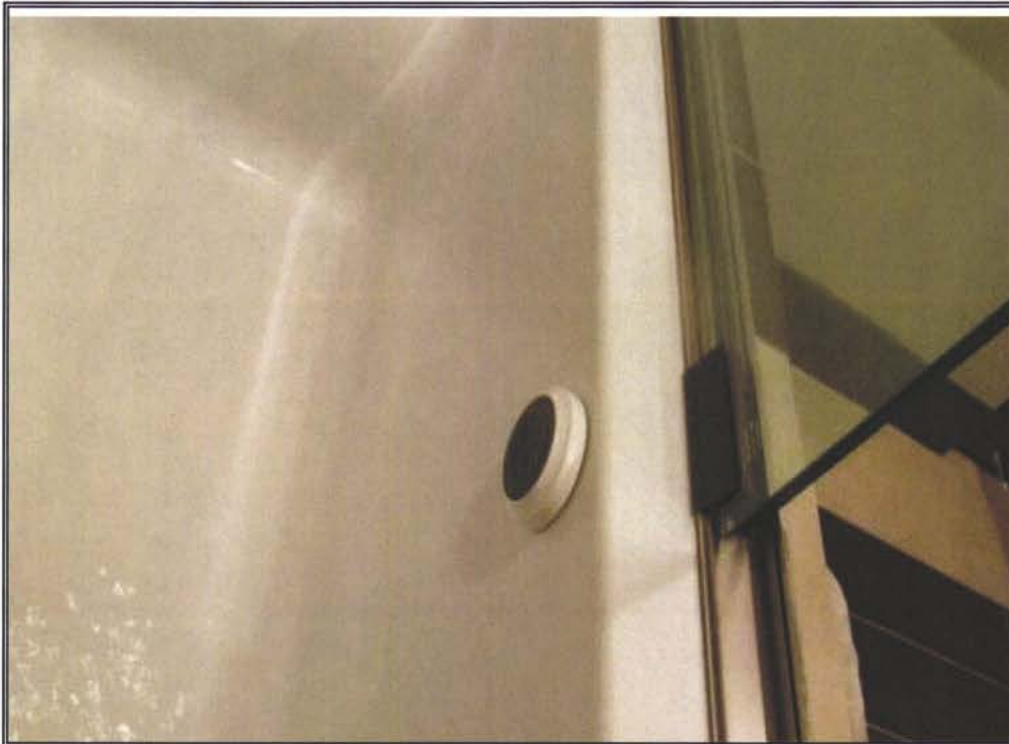
The controls at the second floor tub should be investigated further.

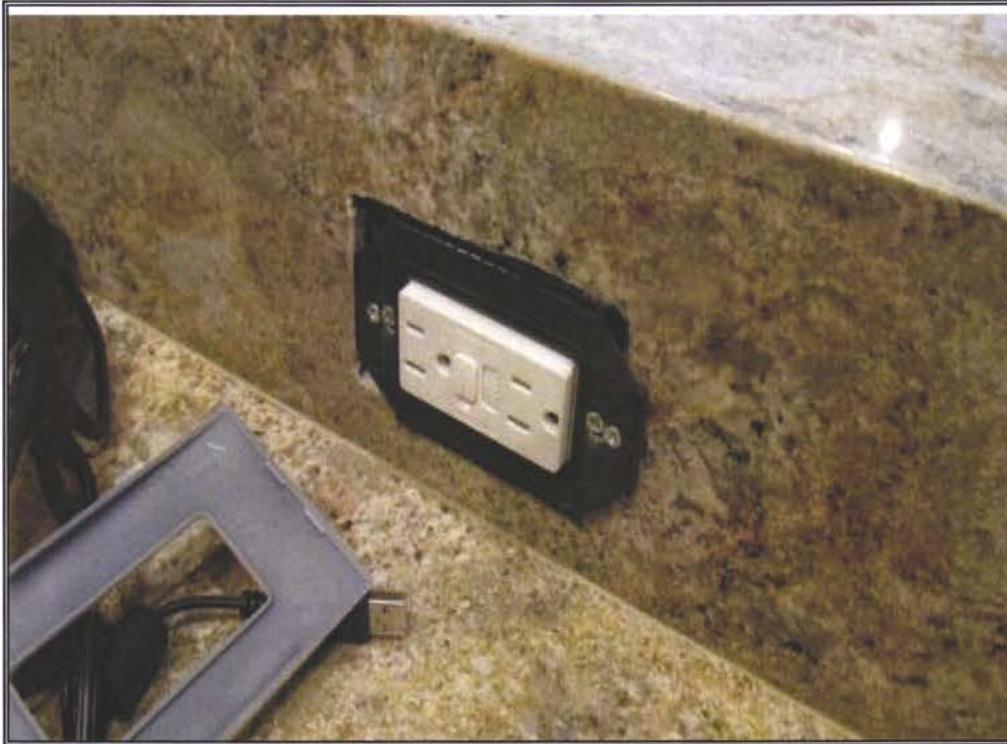
The outlet covers are loose at the media wet bar counter.

Electrician to address

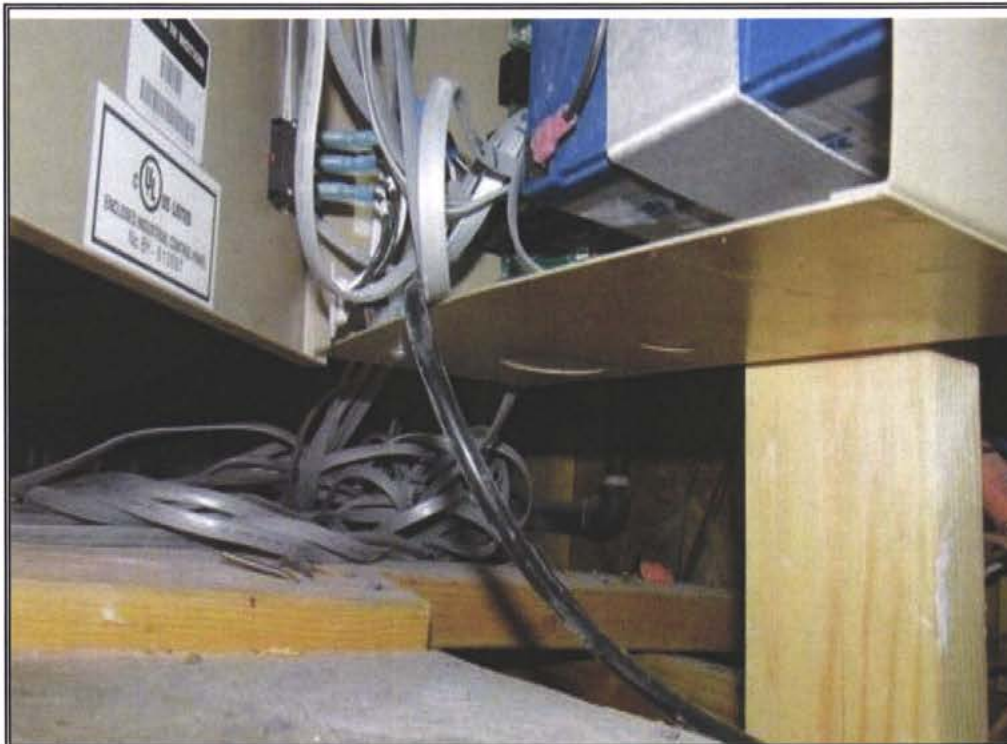
Photo Number
15

The power cord is routed through the door at the panel door controls.

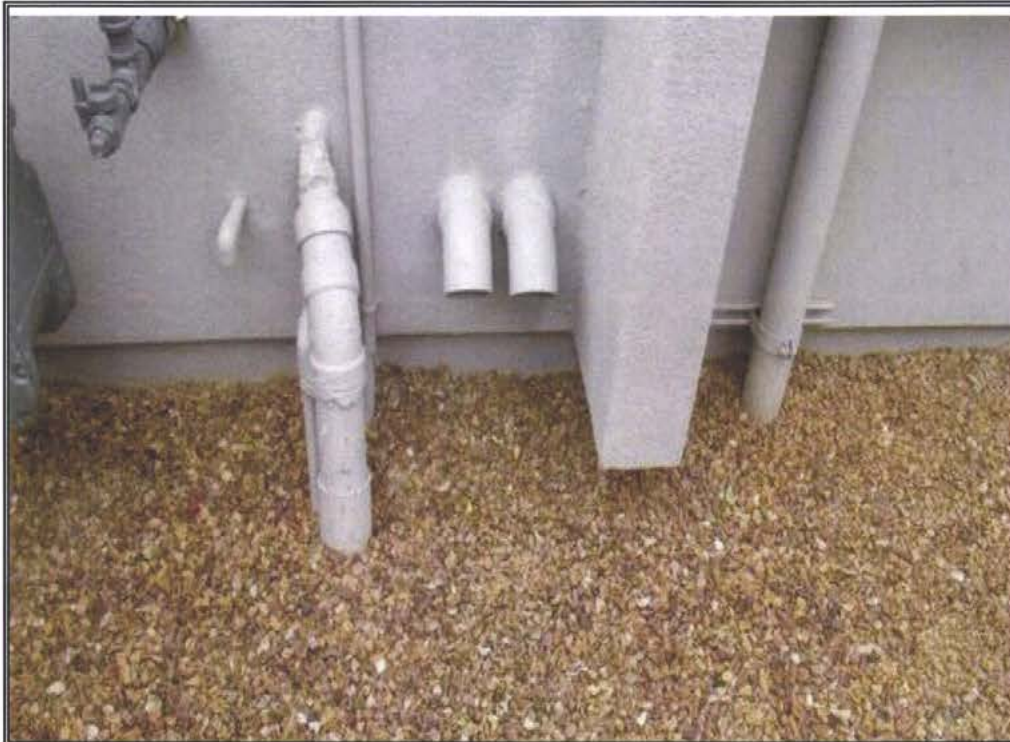
Splash blocks should be placed at all down spouts.

Henry will discuss with Chris Myers

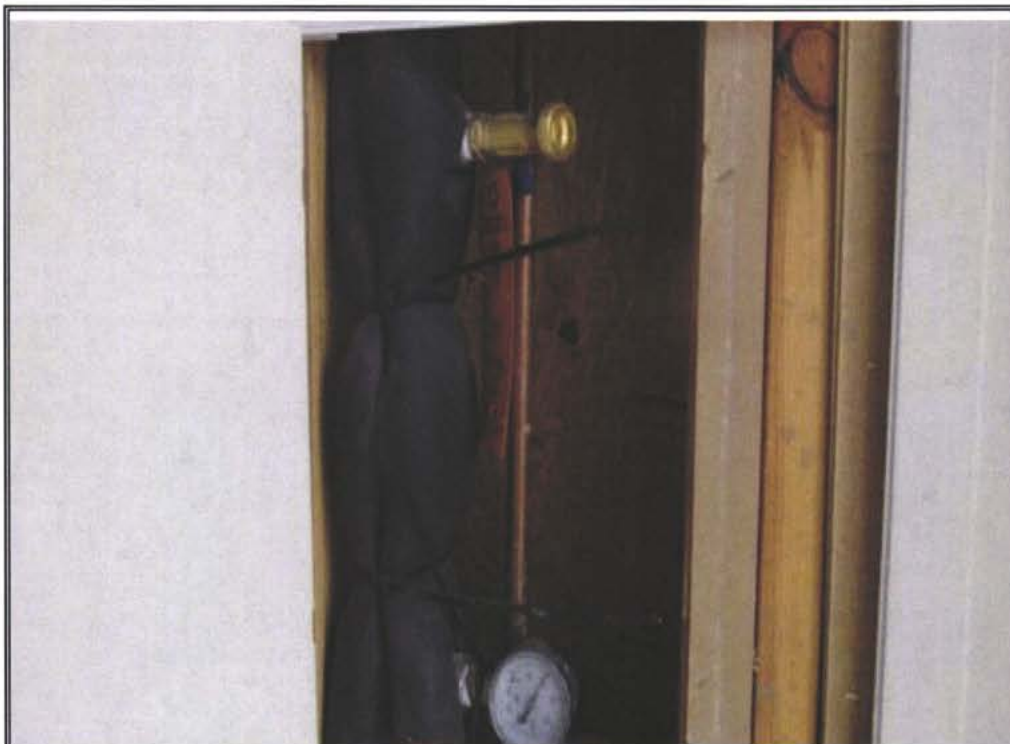
Photo Number
31

The configuration of the sprinkler controls is not what is typically found.
