SWIMMING POOL

The swimming pool consists of an in-ground concrete with pebble aggregate finish surrounded by a stone deck. It is served by a cartridge filtering system. In addition, it has the following equipment:

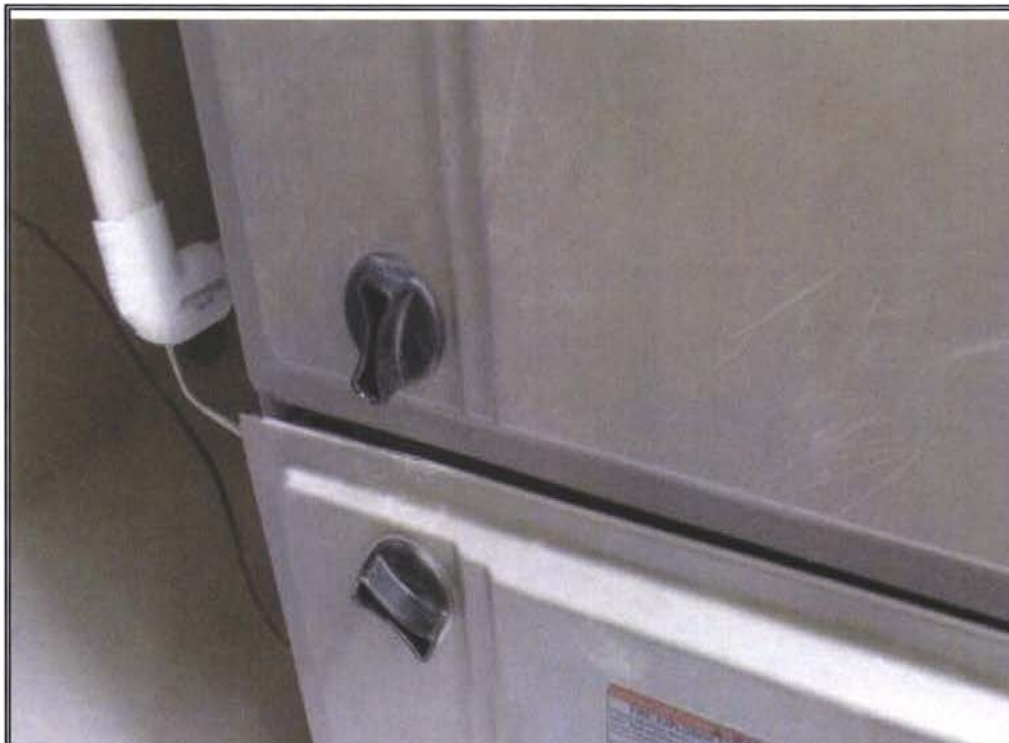
Photo Number
1

The door is not secure at the right side air handler.

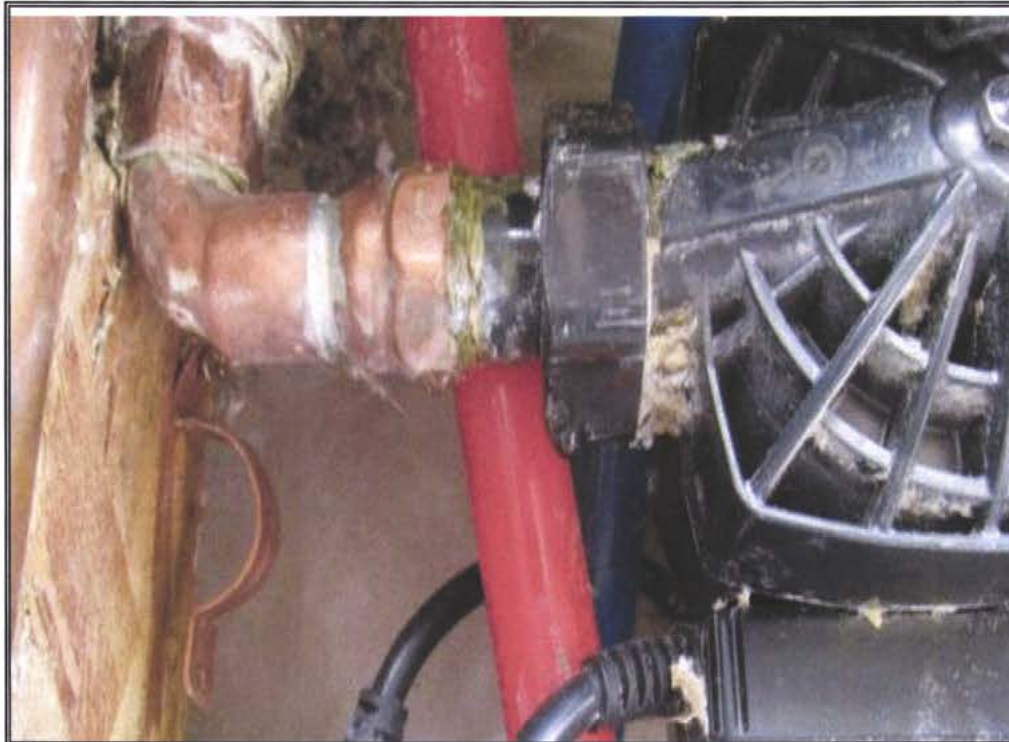
There are leaks at the hot water recirculation pumps.

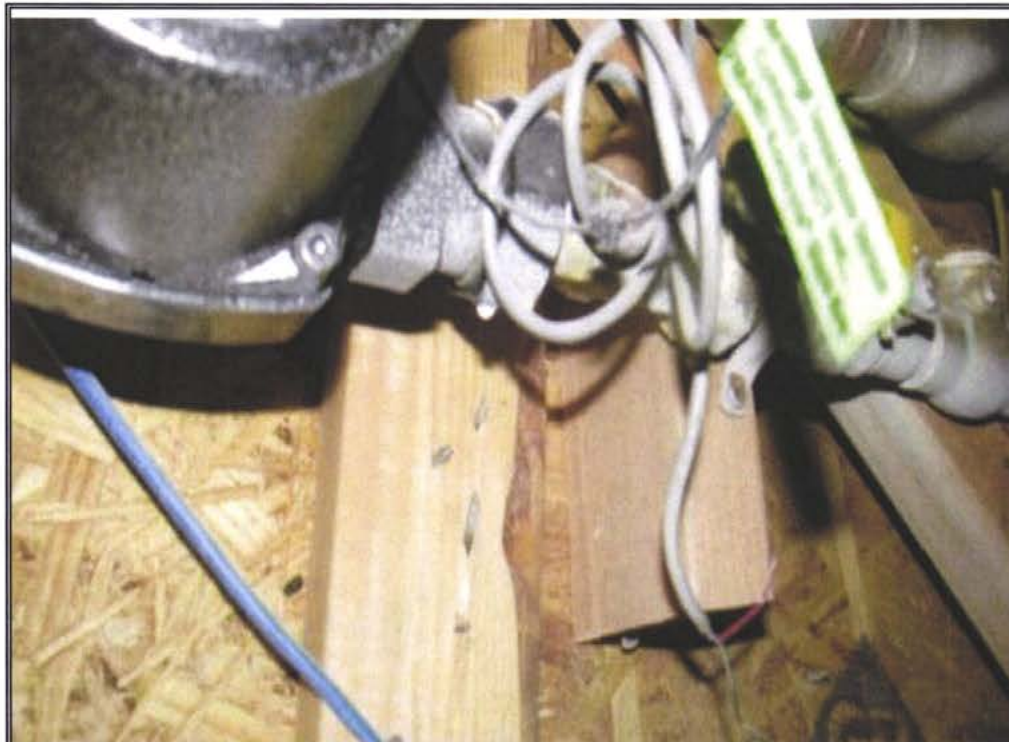
Photo Number
3

There are leaks at the hot water recirculation pumps.

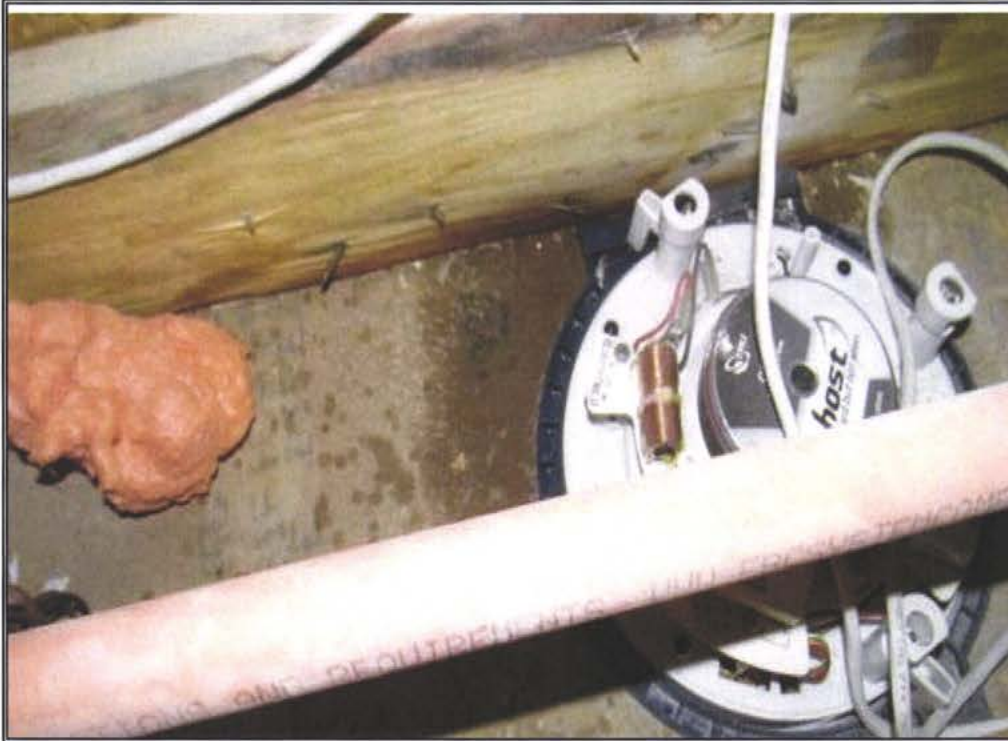
There are leaks at the hot water recirculation pumps.

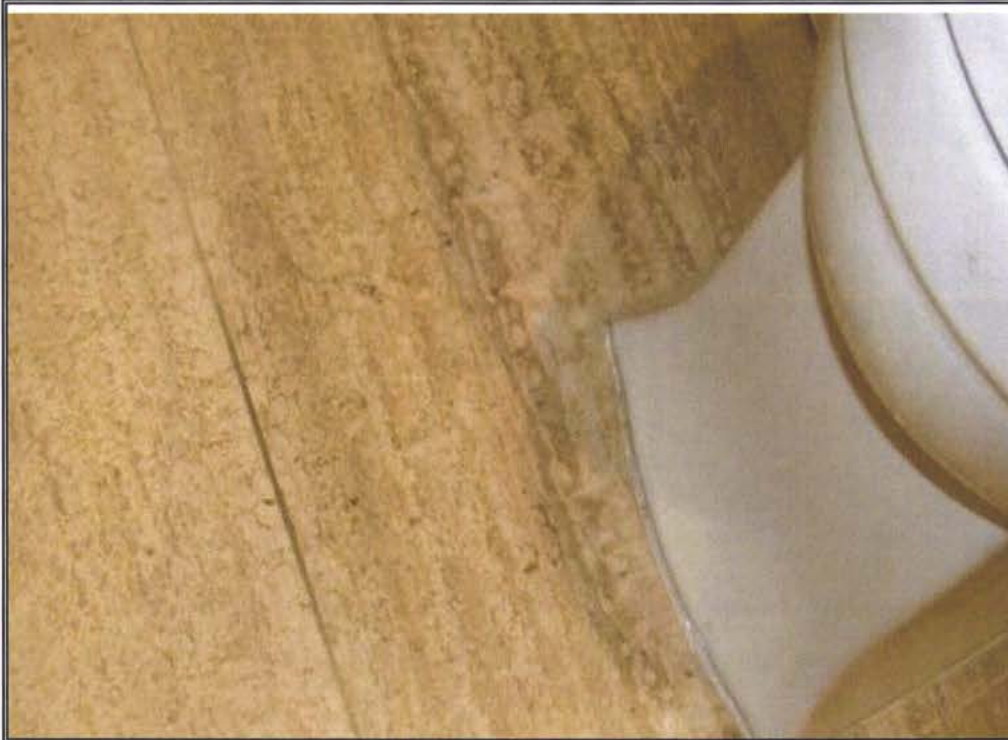
There is a plumbing leak at the ceiling of the basement bathroom. This is the water on the floor under the drip.

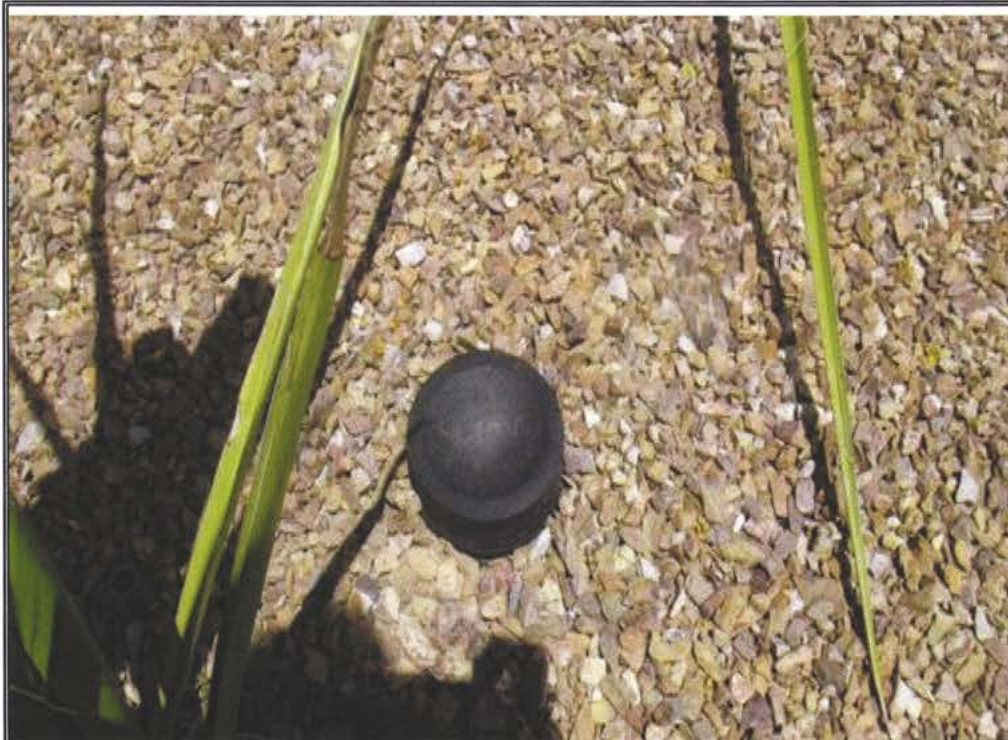
7

The drain clean-outs should have permanent screw type caps.

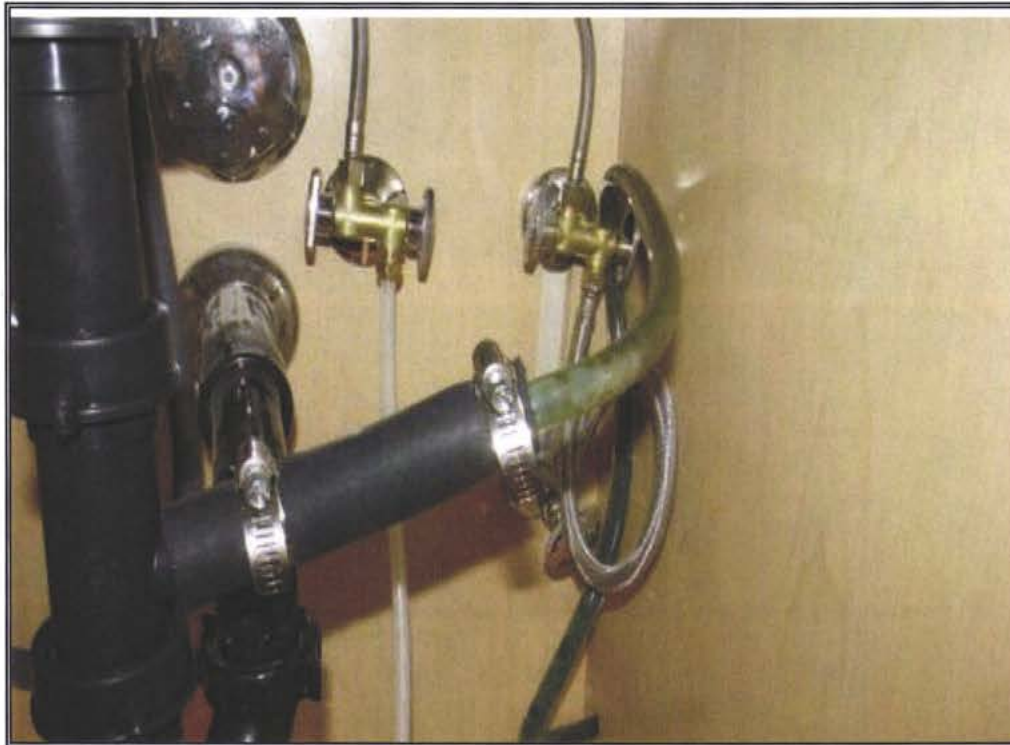
There is no air gap on the ice maker drain line. The discoloration of the drain line should also be investigated.

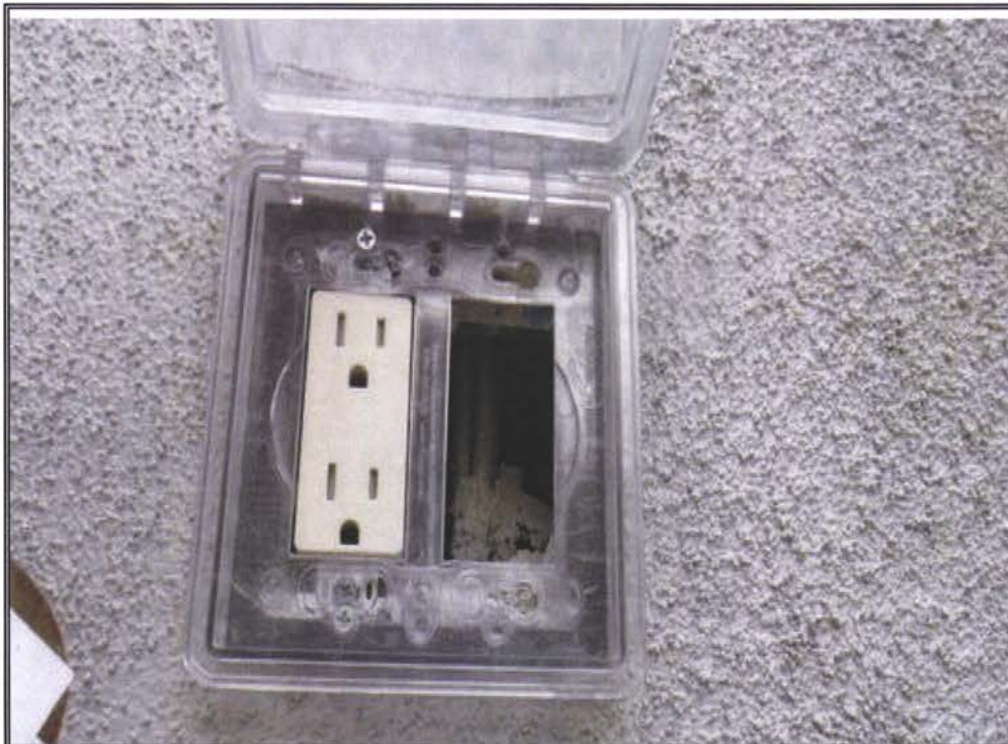
Photo Number
11

There is an incomplete outlet at the wall of the lower patio.

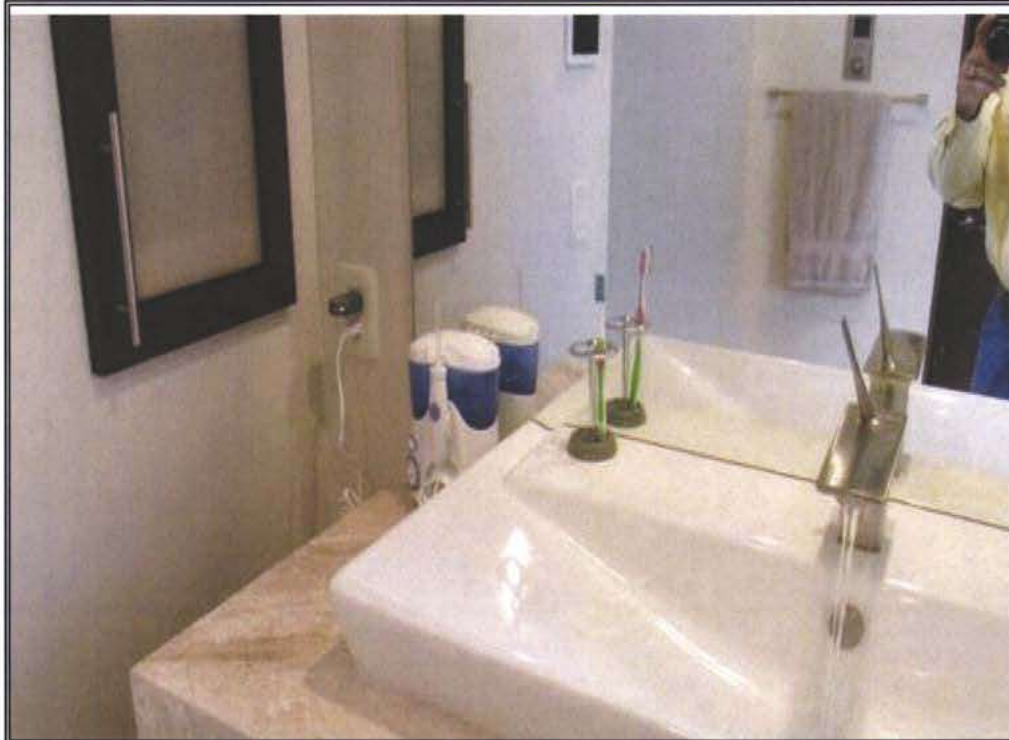
The outlets at the master bathroom sinks are not GFCI protected.

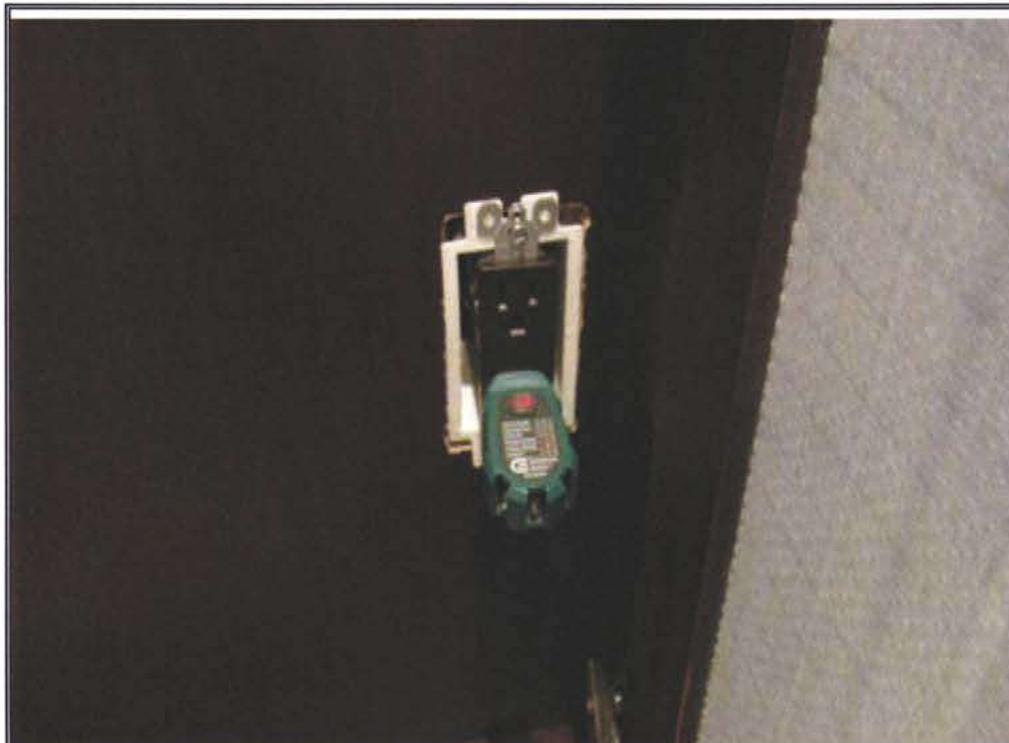
Photo Number
13

One outlet in the master closet does not have power.

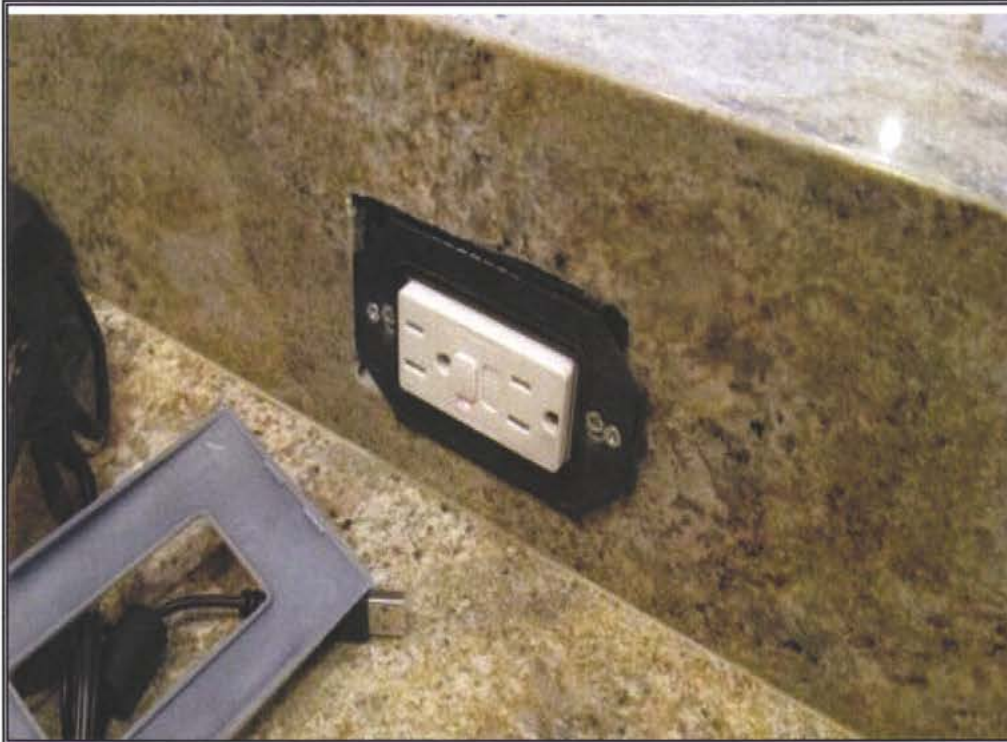
The outlet covers are loose at the media wet bar counter.

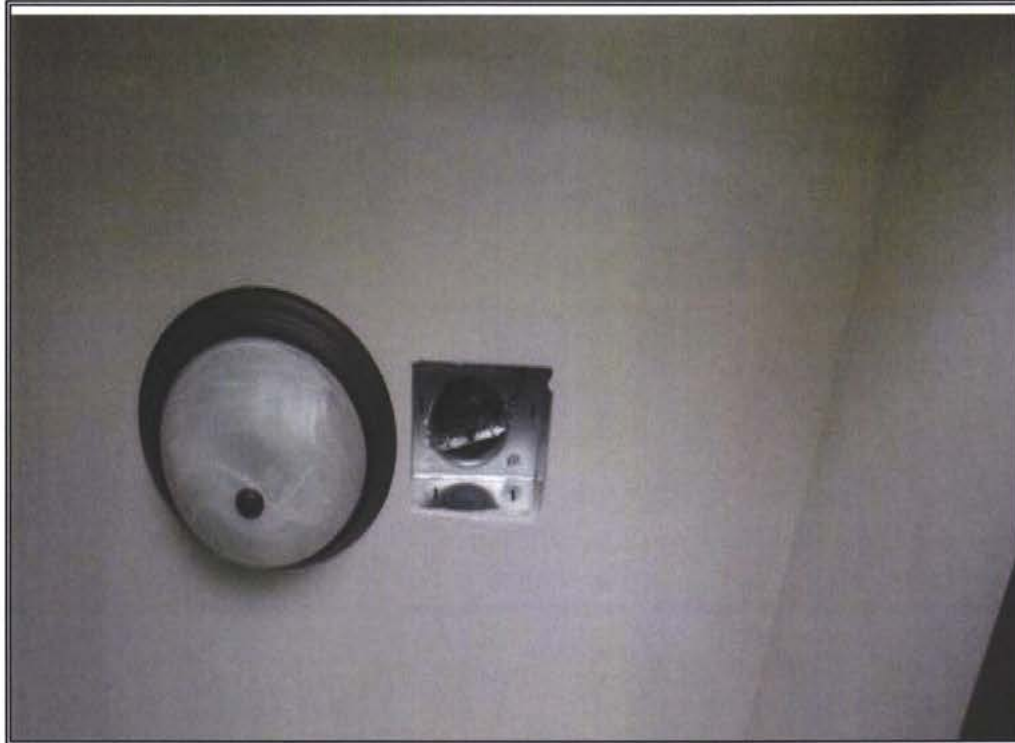
The cover is missing from the vent fan in the media closet.

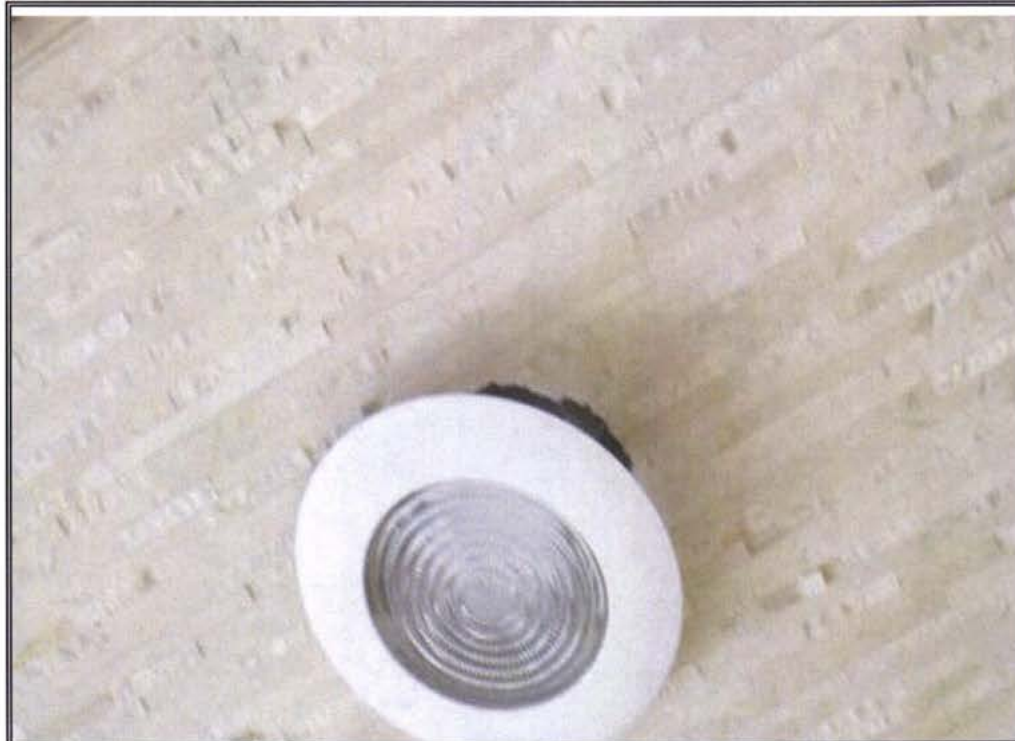
Photo Number
19

There is a loose light in the master shower.

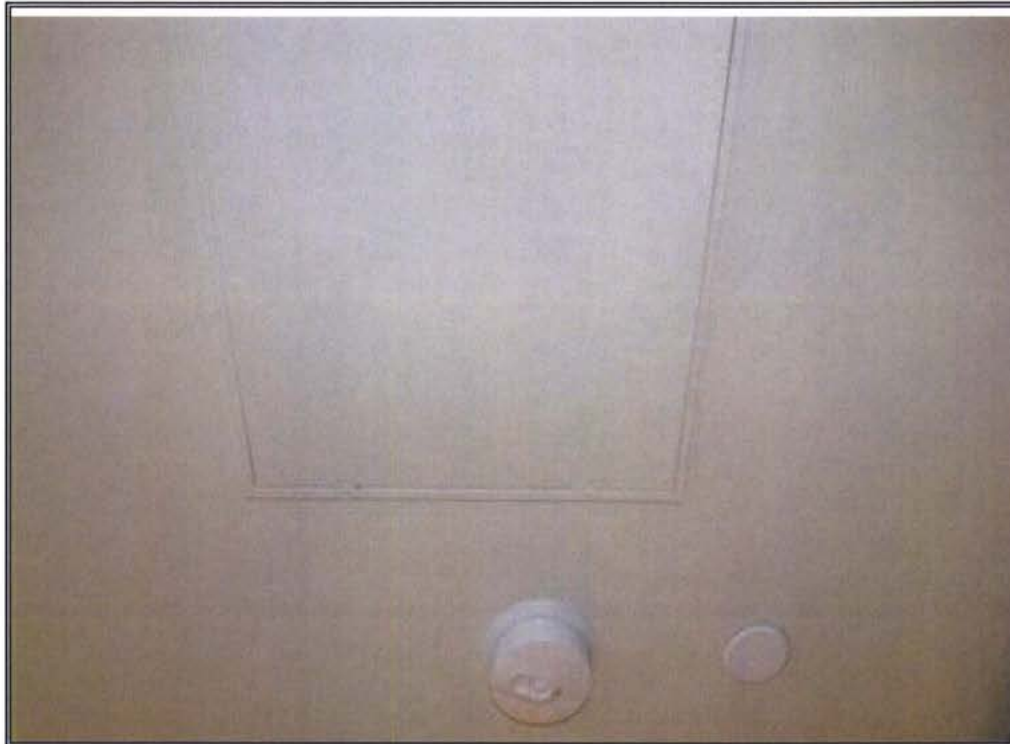
The access cover in the basement hall does not close properly.

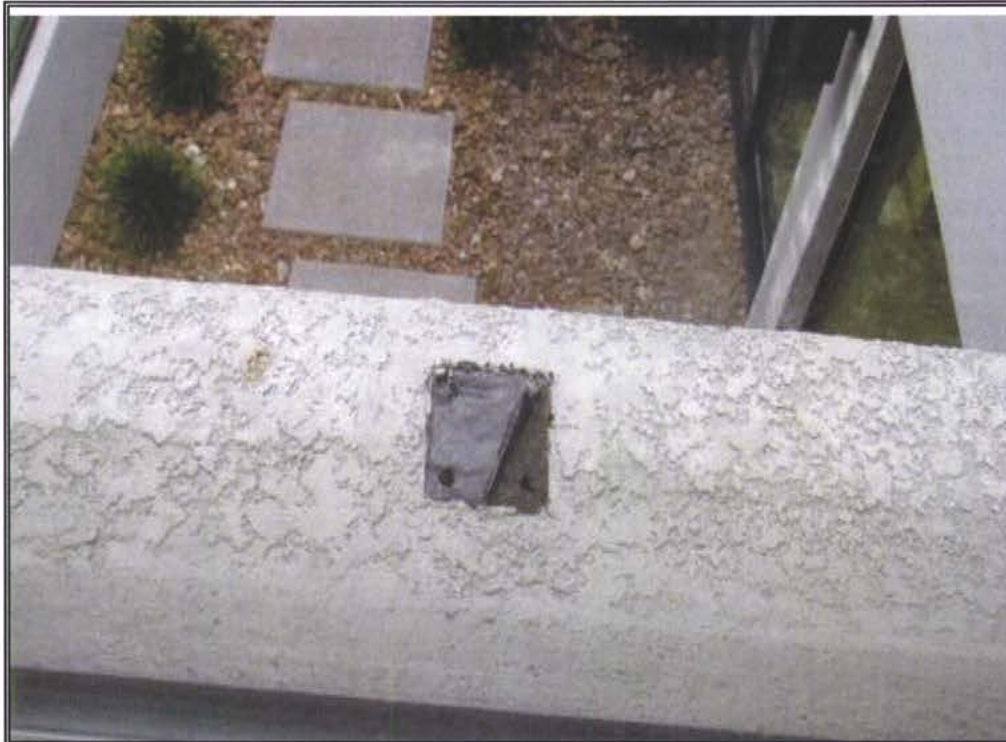
The handrail components at the second floor window should be repaired and sealed.

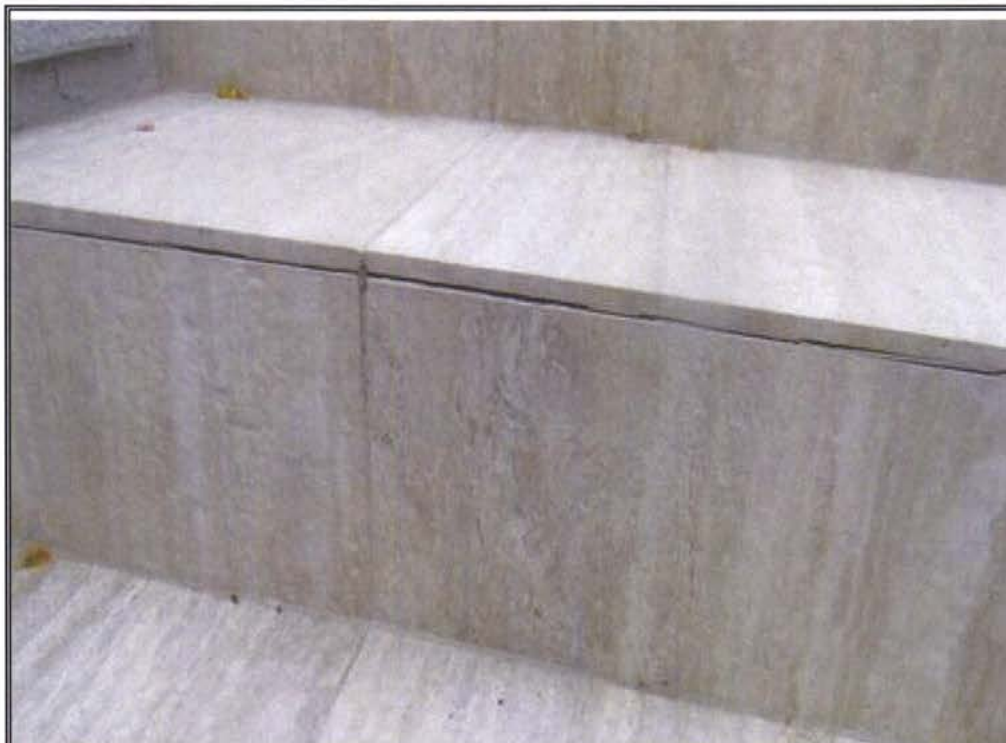
Photo Number
23

There are open grout joints at the steps to the basement.

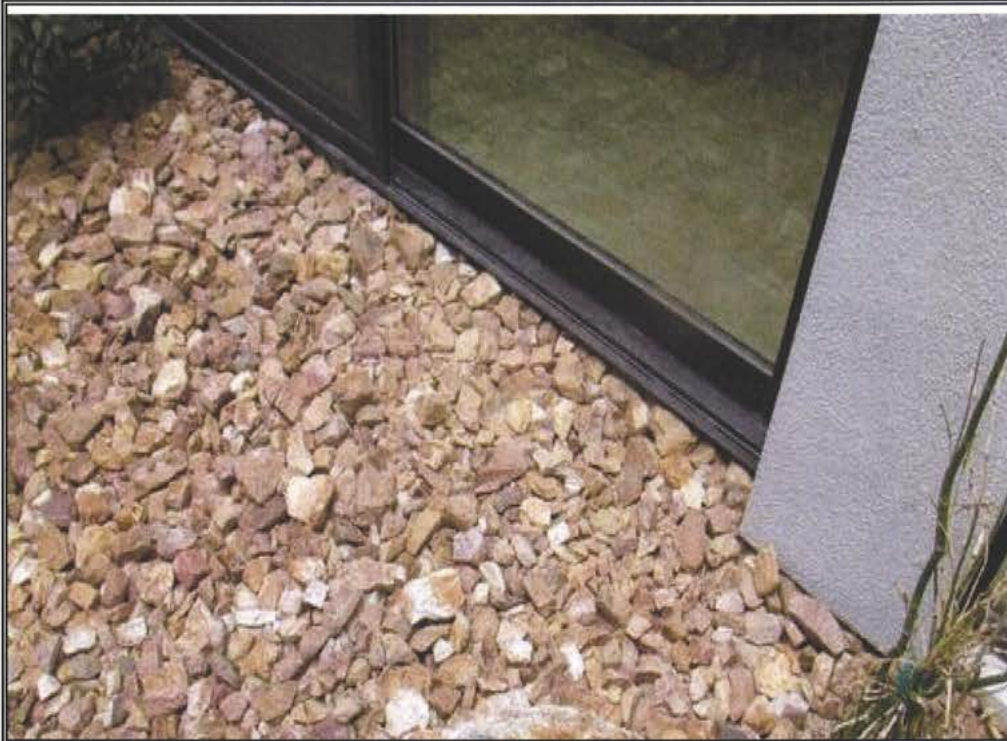
There is no landing
at the exterior door
in the kitchen.

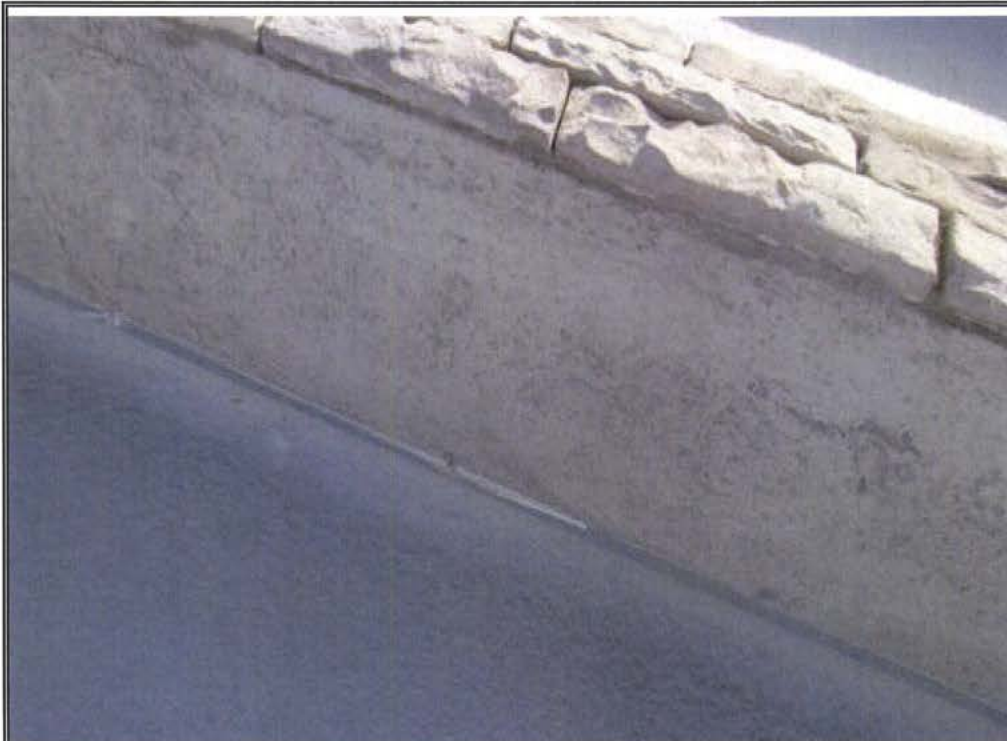
Photo Number
25

There is unfinished
stucco at the roof
parapet feature.

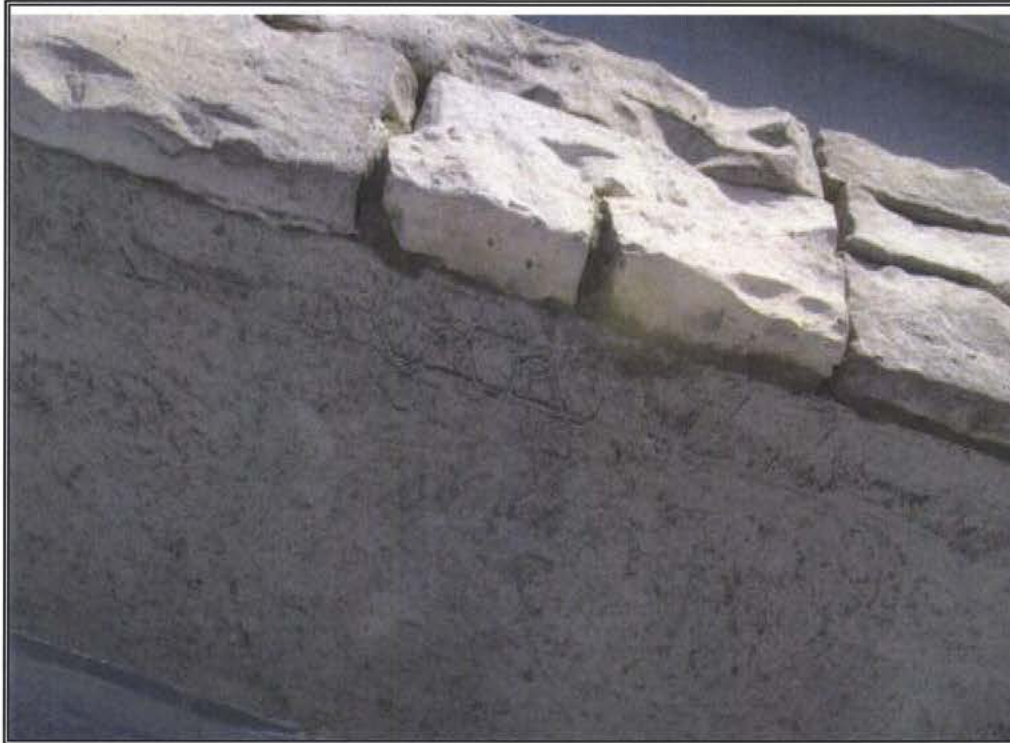
There is unfinished stucco at the roof parapet feature.

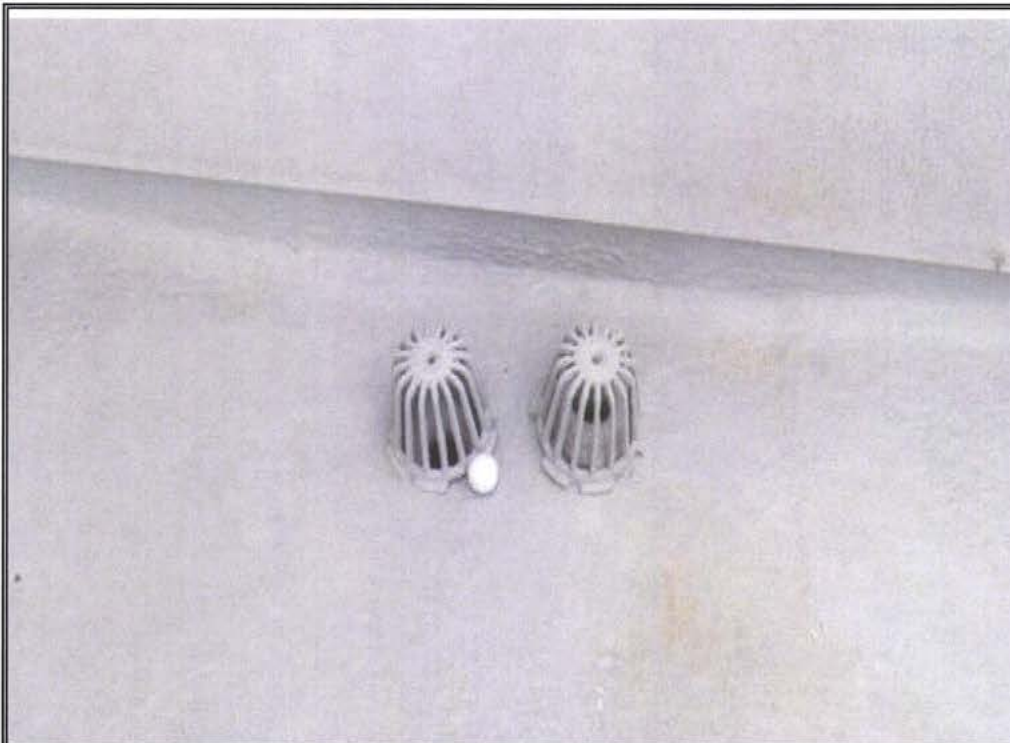
Photo Number
27

The debris guards should be removed from the secondary drains.

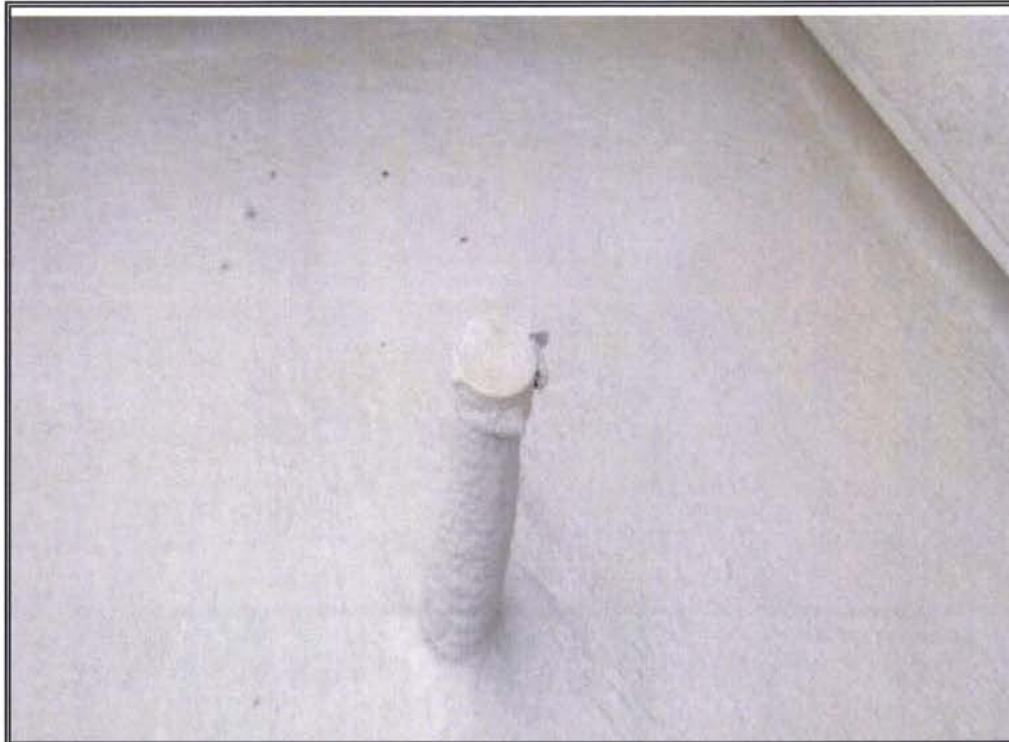
The cap should be removed from the plumbing vent.

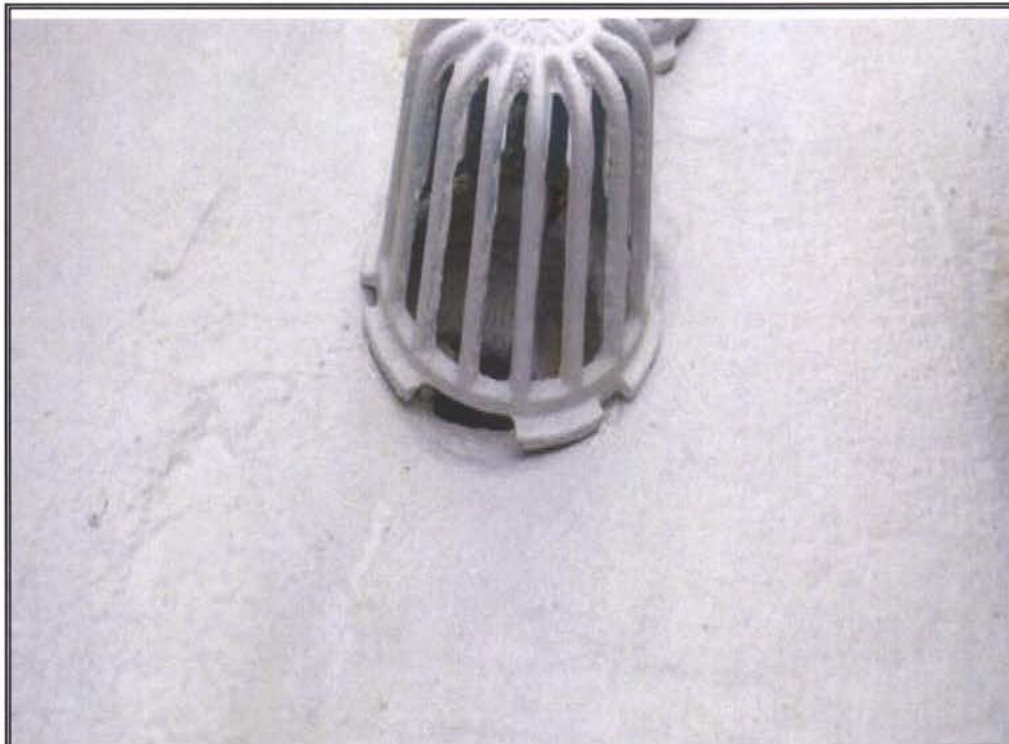
Photo Number
29

The debris guards are not sealed at the roof.

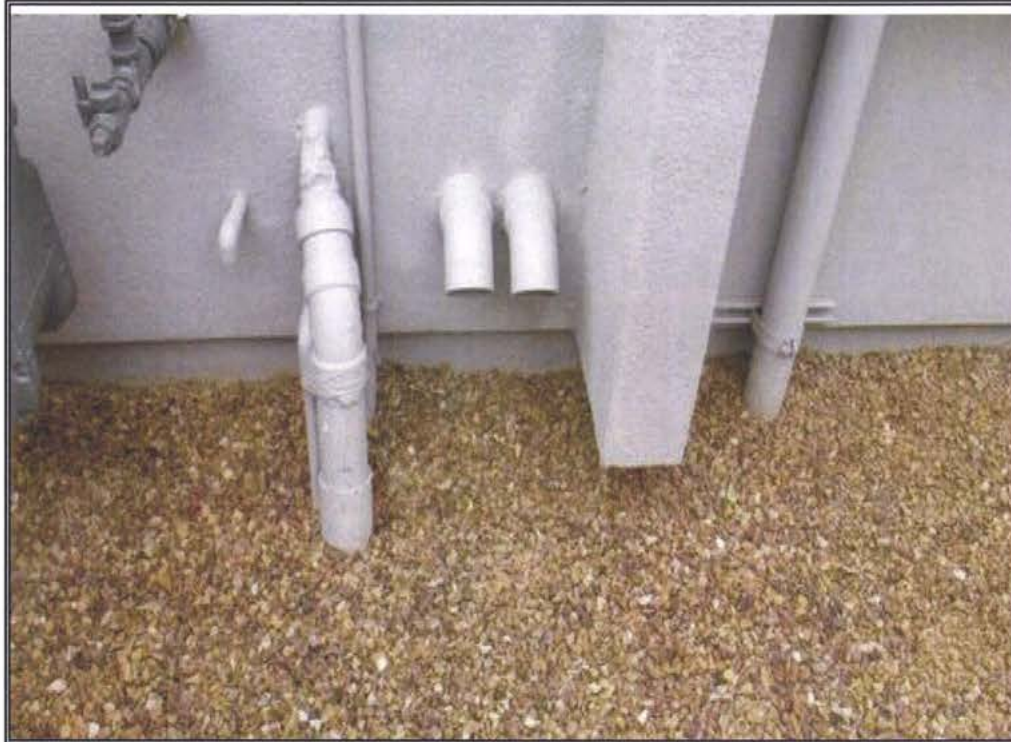
Splash blocks should be placed at all down spouts.

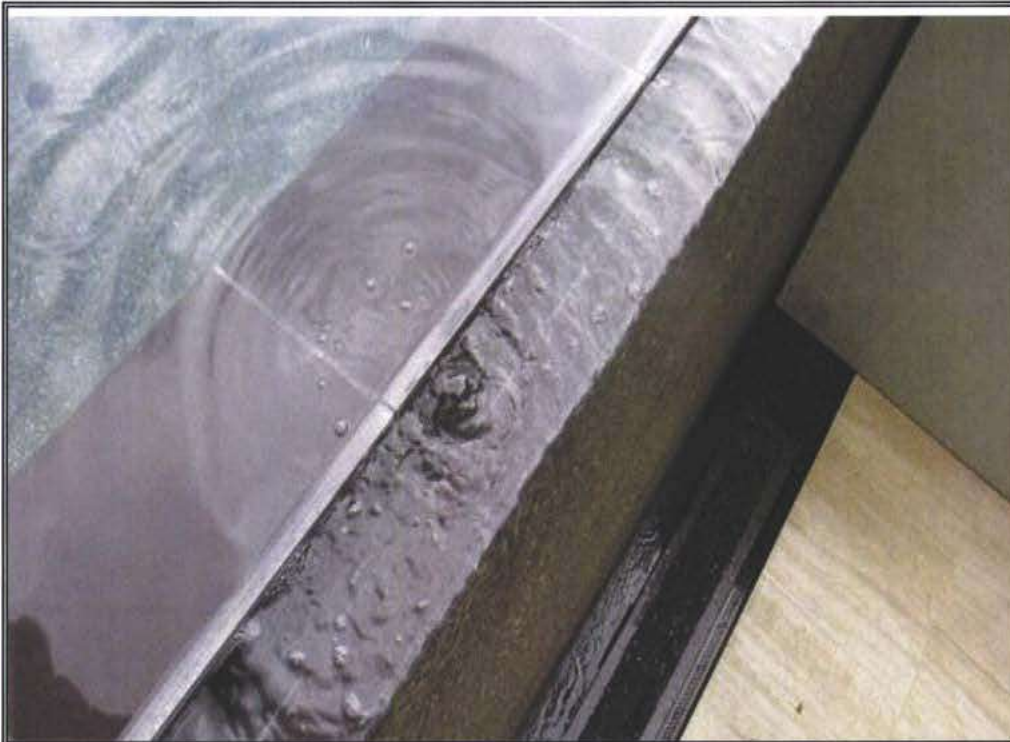
The spa equipment is integrated with the pool equipment. The swimming pool and its related equipment were in operation and appear to be in serviceable condition. The exception to this is that the water distribution for the water wall should be adjusted to reduce splashing.

The water flow at the water feature should be adjusted to prevent splashing.

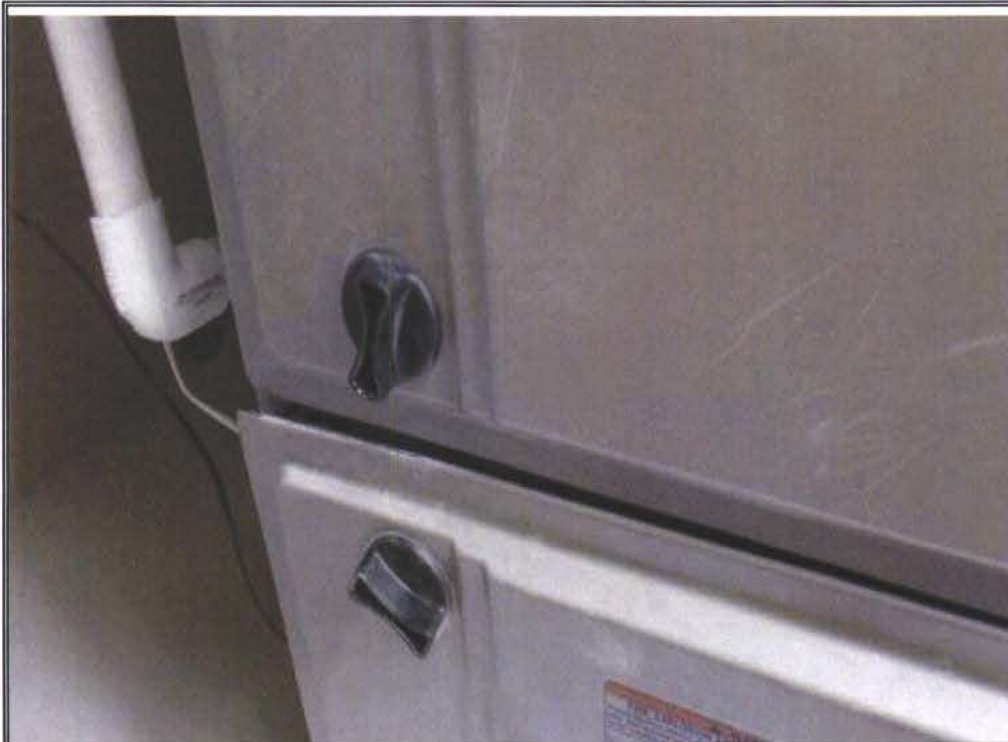
Photo Number
1

The door is not secure at the right side air handler.

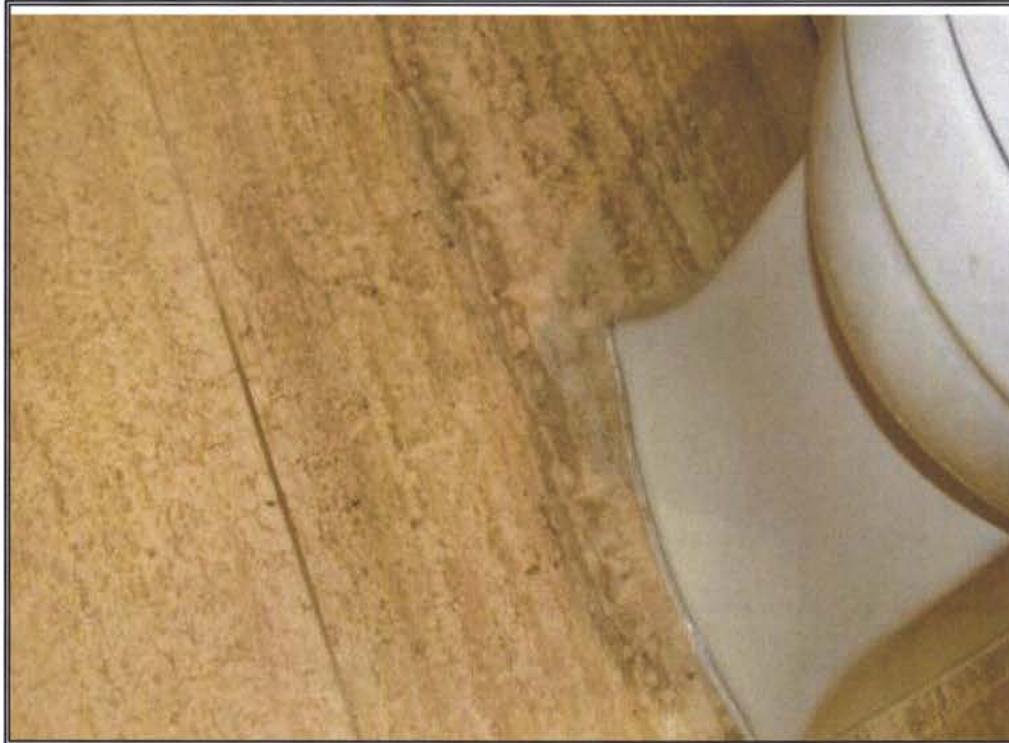
There is a plumbing leak at the ceiling of the basement bathroom. This is the water on the floor under the drip.

Plumber to investigate

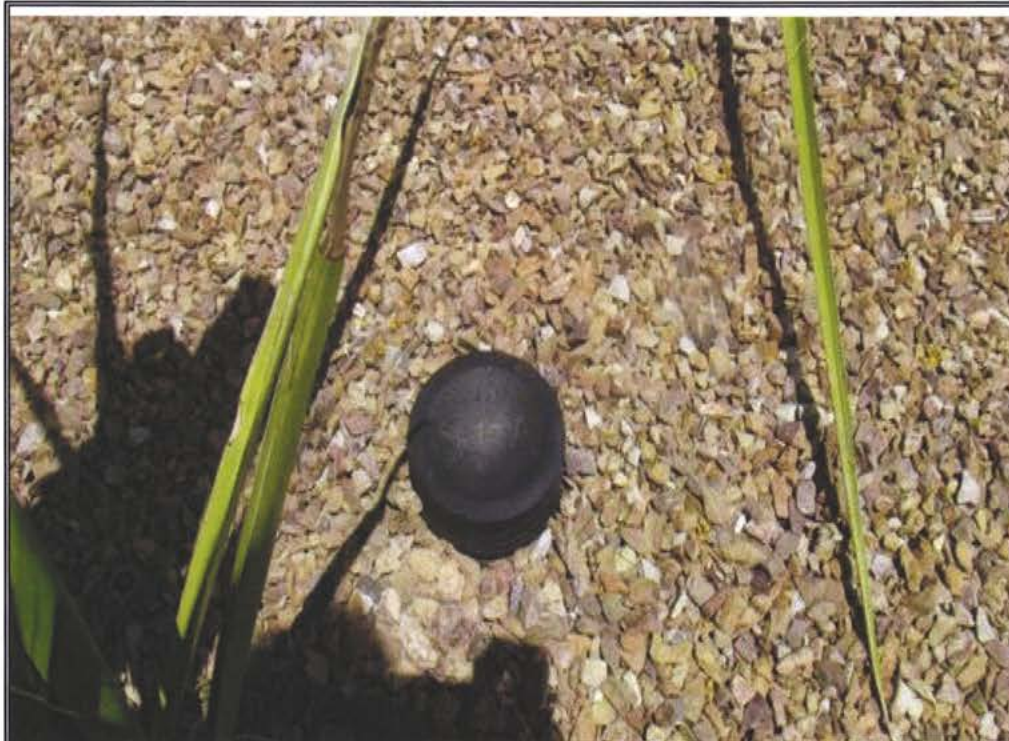
Photo Number
7

The drain clean-outs should have permanent screw type caps.

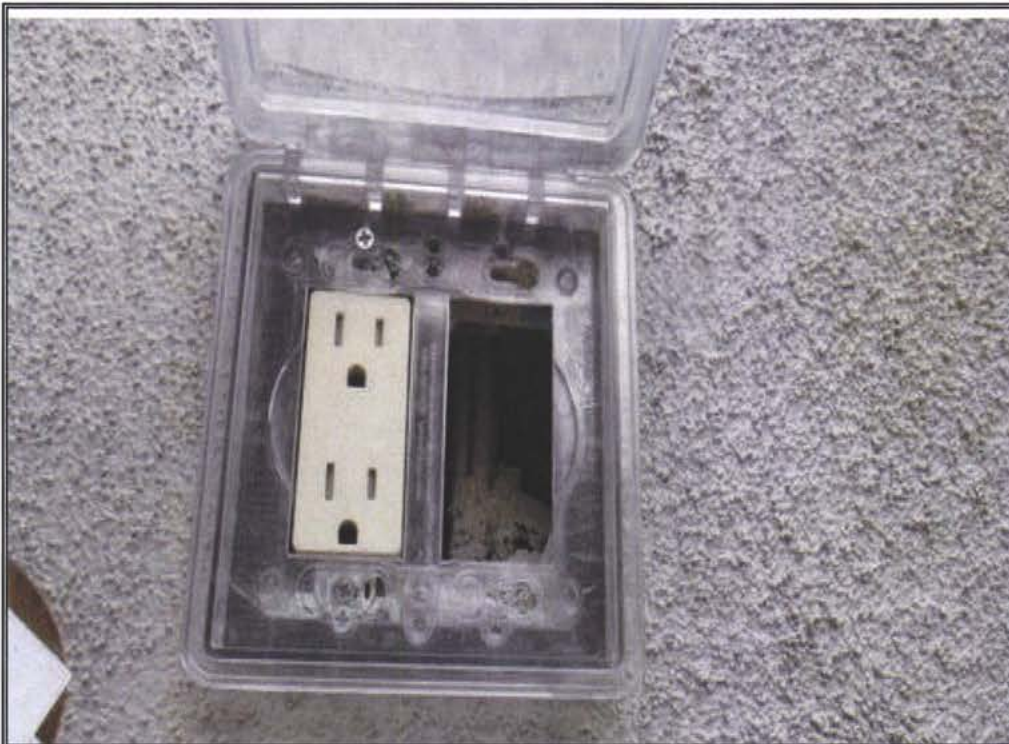
Photo Number
11

There is an incomplete outlet at the wall of the lower patio.

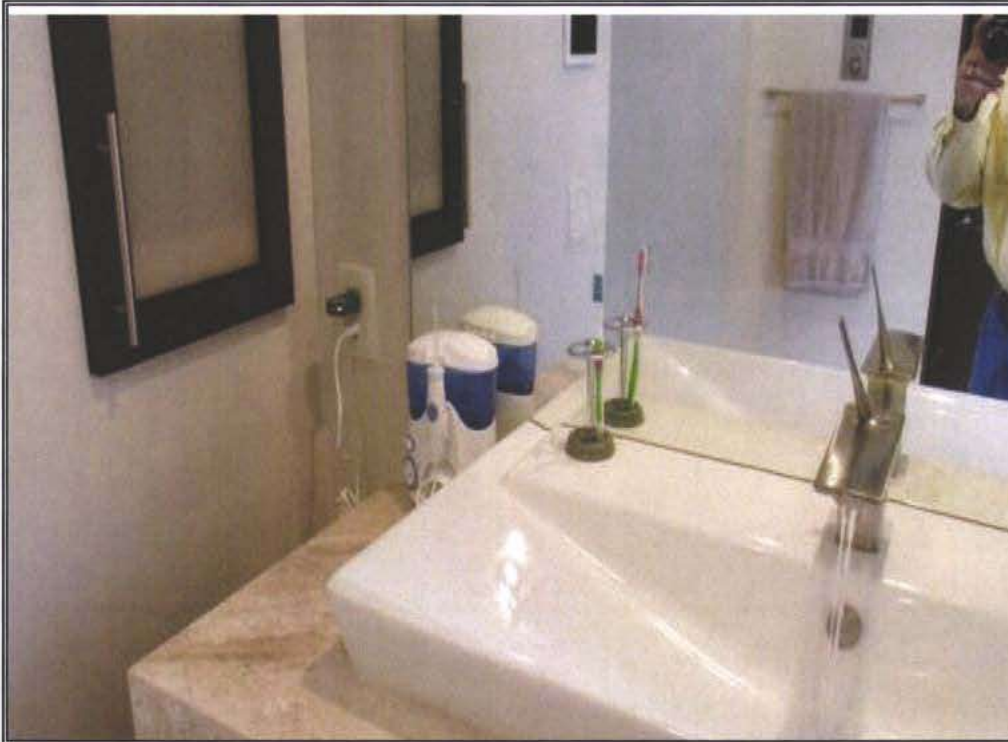
The outlets at the master bathroom sinks are not GFCI protected.

Electrician to address

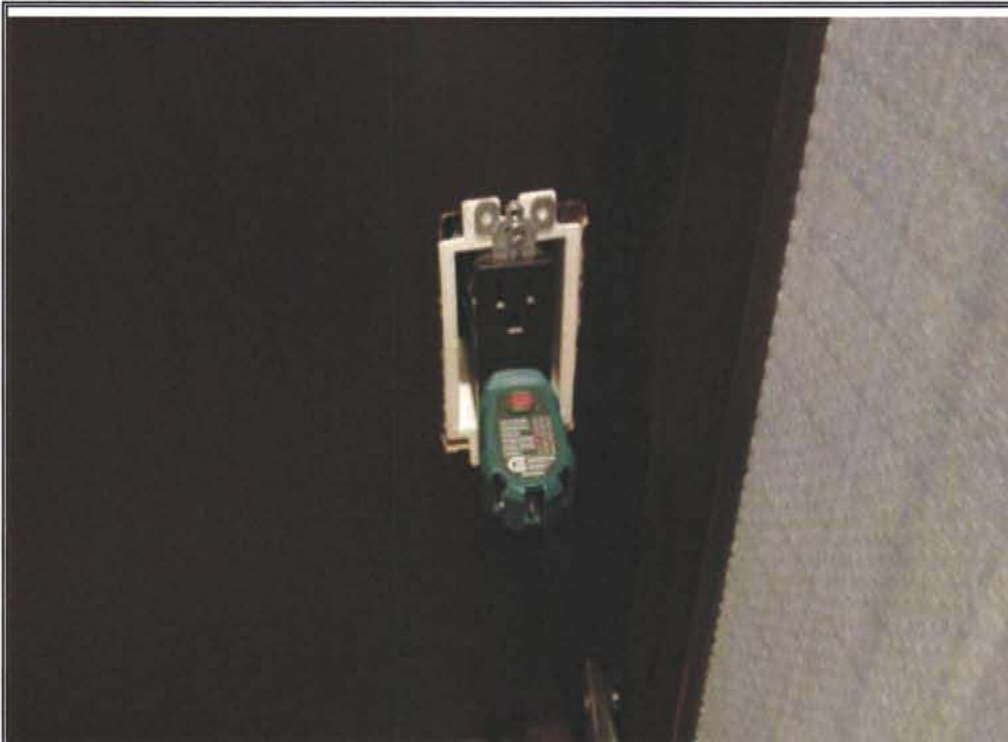
Photo Number
13

One outlet in the master closet does not have power.
