SWIMMING POOL

The swimming pool consists of an in-ground concrete with pebble aggregate finish surrounded by a stone deck. It is served by a cartridge filtering system. In addition, it has the following equipment:

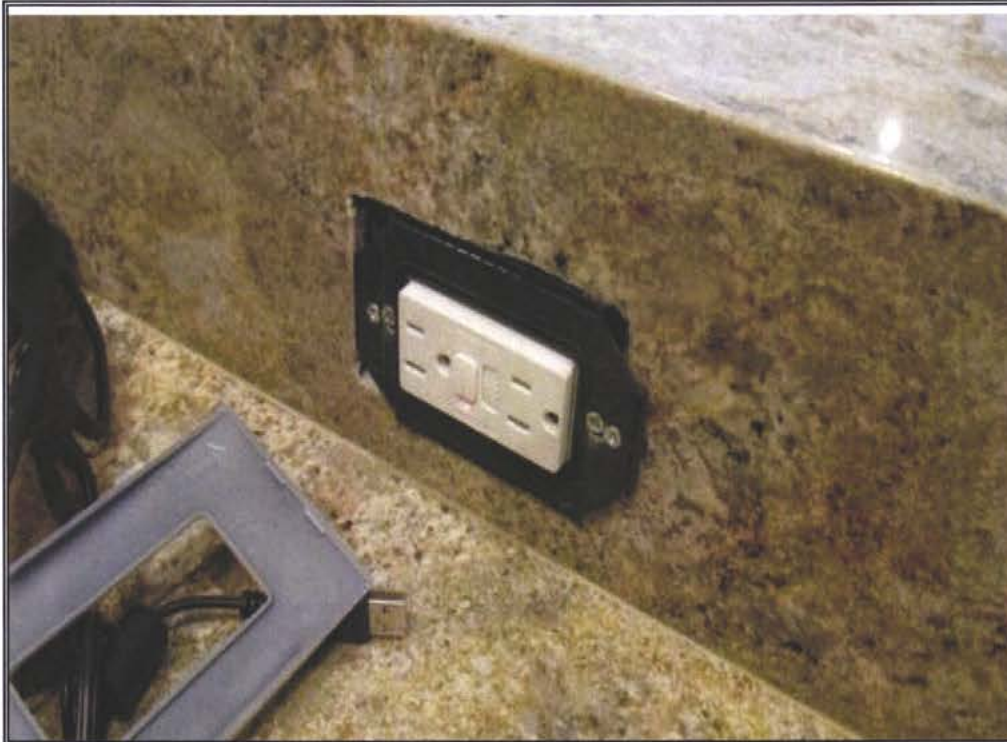
The outlet covers are loose at the media wet bar counter.

Electrician to address

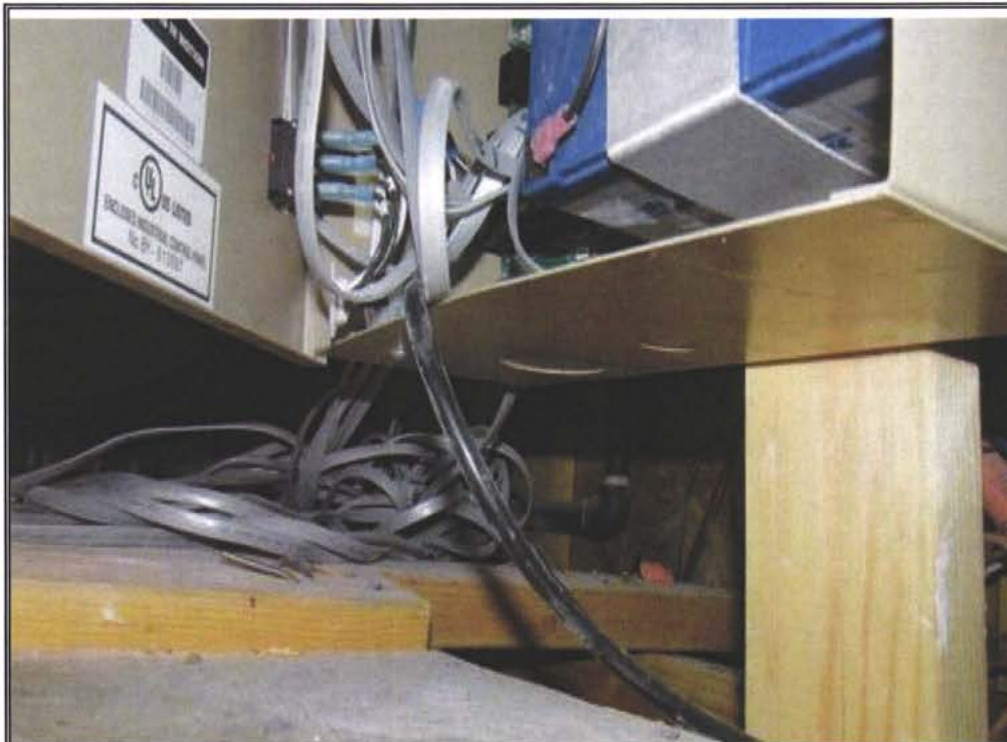
Photo Number
15

The power cord is routed through the door at the panel door controls.

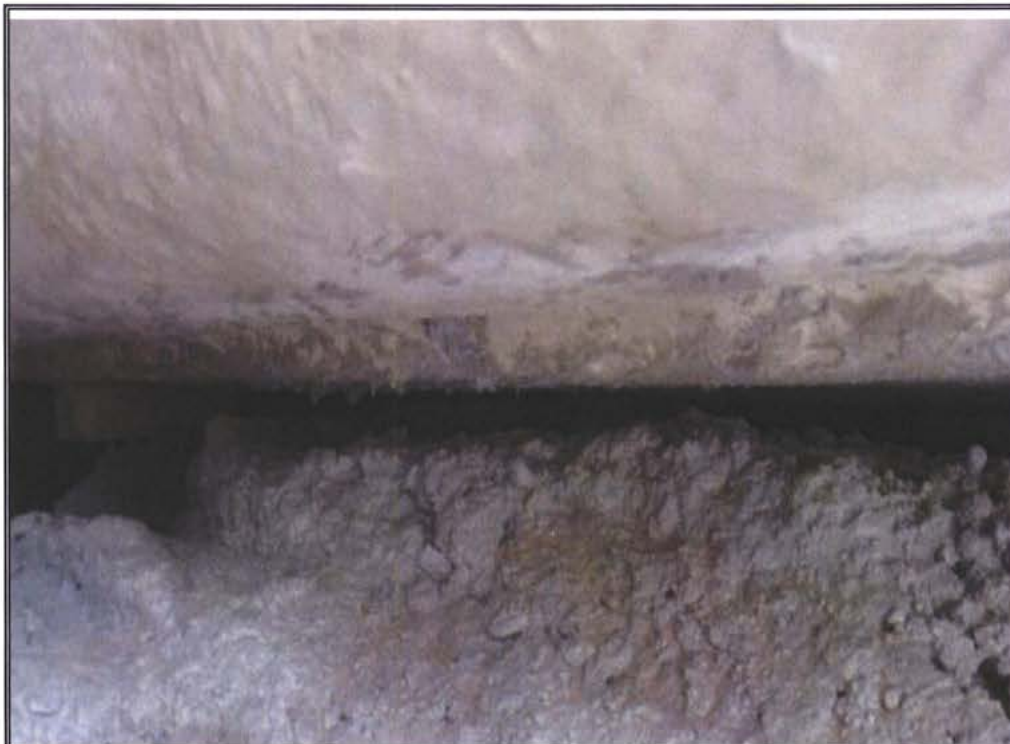
17

The whirlpool tub is not supported from the floor.

- Plumber to supply jets ~~The jet nozzles are missing. They should be installed. Henry will call tub installer to provide~~
- Plumber fixed; I will check ~~There is no support under the tub, appropriate support should be installed. Henry will discuss with plumber~~

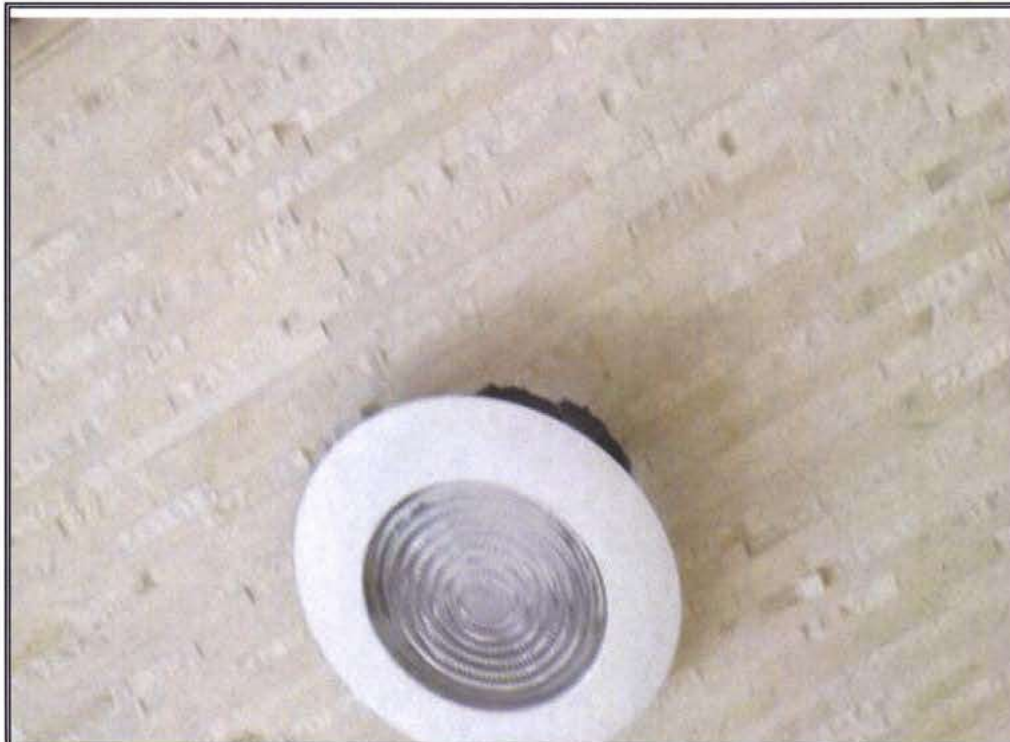
Photo Number
19

There is a loose light in the master shower.

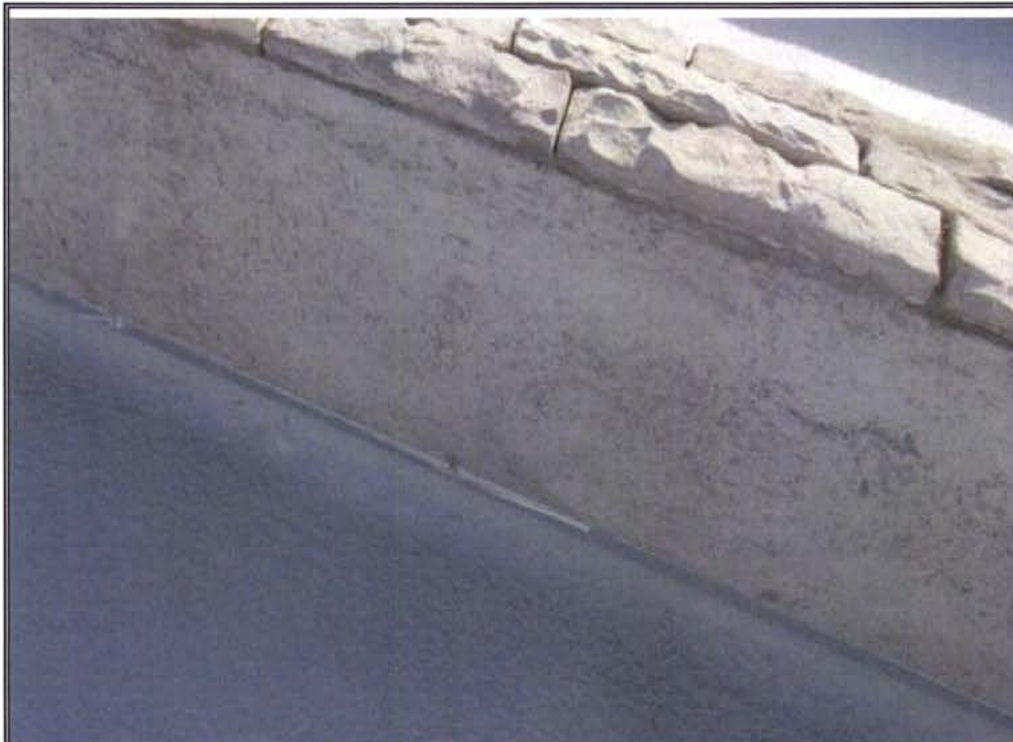
Photo Number
25

There is unfinished
stucco at the roof
parapet feature.

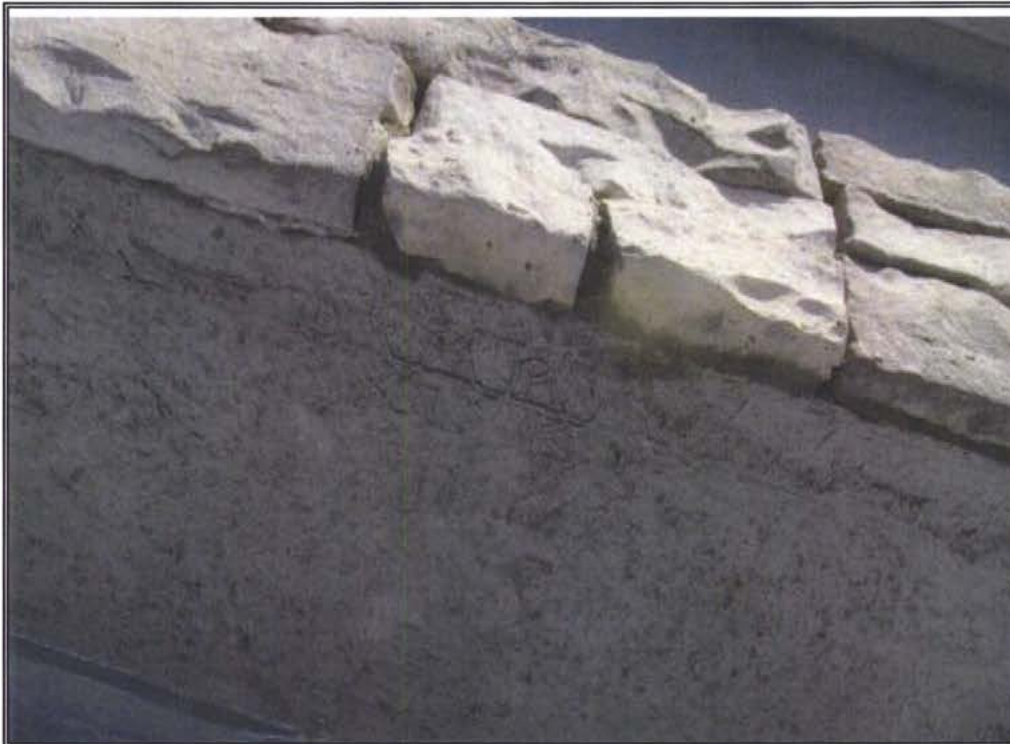
There is unfinished stucco at the roof parapet feature.

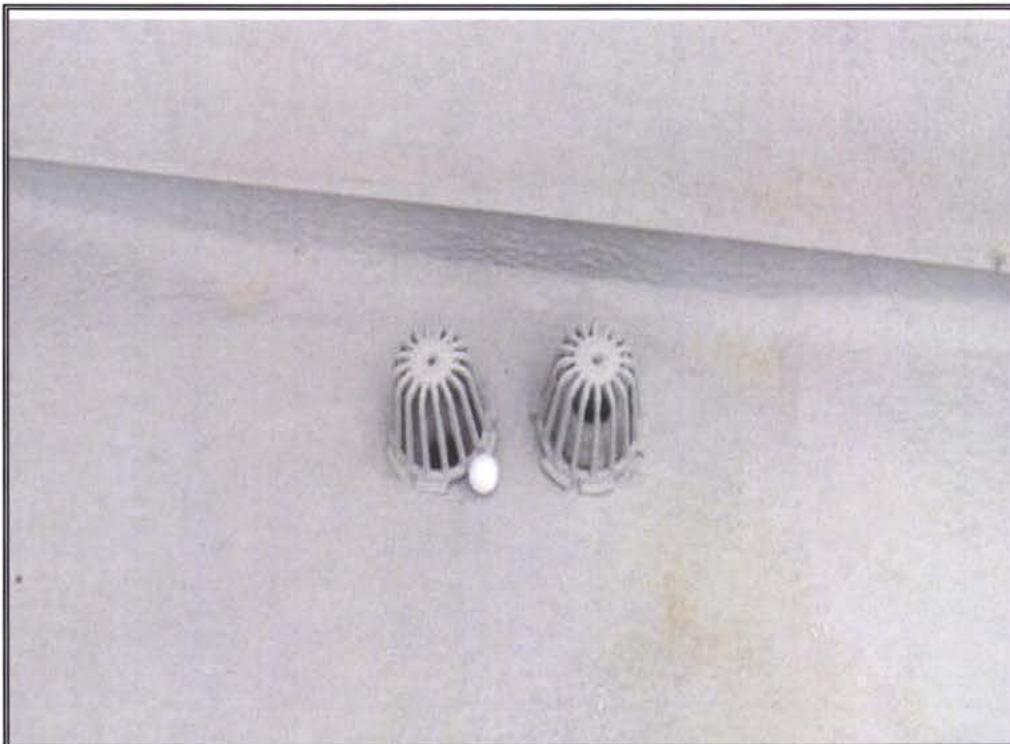
Photo Number
27

The debris guards should be removed from the secondary drains.

Not sure why this was recommended. n/a

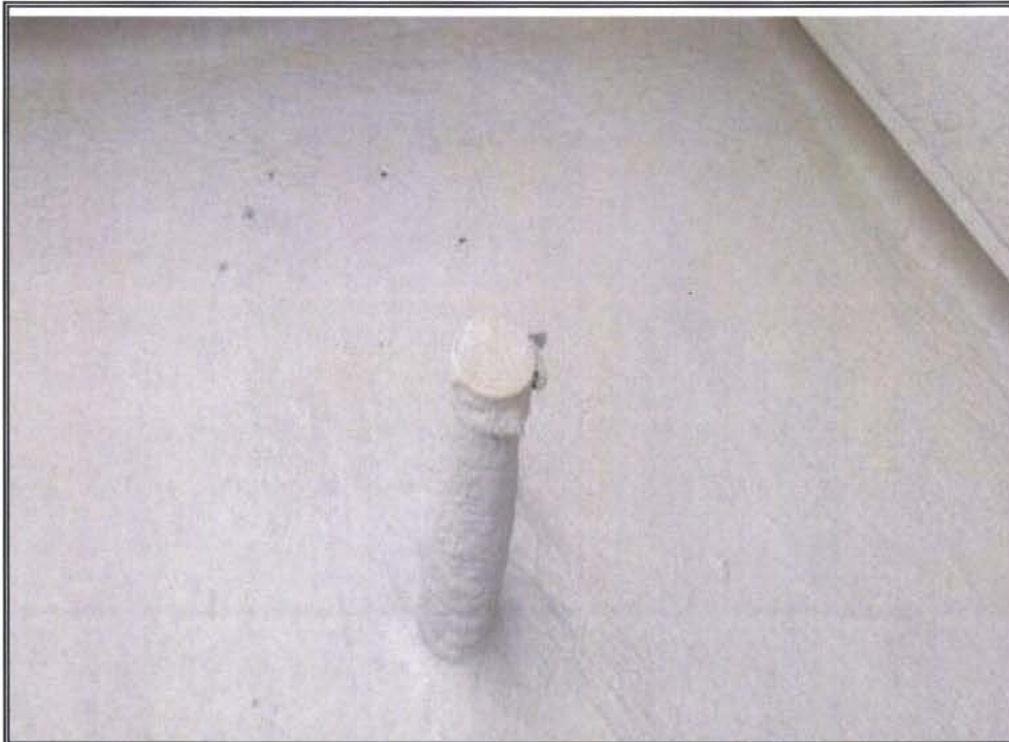
The cap should be removed from the plumbing vent.

Henry will investigate with plumber

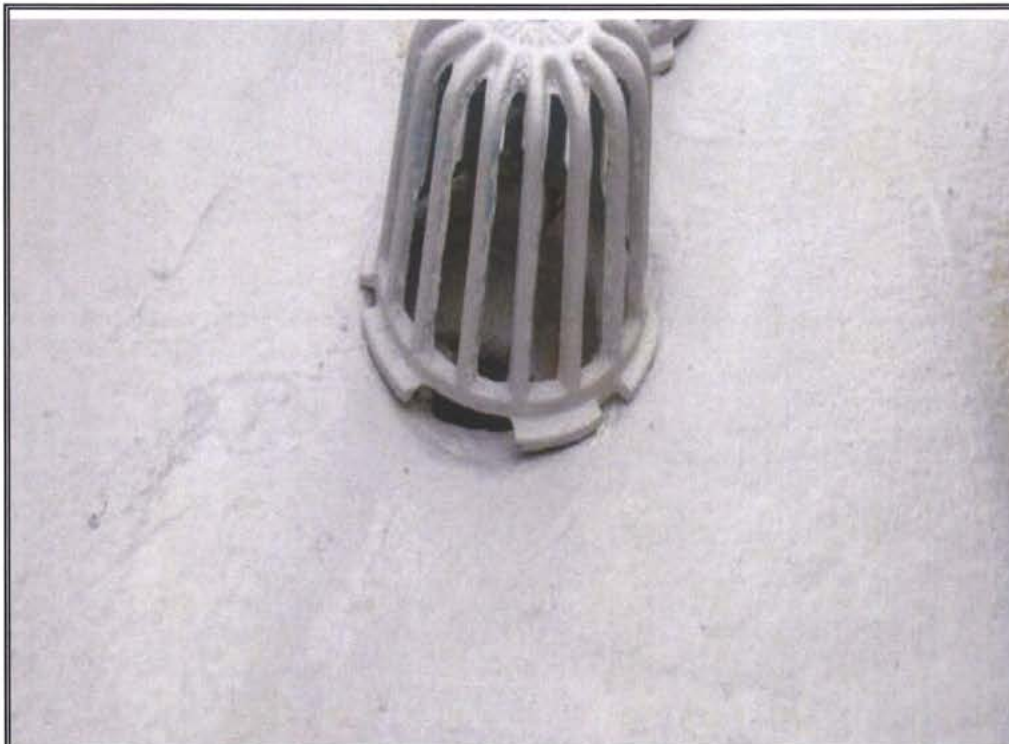
Photo Number
29

The debris guards are not sealed at the roof.

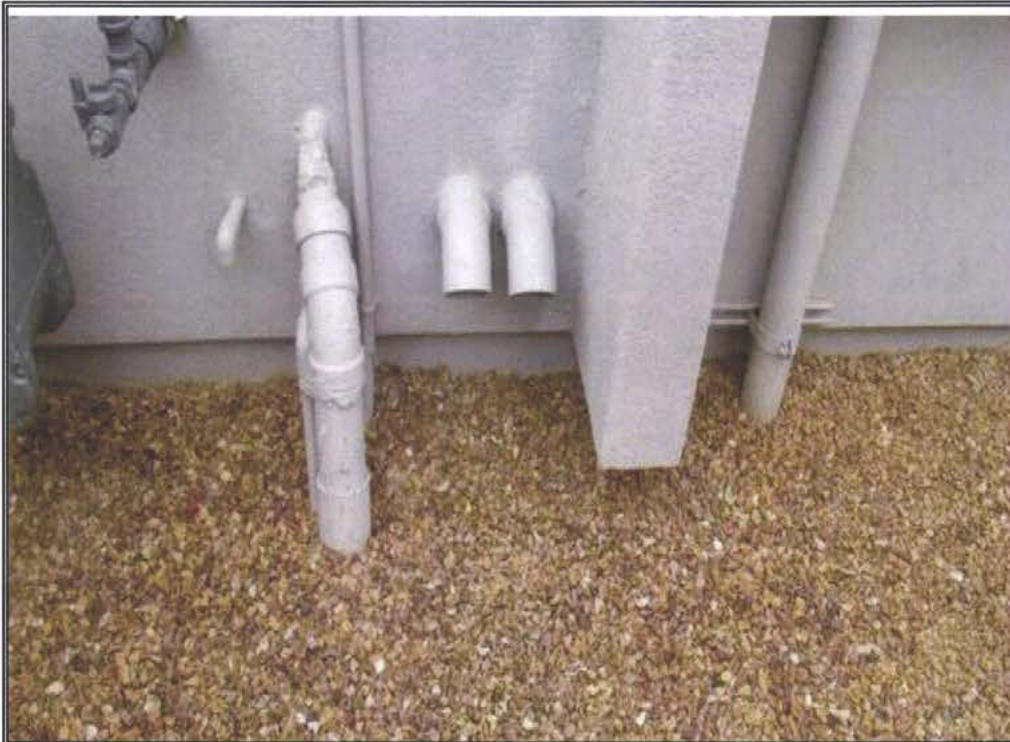
Splash blocks should be placed at all down spouts.

Henry will discuss with Chris Myers

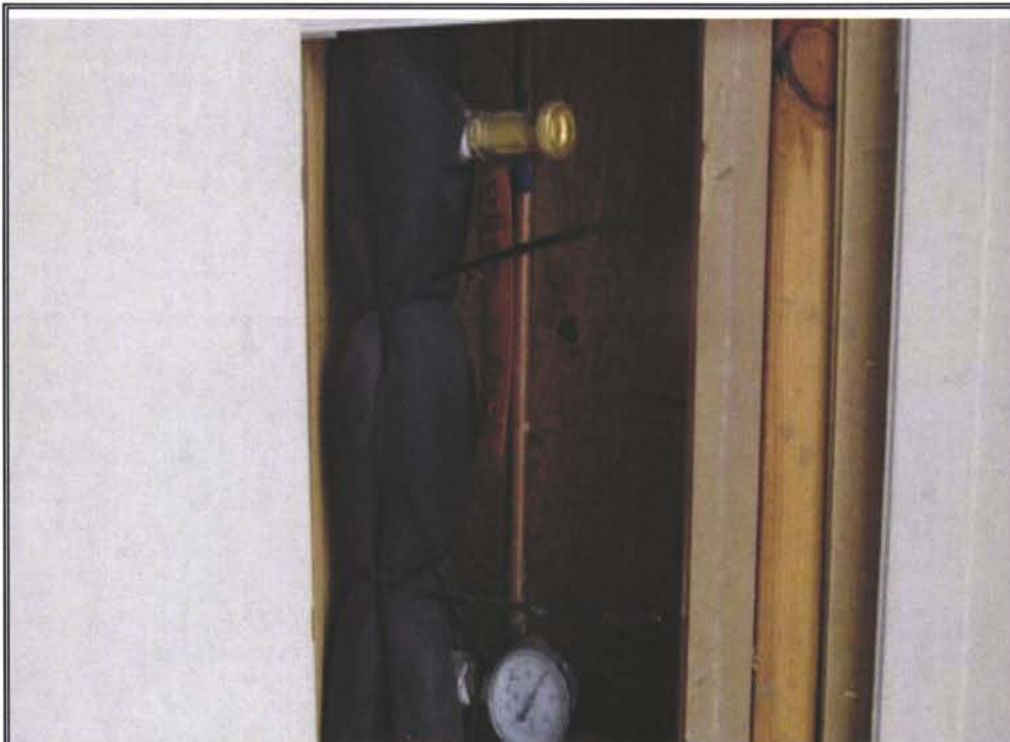
Photo Number
31

The configuration of the sprinkler controls is not what is typically found.

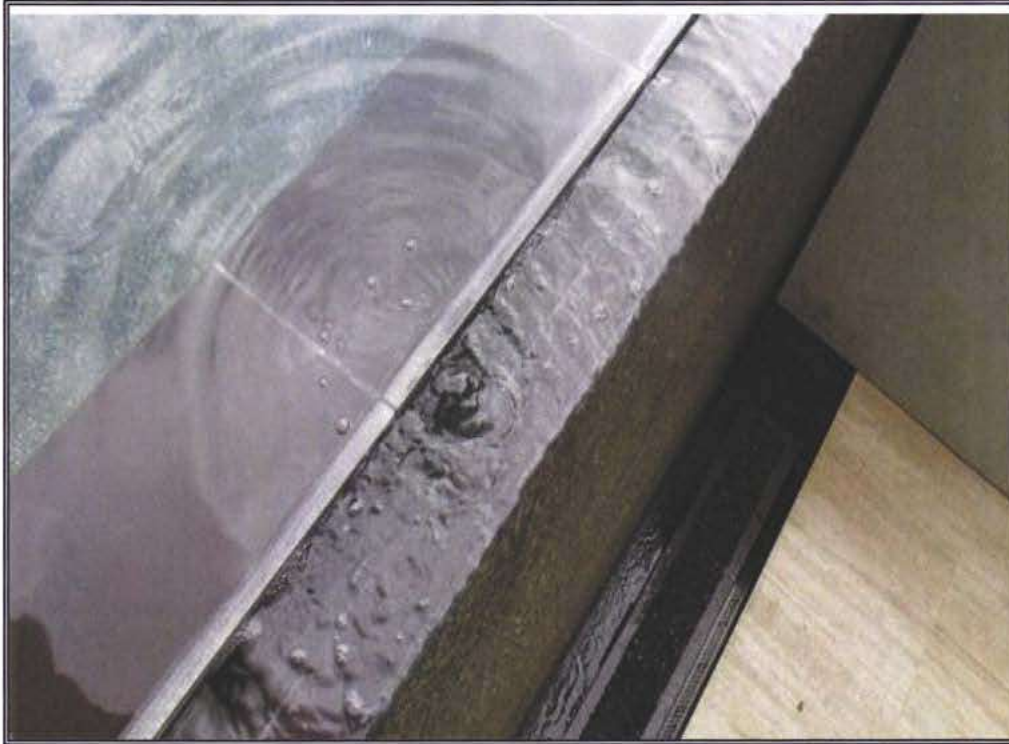
The spa equipment is integrated with the pool equipment. The swimming pool and its related equipment were in operation and appear to be in serviceable condition. The exception to this is that the water distribution for the water wall should be adjusted to reduce splashing.

The water flow at the water feature should be adjusted to prevent splashing.
